REPUBLIC OF SERBIA  
CENTER FOR INVESTIGATION OF ACCIDENTS IN TRANSPORT  
SECTOR FOR INVESTIGATION OF ACCIDENTS IN RAILWAY TRAFFIC  
Nemanjina 11, 11000 Belgrade

## FINAL REPORT ON SERIOUS ACCIDENT INVESTIGATION

Serious accident type: Train derailment

Place: City of Pirot, outskirts of the village of Sopot, open track  
between the Staničenje crossing point and the Pirot station

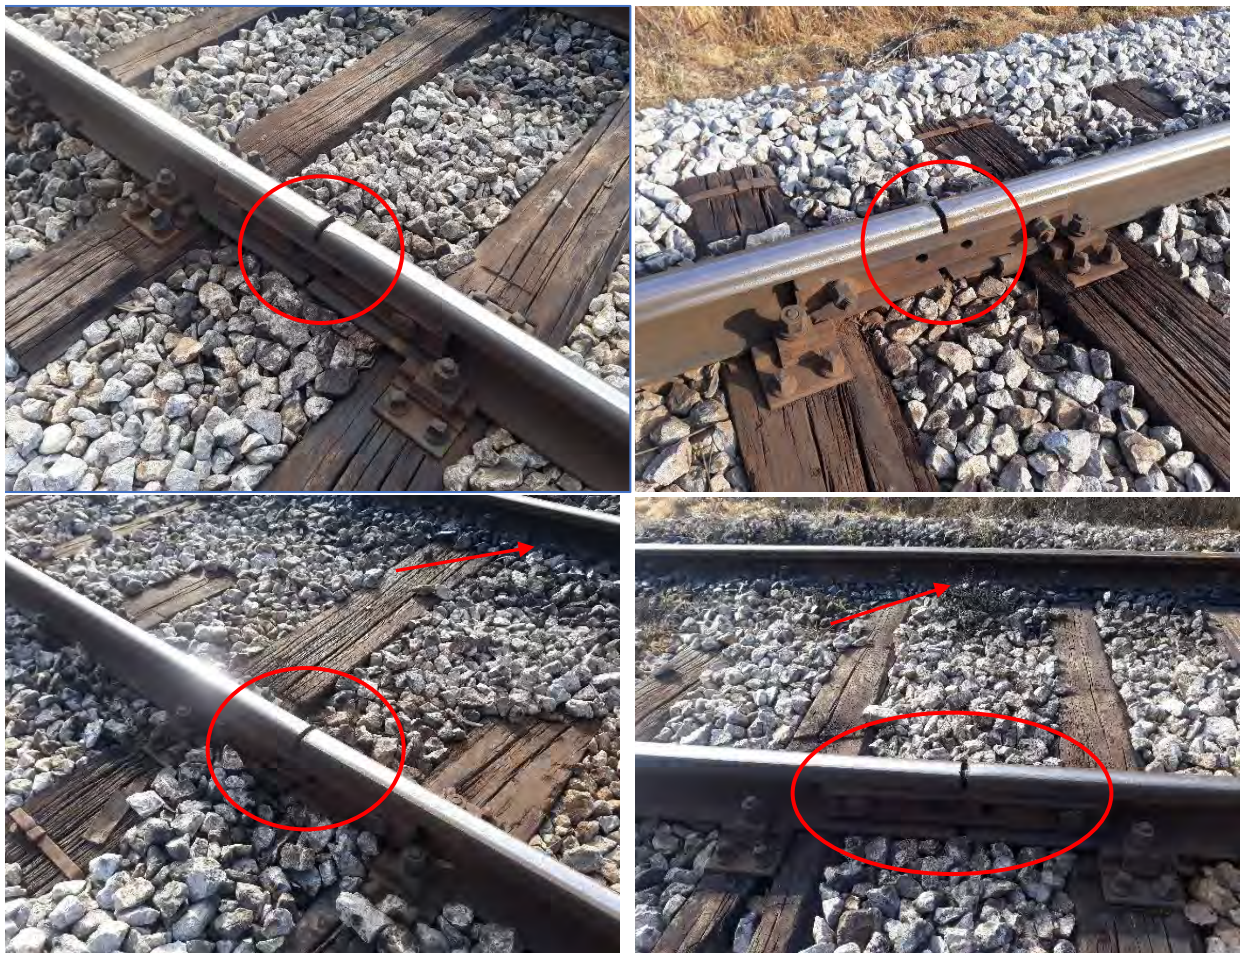
In the broader area of the serious accident site, several non-aligned floating rail joints have been observed. The appearance of these rail joints is shown in Figure 3.4.2.2.

**Figure 3.4.2.2:** Appearance of rail joints (source: “IŽS”a.d.)

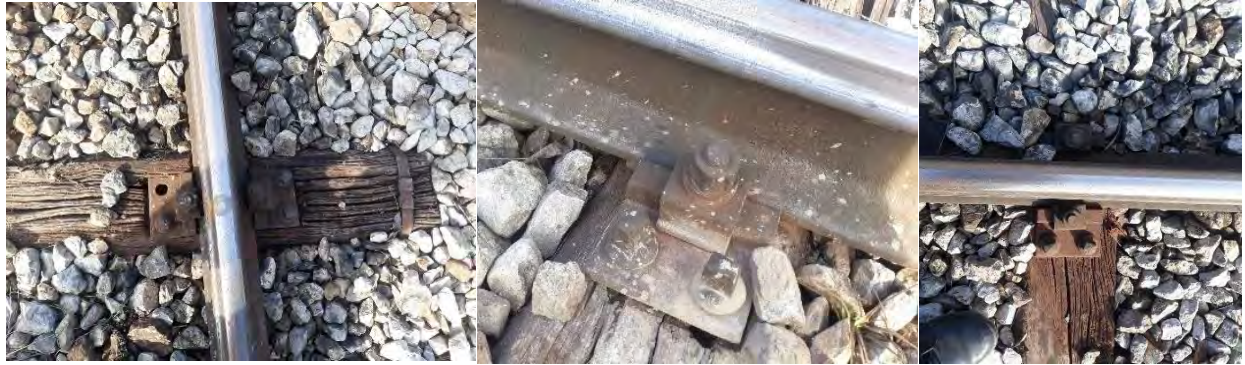
Between the Staničenje crossing point and the Pirot station, from km 63+800 to km 72+900, wooden sleepers have been installed at a distance of 60 cm with fastening equipment of type “K”. The appearance of the sleepers and the fastening equipment is shown in Figure 3.4.2.3.

**Figure 3.4.2.3:** Appearance of track fastening equipment (source: “IŽS” a.d.)

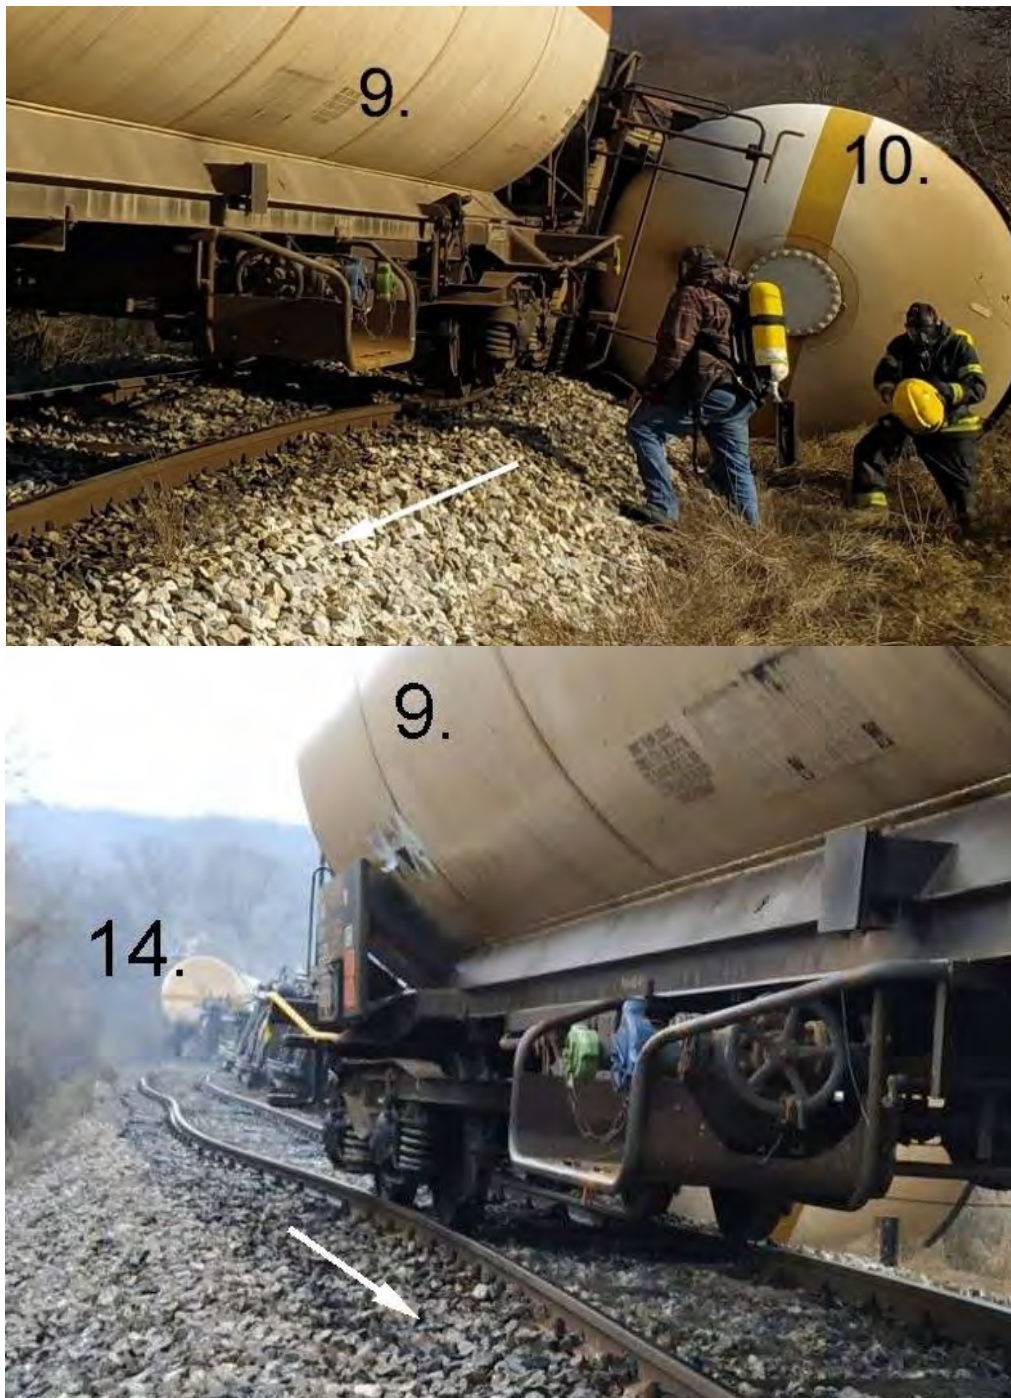
The locomotive No. 661-249 and the first eight wagons were located on the track. The front bogie of the ninth wagon No. 33 87 7813 563-6 was standing on the track. The rear bogie had both left wheels (when viewed in the direction of movement) on a rail that was transversely deformed towards the inside of the curve (image 4.2.1.2.). Due to this deformation, the two right wheels of the rear bogie pedestal became trapped in the track. Based on the shape of the deformed couplings and the coupling guides between the ninth and tenth wagons No. 33 87 7813 580-0, as well as their relative position, it can be concluded that the track deformation occurred due to the pulling of the rear end of the ninth wagon by the tenth wagon during their overturning.

**Figure 4.2.1.2:** Position of the ninth wagon rear bogie

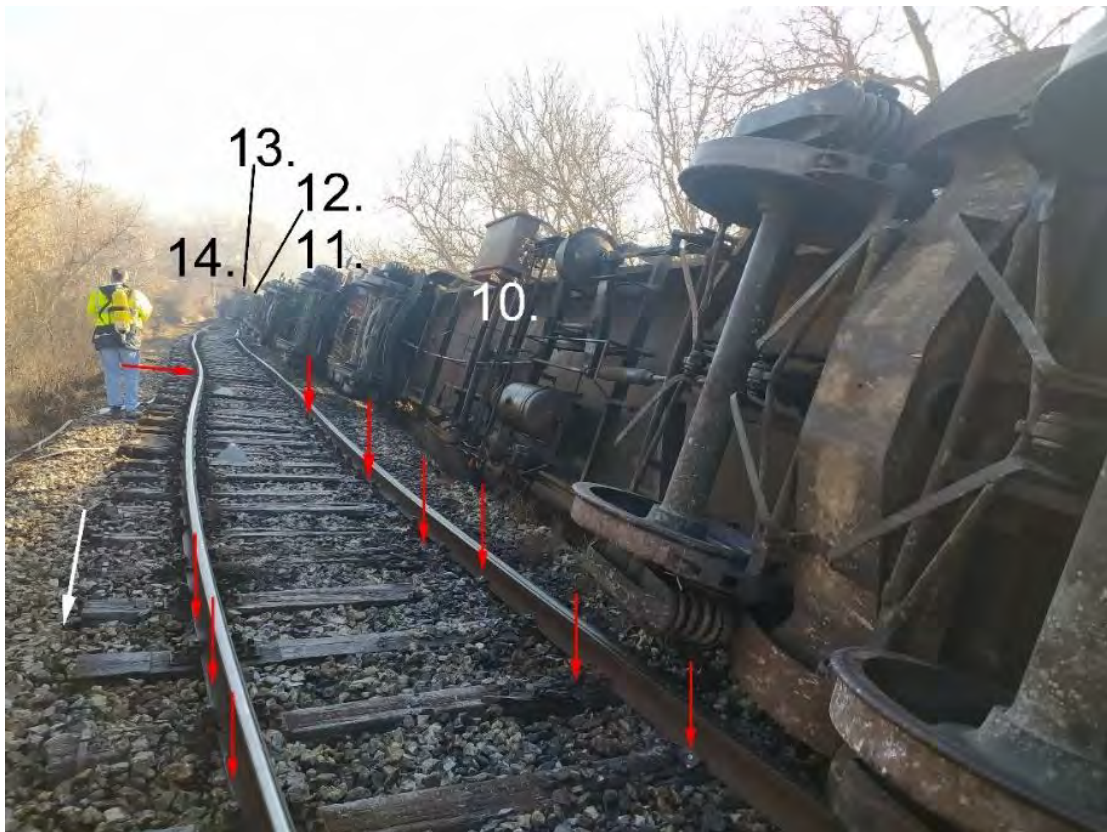
The tenth wagon No. 33 87 7813 580-0, eleventh wagon No. 33 87 7813 586-7, twelfth wagon No. 33 80 7922 029-3, and thirteenth wagon No. 33 80 7818 081-1 overturned on their left side, towards the inside of the curve (image 4.2.1.3). Traces of movement of the derailed wheels can be seen on the track extending up to the front axle of the tenth wagon (indicated on the image by vertical red arrows).

**Figure 4.2.1.3:** Appearance of the derailed wagon from tenth to thirteen

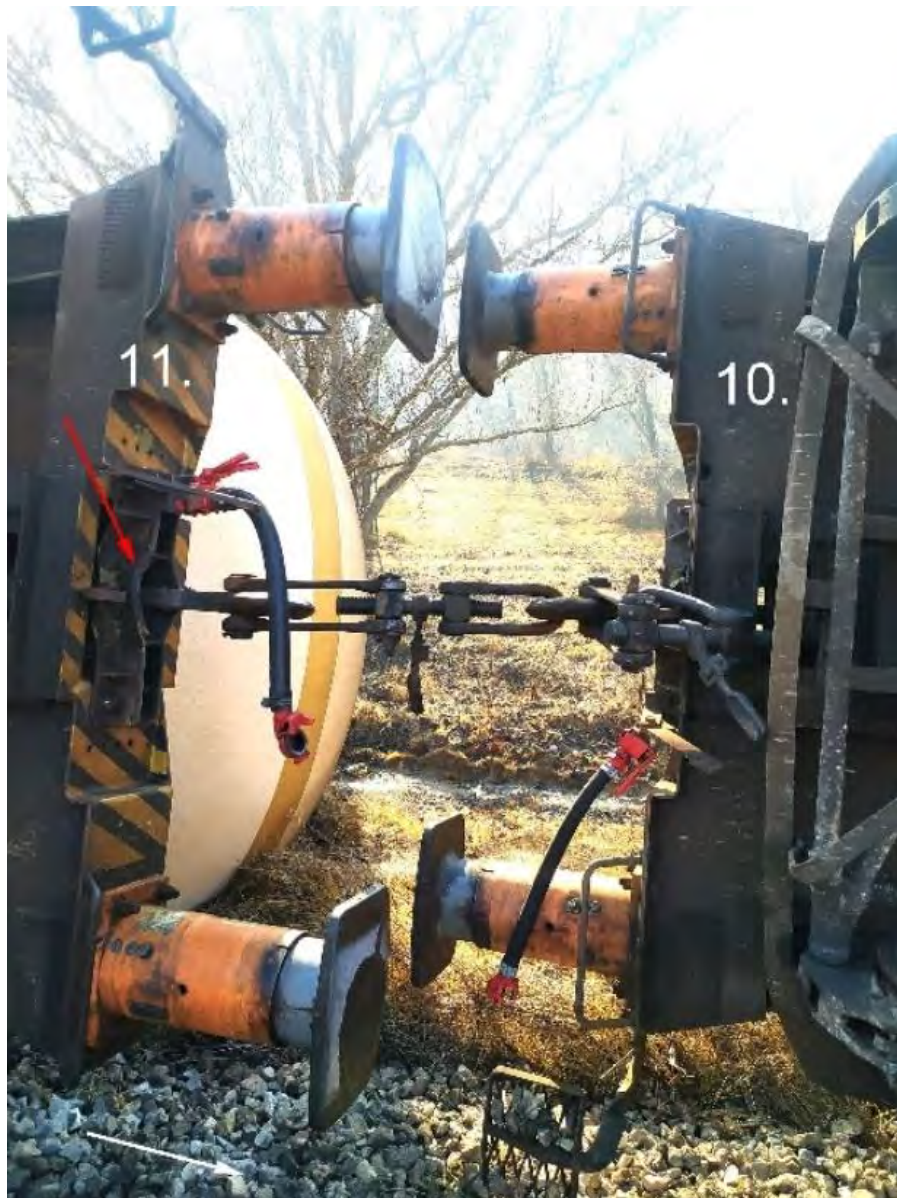
In the zone of the rear bogie of the tenth wagon, the track is transversely deformed towards the inside of the curve. Based on this, as well as on the basis of the deformations of the traction devices and the guides of the traction devices between the tenth and eleventh wheels (Figure 4.2.1.4.), it can be concluded that the eleventh wheels pulled the tenth wheels to the side during the overturning, caused the deformation of the track, and then the overturning of ten wagons.

**Figure 4.2.1.4:** Joint position of the overturned tenth and eleventh wagon

In Figure 4.2.1.4., it is observed that the brake couplings are disconnected, which indicates a strong tightening in the connecting hoses during the relative rotation of the tenth and eleventh wagon during overturning.

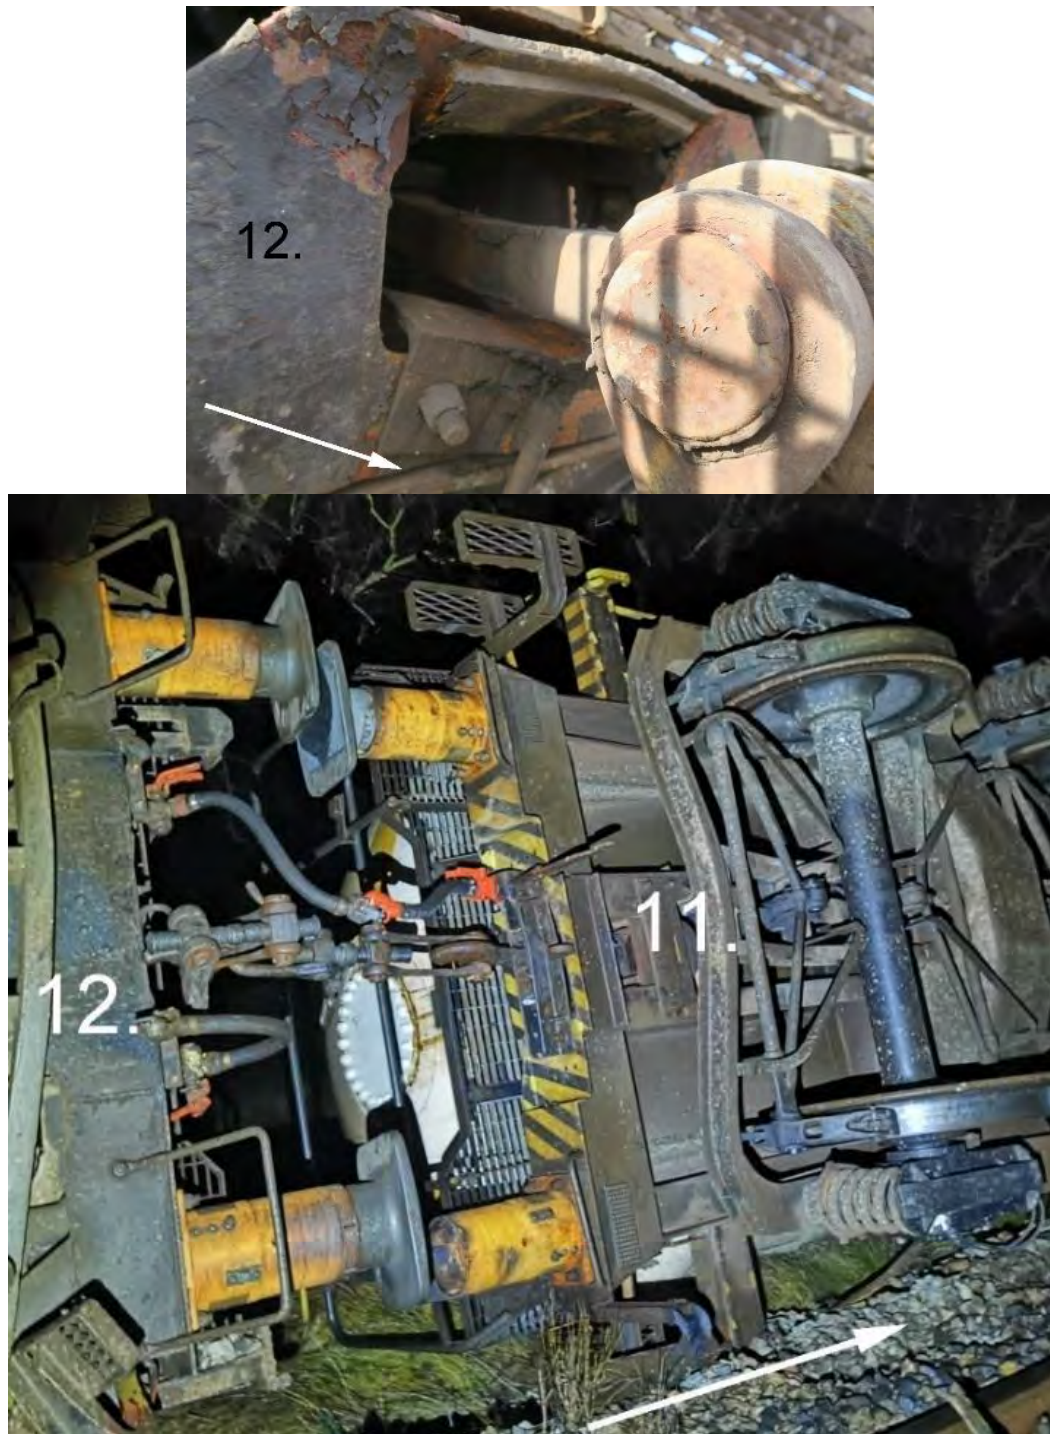
**Figure 4.2.1.5:** Draw devices of the eleventh and twelfth wagon

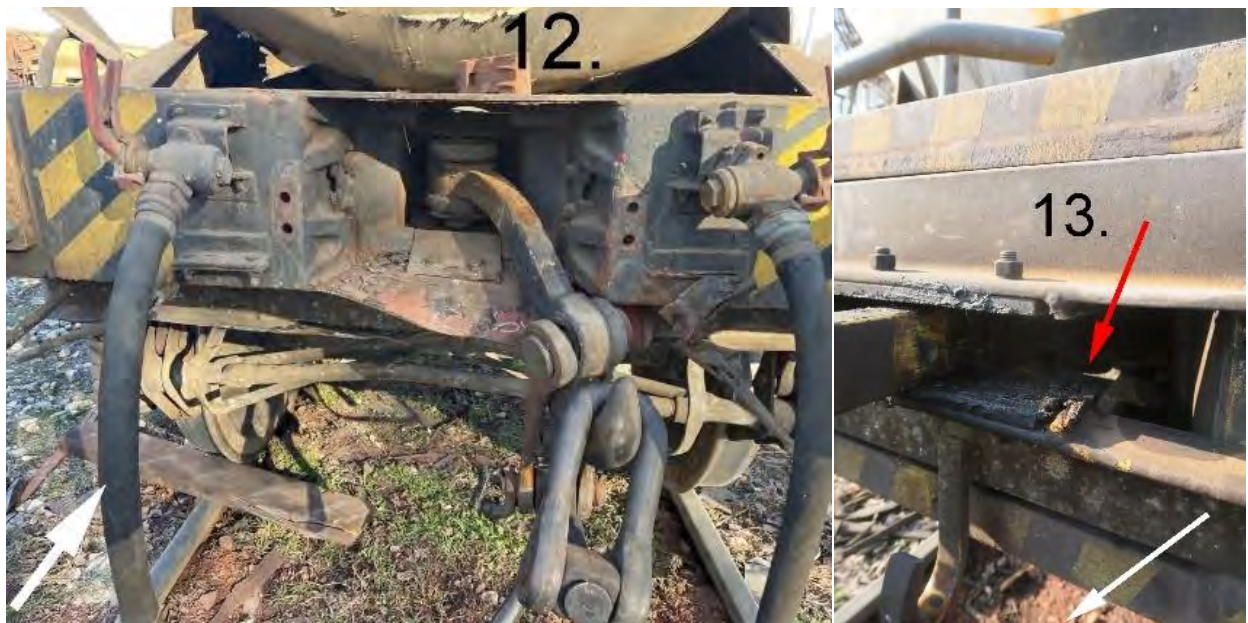
Figure 4.2.1.6. shows deformed hooks and their guides between the twelfth and thirteenth wagon. The neck of the twelfth wagon hook is strongly bent downwards and to the right relative to the direction of movement. The left (in relation to the direction of movement) boundary of the thirteenth car's hook is detached, and the neck of the hook is slightly deformed on that side. These deformations indicate that the twelfth wagon strongly pulled the thirteenth wagon to the side during overturning, after which the thirteenth wagon also overturned.

**Figure 4.2.1.6:** Deformed hooks and guides between the twelfth and thirteenth wagon

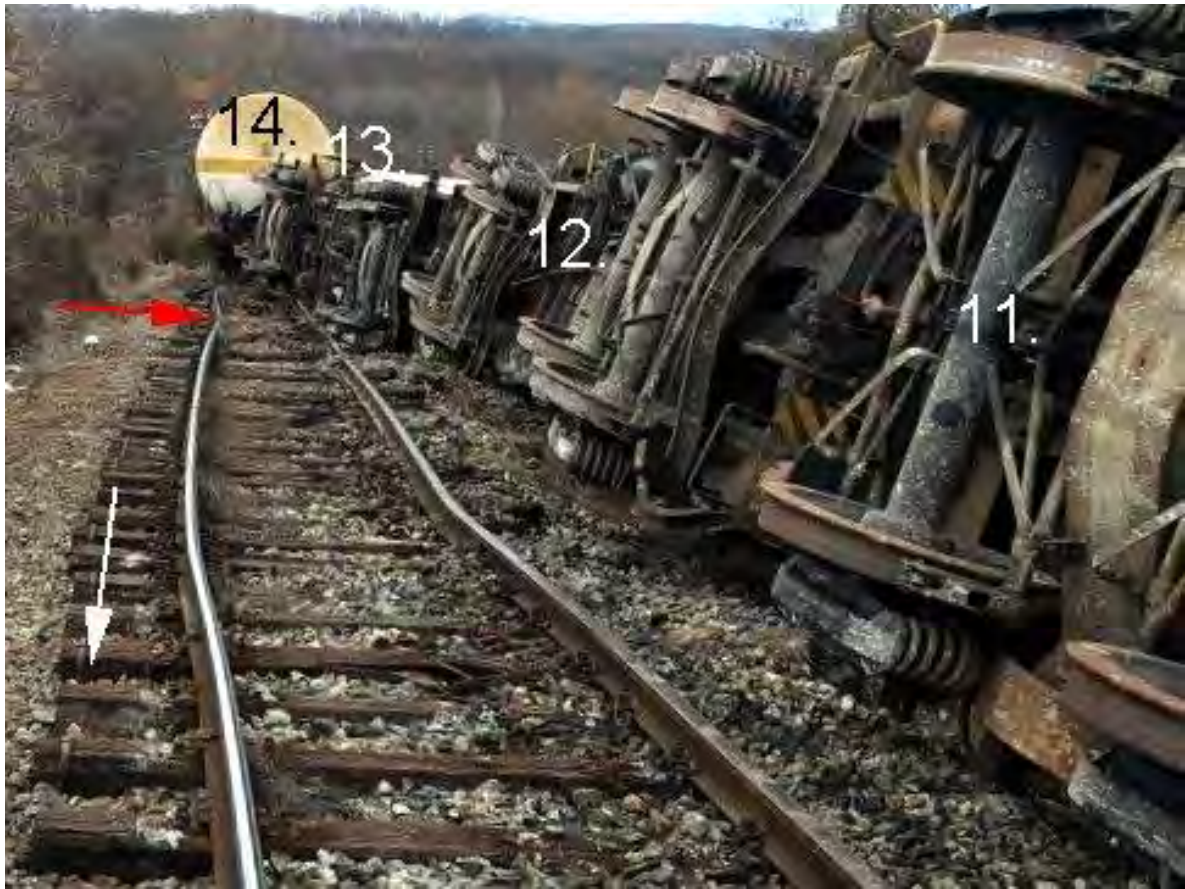
Figure 4.2.1.7. shows the transverse deformation of the rails (indicated by the red arrow) in the area of the front bogie of the thirteenth wagon, which indicates a strong pulling of that end of the wagon to the side before their overturning.

**Figure 4.2.1.7:** Track deformation in the zone of the front thirteen wagon bogie

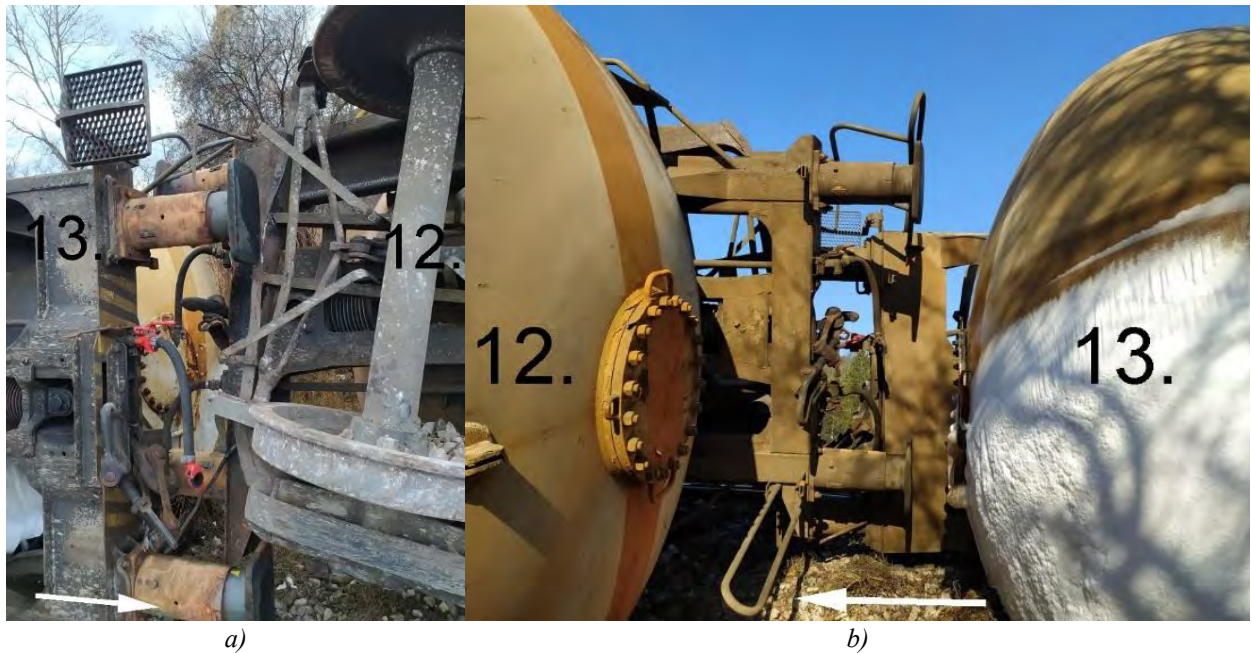
The brake couplings also disconnected during the overturning, due to the strong tightening in the connecting hoses.

**Figure 4.2.1.8:** Condition found between the twelfth and thirteenth wagon

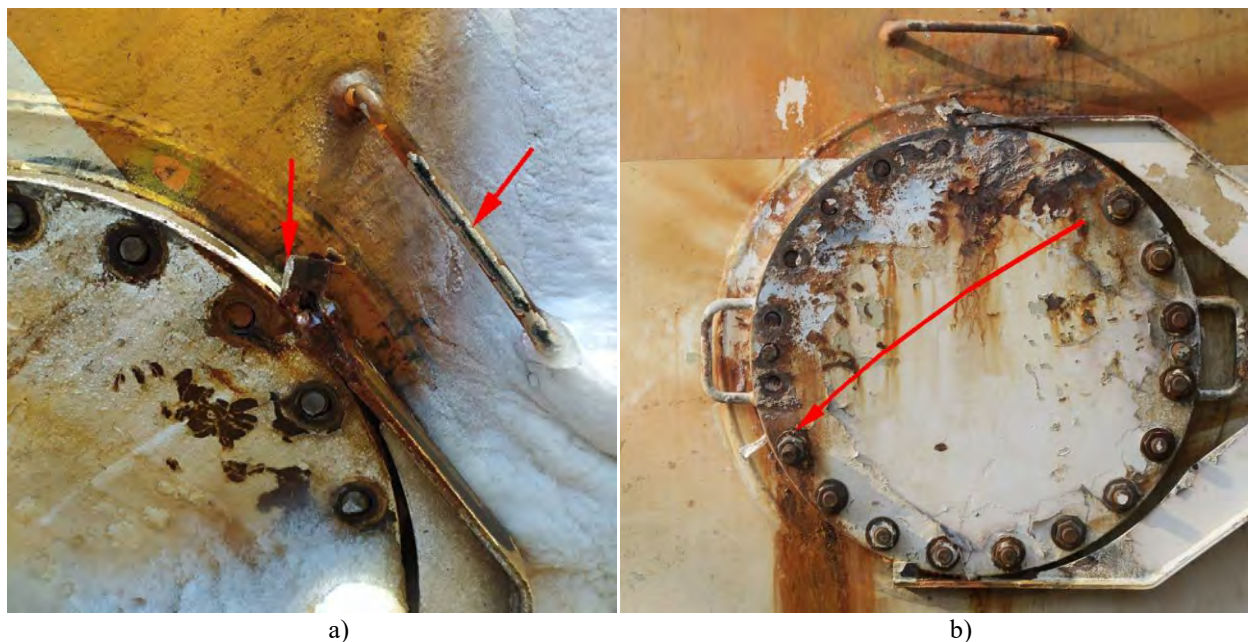
There has been a leak of ammonia under the inspection hole cover of the thirteenth wagon. In image 4.2.1.9. a), taken at the scene, the cover is shown with detached screws, as well as traces of scratched paint on the handle above the inspection hole and on the cover holder. Eight out of twenty screws have been detached, and the contact marks can still be seen on one screw in front and one screw behind the group of detached ones. In image 4.2.1.9. b), which was taken during a subsequent inspection of the wagon at the “Inter-mehanika” d.o.o. Skorenovac workshop in Smederevo on 08.02.2023, it can be observed that all the detached screws in the cover openings have been shifted in the direction indicated by the arrow. This suggests that they were detached by sliding in the same direction.

**Figure 4.2.1.9:** Damages on the inspection hole cover of the thirteenth wagon

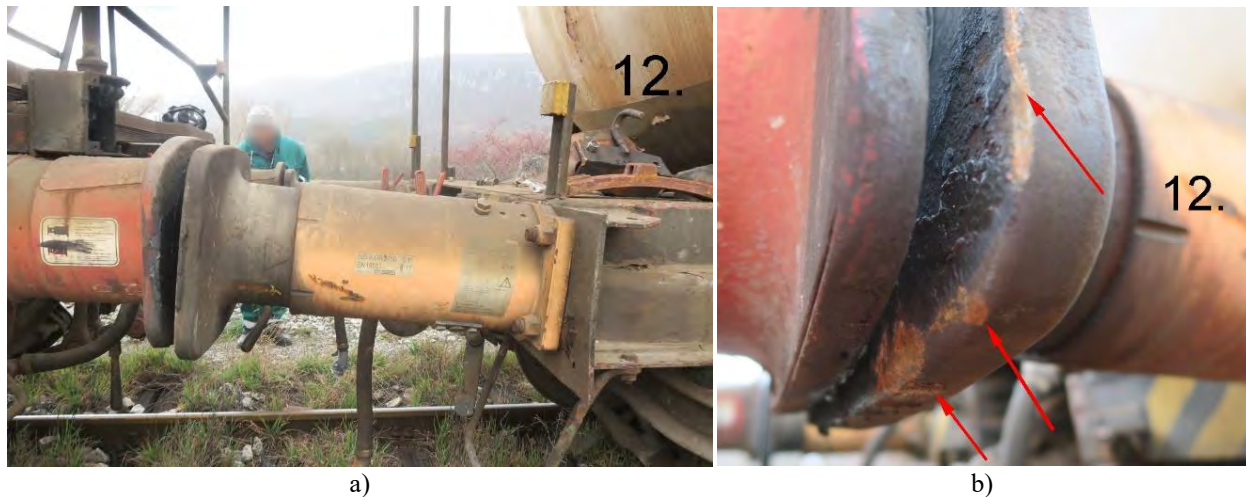
In Fig.4.2.1.10. the rear right buffer of the twelfth wagon is shown after lifting the wagon for inspection on 19.01.2023. The buffer is tilted upwards with deformation of the attachment plane on the chest beam (see image 4.2.1.10. a)). On the lower and right side of the buffer plate, there are surface traces of damage (see image 4.2.1.10. b)).

**Figure 4.2.1.10:** Bent buffer and traces on the buffer plate of the twelfth wagon

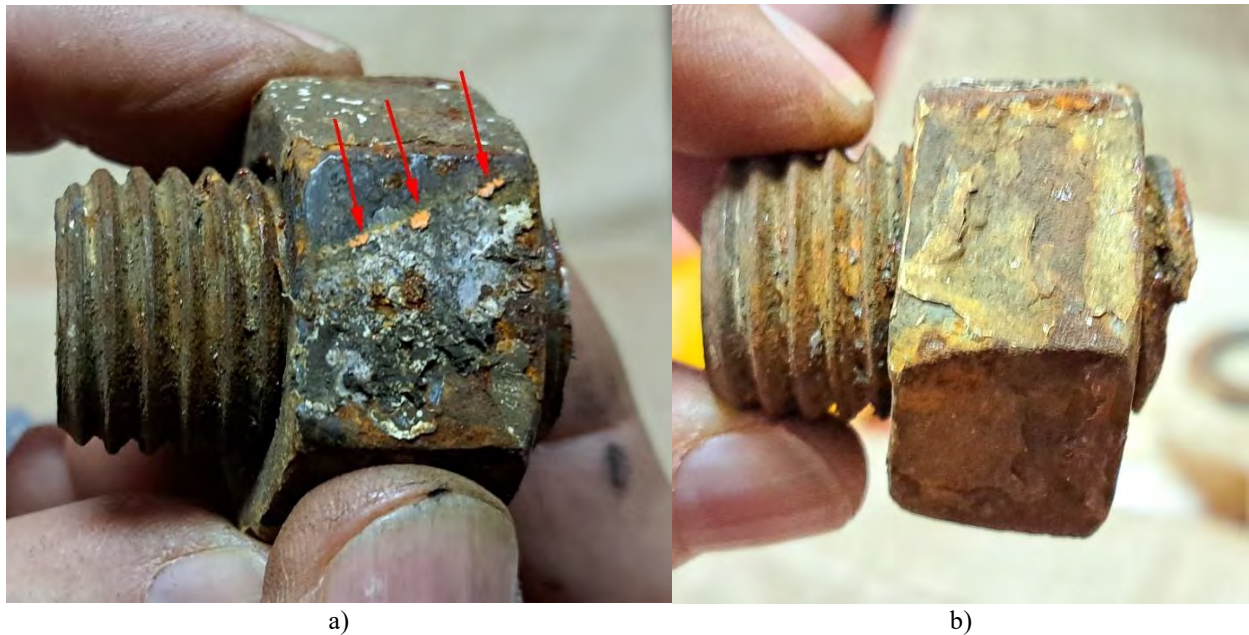
On one side of nut 1 (Figure 4.2.1.11. a)), a gray area is visible, which differs from the rusty appearance of the other sides. Traces of paint, which could come from an impact with the buffer plate shown in Figure 4.2.1.10. b)), are also observed. Nut 2 (Figure 4.2.1.11. b)) is deformed from the received lateral impact.

**Figure 4.2.1.11:** The appearance of the found severed screws

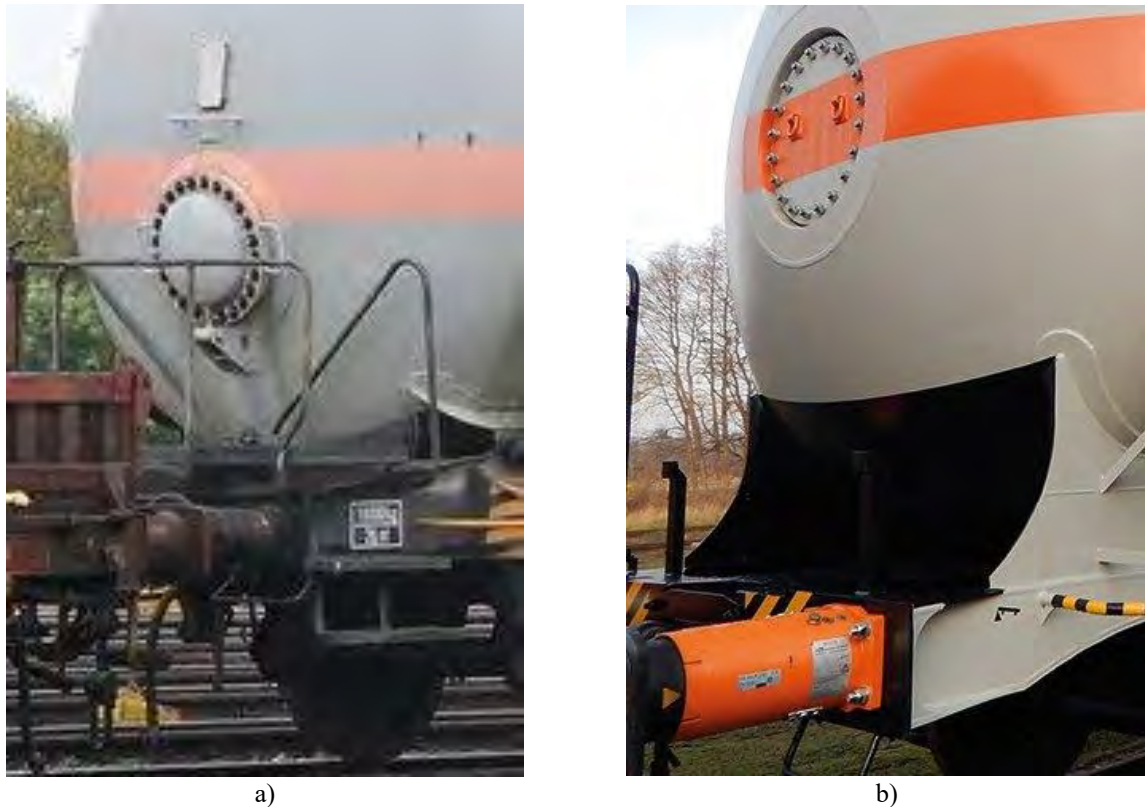
**Figure 4.2.1.12:** Appearance of structural variations of the inspection hole cover

An even better solution is shown in Figure 4.2.1.12. b), with a recessed inspection hole, which would probably avoid screw severing and gas leakage in such accidents. Additionally, the recessed inspection hole is positioned in the center of the beam, which reduces the likelihood of contact with neighboring buffers in accidents similar to this one.

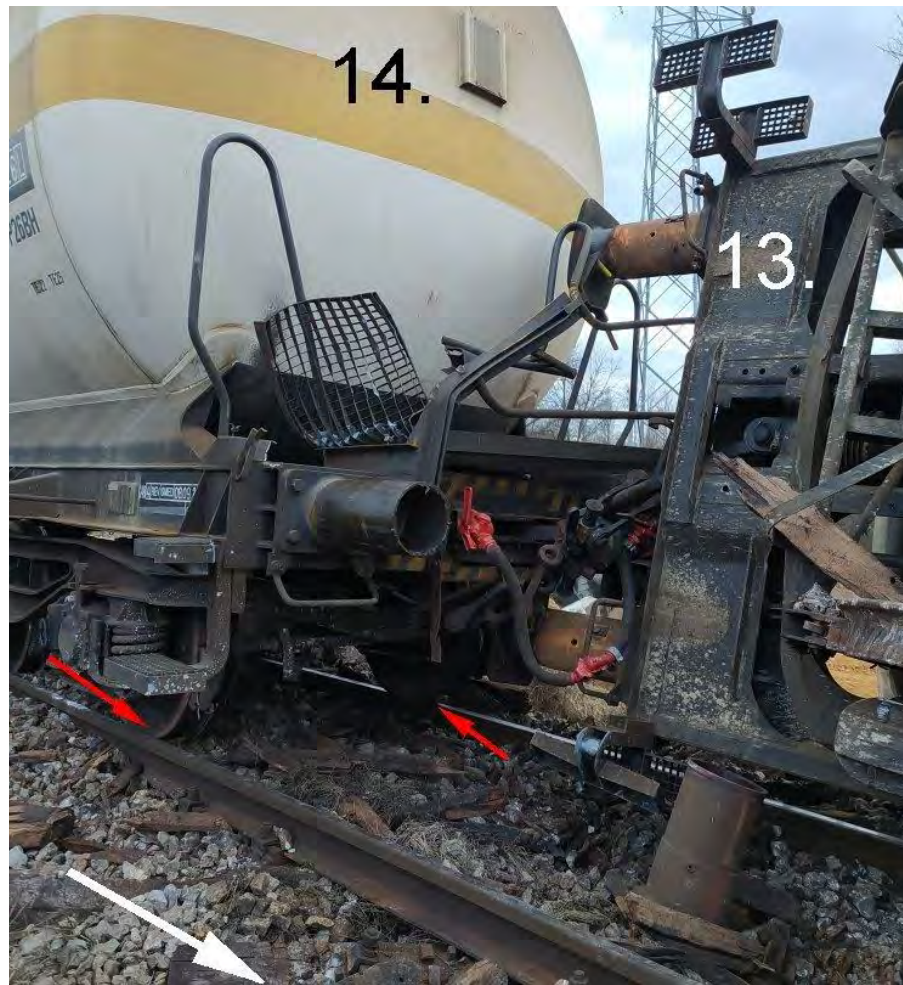
The buffer sleeve on the front right buffer of the fourteenth wagon fell off.

**Figure 4.2.1.13:** The condition found between the thirteenth and the fourteenth wagon

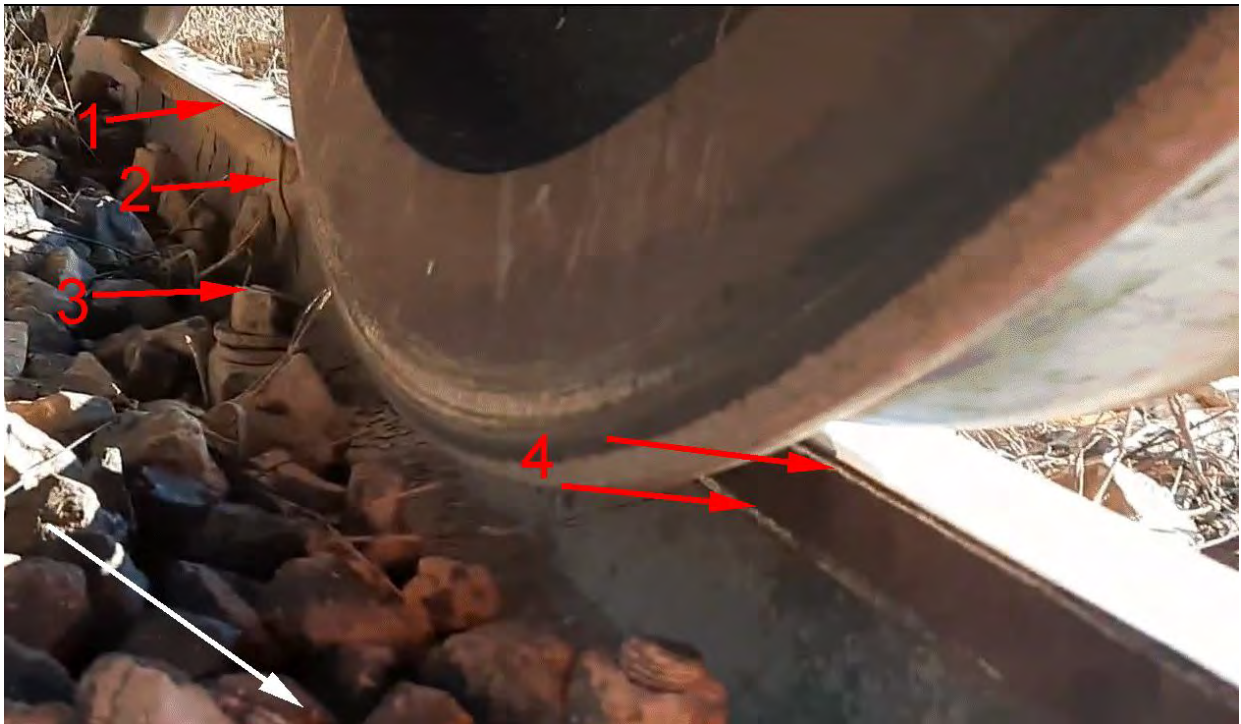
On the outer, right rail in the direction of movement, there are no signs of derailment.

**Figure 4.2.1.14:** Trace of the first fall of the wheel into the track

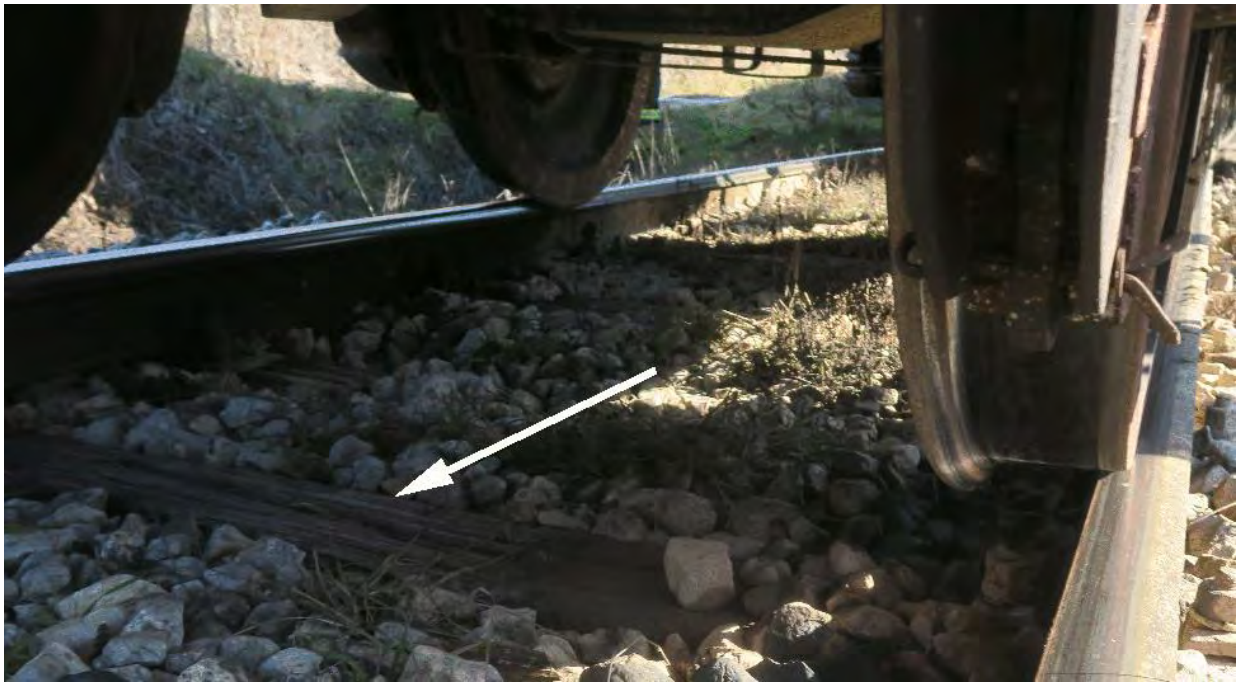
Figure 4.2.1.15. shows the observed position of the inner point of the third axle of the seventeenth wagon No. 33 80 7814 612-7, which is the closest to the point of impact. Under the weight of the wagon, in a stationary state, the wheel rests on the rail with a width of approximately 15 mm. At the scene, under the weight of the train in front of the third axle of the seventeenth wagon, the width of the railway track was measured using the “Geismar” measuring instrument owned by “IŽS” a.d. The width of the railway track was beyond the measurement range of the instrument (1475 mm), and it was estimated to be approximately 1490 mm. Towards the front part of the seventeenth wagon, the width was even greater, meaning further outside the scale of the measuring instrument. Nevertheless, the rear part of the fourteenth, fifteenth, sixteenth, and seventeenth wagons crossed the widened railway track and remained with their wheels on both rails.

**Figure 4.2.1.15:** Position on the rail of the third axle of the seventeenth wagon's left wheel

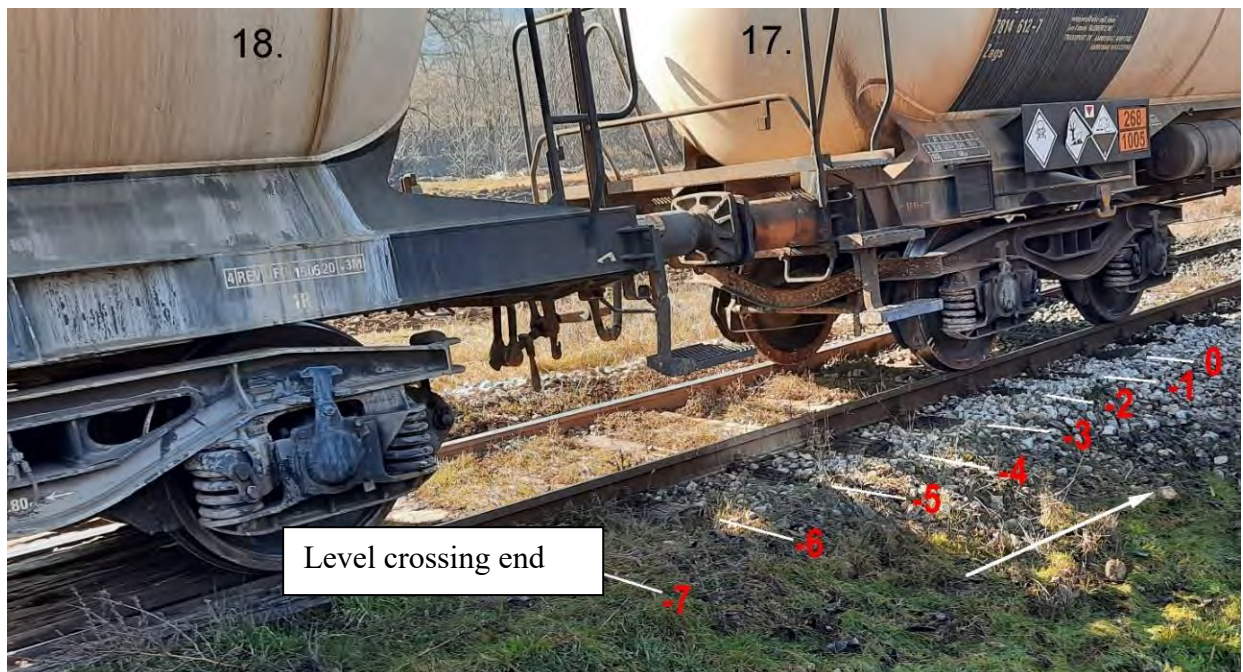
Figure 4.2.1.16. shows the sleeper where the first deformation on the top of the screw caused by the wheel's impact was found, marked as the zero sleeper. Sleepers in front of the impact site are marked with negative numbers, while sleepers after the impact site are marked with positive numbers (see Figure 4.2.1.19.).

**Figure 4.2.1.16:** Point of the falling of the wheel into the track (zero sleeper)

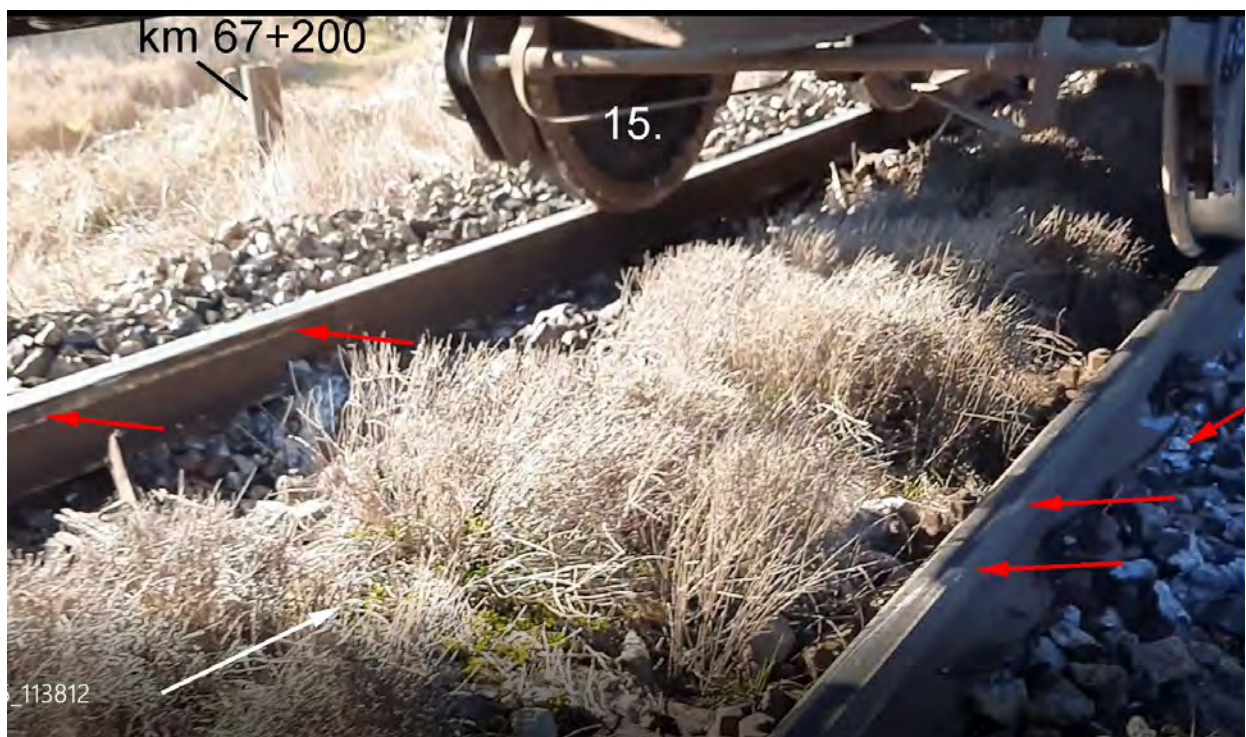
Based on this, it can be assumed that only one wheel, most likely from the front axle, fell onto the railway track, and therefore, the bogie had support along the other diagonal all the way to km 67+203. At that location, there are traces of derailment on the outer side of the right rail, and the trace of scraping from the fallen point on the left rail ceases (Figure 4.2.1.17.).

**Figure 4.2.1.17:** Trace of derailment on the right rail

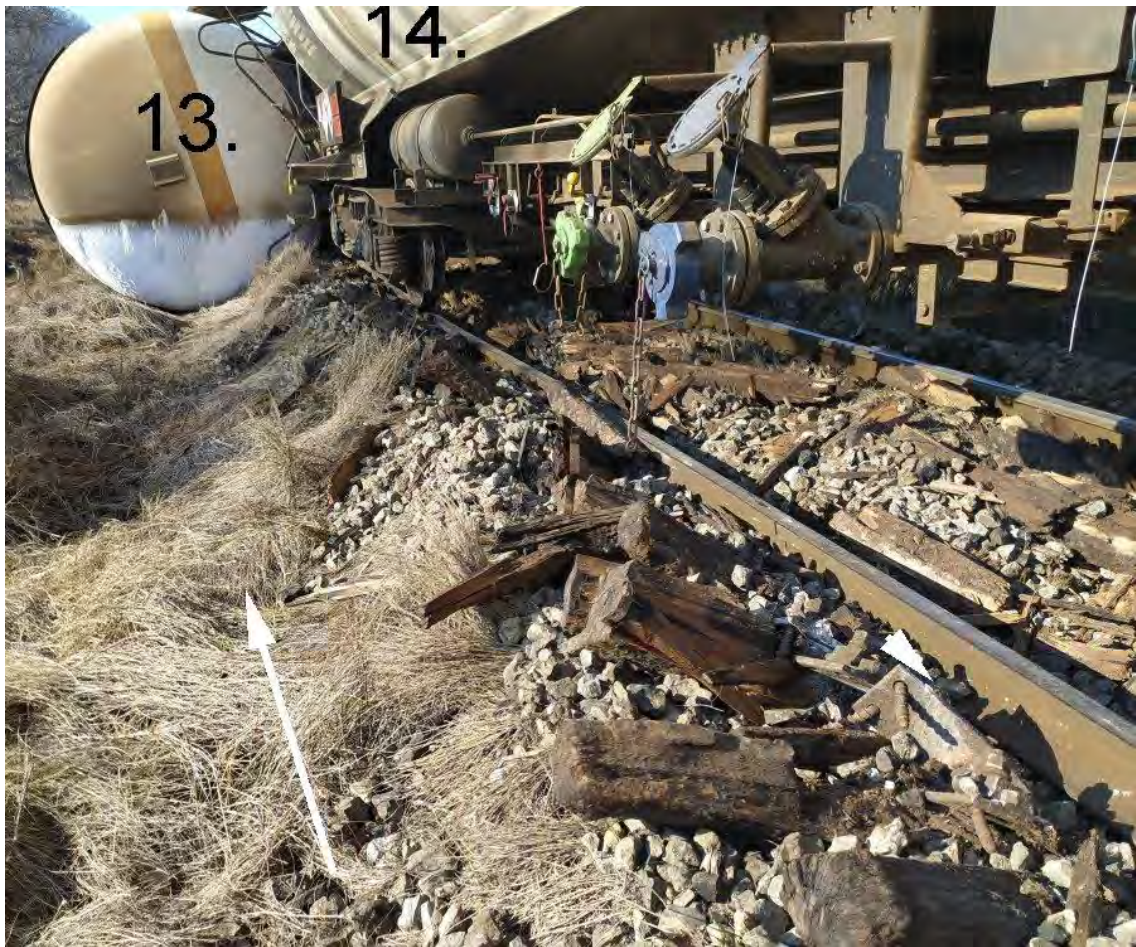
Over the next twenty meters, the railway track is severely damaged with torn-up sleepers, leading to the point where four wagon-tanks were overturned (Figure 4.2.1.18.). It was not possible to determine how many axles in total derailed before the wagon-tanks overturned. However, it is confirmed that the traces of derailment extend all the way to the first axle of the tenth wagon (Figure 4.2.1.3.), so there is a probability that this axle was the first to derail.

**Figure 4.2.1.18:** Severely damaged track in the fourteenth wagon area

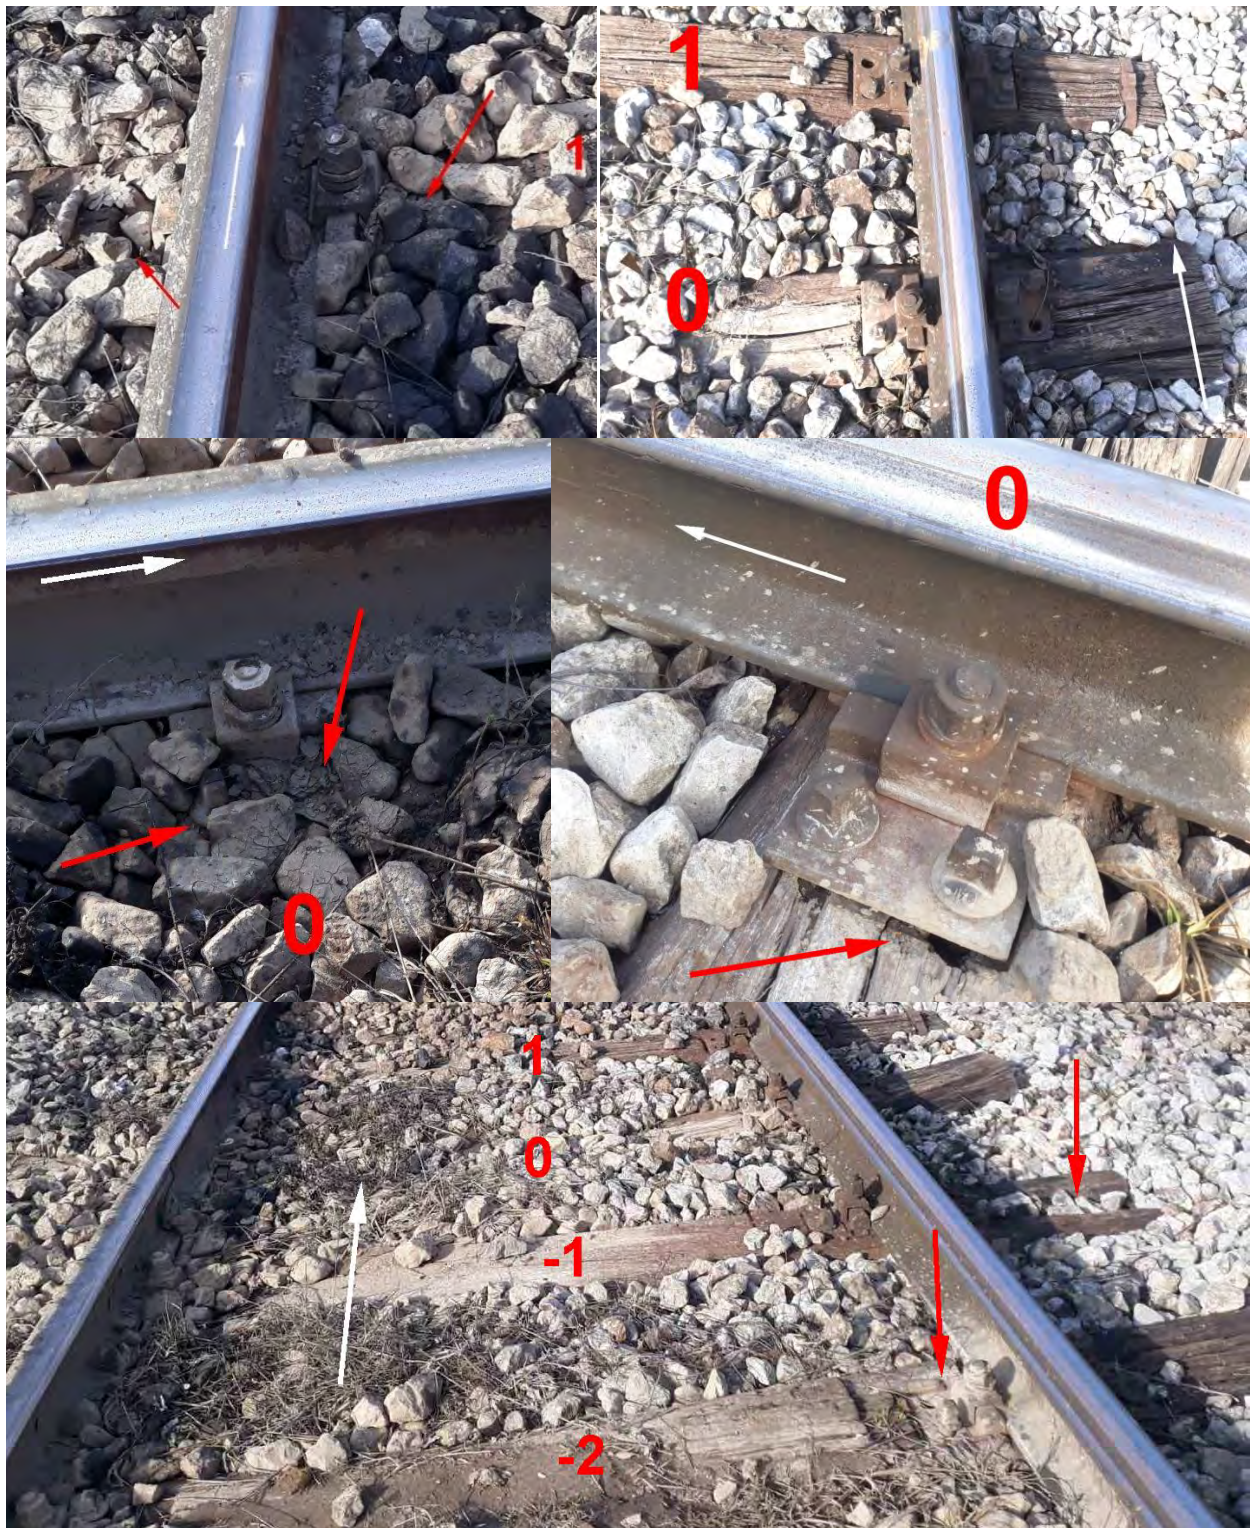
Figures from 4.2.1.19. to 4.2.1.21. show examples of the condition of the fastening equipment in the area of the first wheel derailing. Given that the expansion of the railway track required for the wheels derailing occurred during approximately one rotation of the wheel, the available images of the fastening equipment cover approximately 3 m before the point of derailing. A similar condition of the fastening equipment exists in the broader area around that location. On all sleepers, there is evidence of cracking, with some sleepers showing direct alignment with the tyrphons. Multiple tyrphons are missing, and the remaining ones are partially pulled out or loose. The ballast is soiled and partially muddy.

**Figure 4.2.1.19:** Condition of the fastening equipment in the area of the first wheel derailment
