REPUBLIC OF SERBIA  
CENTER FOR INVESTIGATION OF ACCIDENTS IN TRANSPORT  
SECTOR FOR INVESTIGATION OF ACCIDENTS IN RAILWAY TRAFFIC  
Nemanjina 11, 11000 Belgrade

## FINAL REPORT ON SERIOUS ACCIDENT INVESTIGATION

Serious accident type: Train derailment

Place: City of Pirot, outskirts of the village of Sopot, open track  
between the Staničenje crossing point and the Pirot station

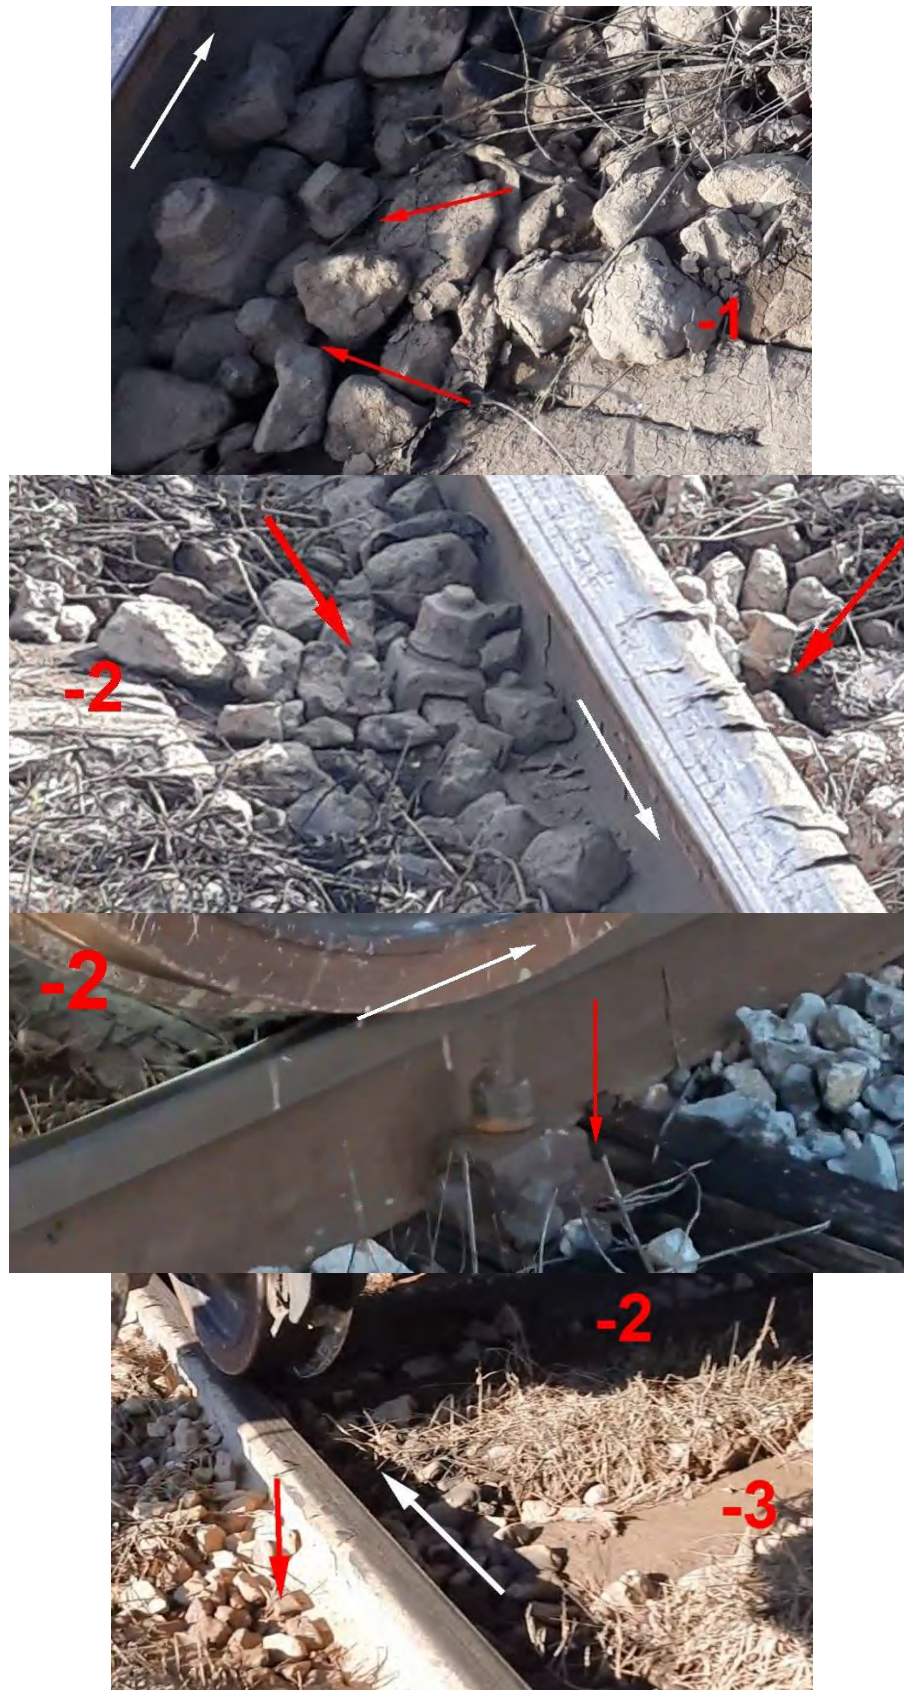
Figures from 4.2.1.19. to 4.2.1.21. show examples of the condition of the fastening equipment in the area of the first wheel derailing. Given that the expansion of the railway track required for the wheels derailing occurred during approximately one rotation of the wheel, the available images of the fastening equipment cover approximately 3 m before the point of derailing. A similar condition of the fastening equipment exists in the broader area around that location. On all sleepers, there is evidence of cracking, with some sleepers showing direct alignment with the tyrphons. Multiple tyrphons are missing, and the remaining ones are partially pulled out or loose. The ballast is soiled and partially muddy.

**Figure 4.2.1.20:** Condition of the fastening equipment in the zone of the first wheel derailment

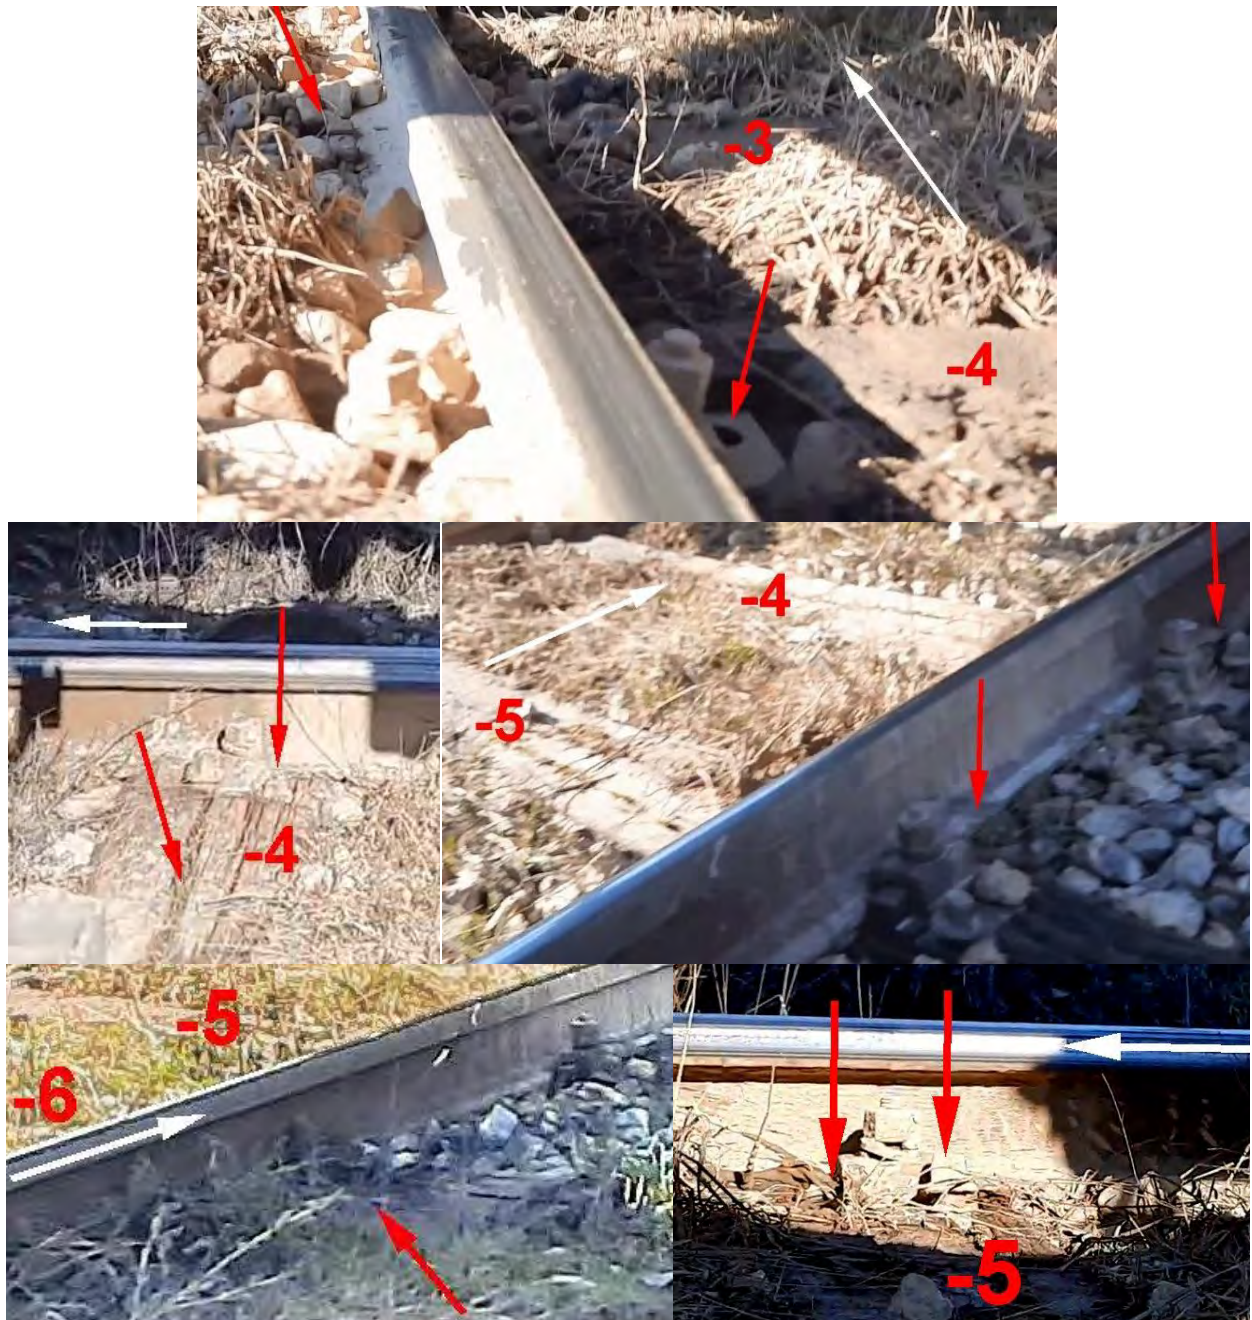
**Figure 4.2.1.21:** Condition of the fastening equipment in the zone of the first wheel derailment

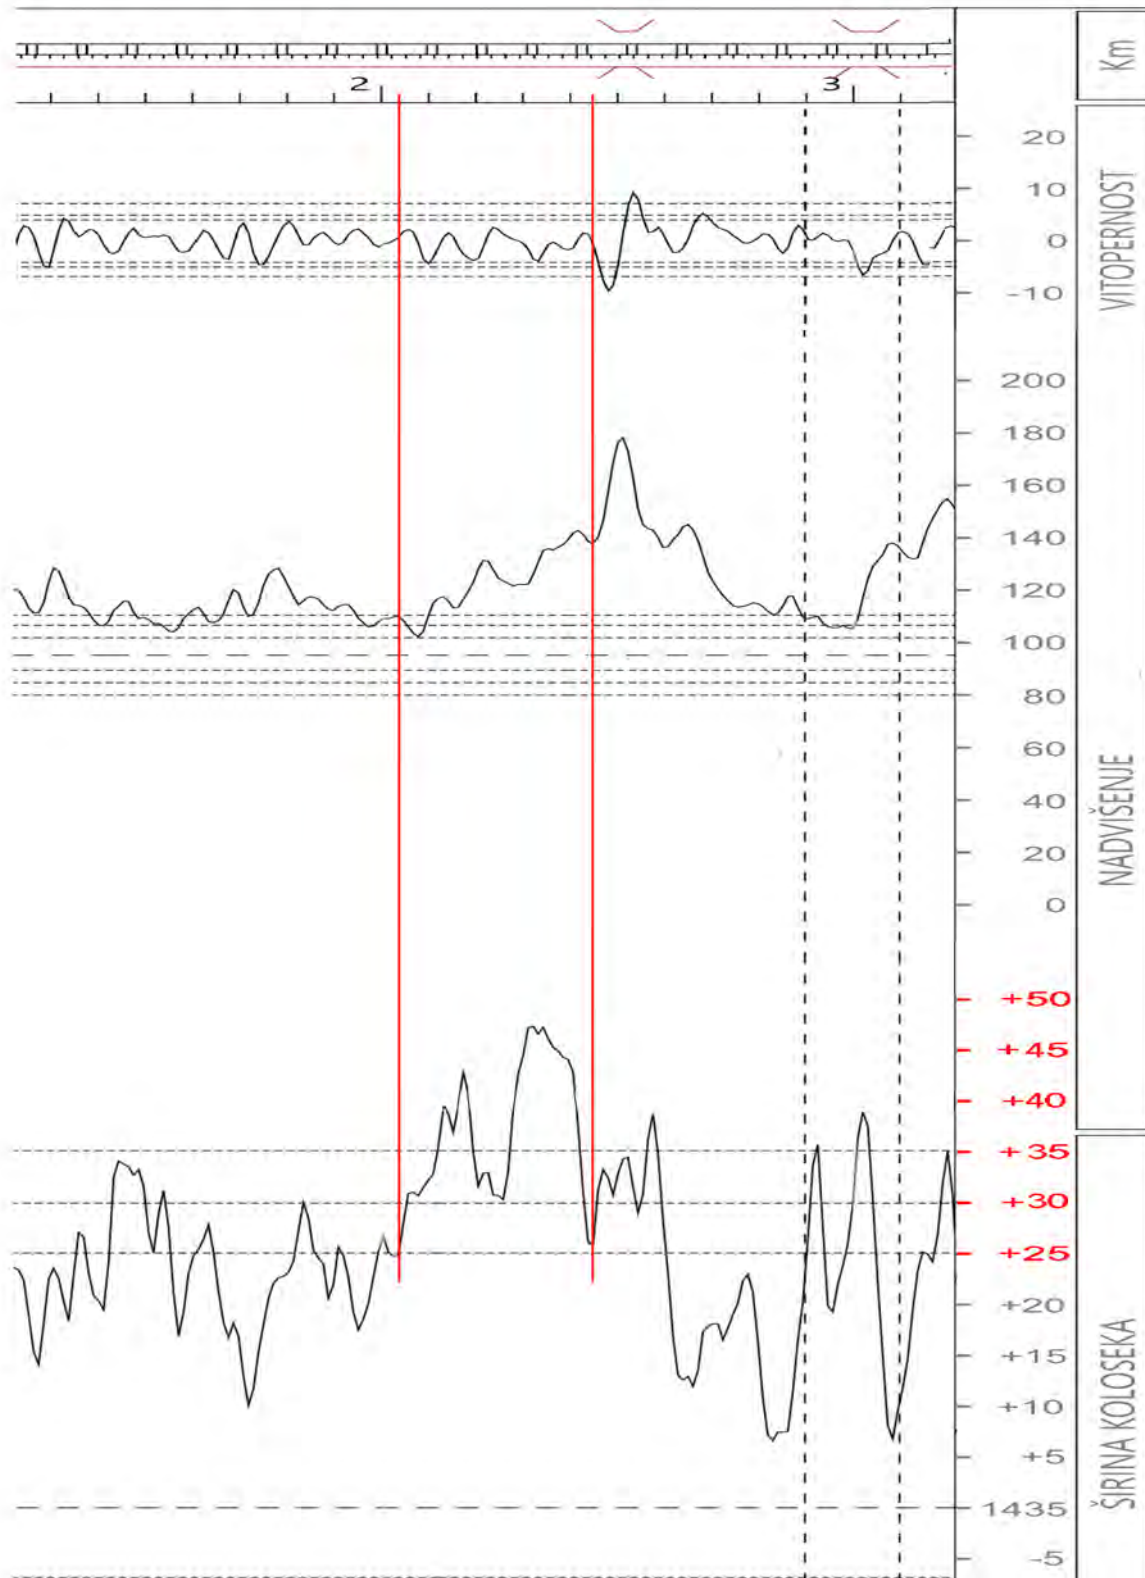
The data provided indicate that due to the large excess of cross level, the vertical load on the inner (left in the direction of movement) wheels was increased. At the same time, the change in twist between two values above the current intervention boundary further triggered oscillations around the longitudinal axis, resulting in even greater amplitude load on the inner wheels. In combination with the lateral guiding force in the curve, the very poor condition of the fastening equipment and sleepers led to the spreading of the rail heads and the derailment of the inner point into the railway track. This has occurred on the axle where at a given moment a critical combination of a number of the mentioned parameters simultaneously happened, some of which have a random oscillatory character.

**Figure 4.2.1.22:** The geometric condition of the railway track in the zone of the wheel's derailment

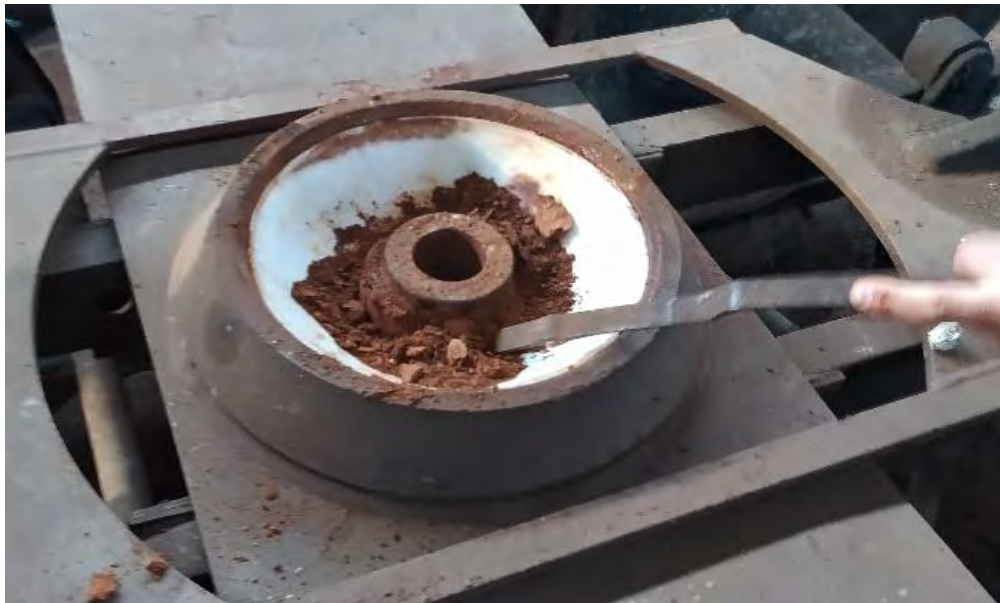
Figure 4.2.2.1. shows the center bowl with foreign material from the tenth wagon (which was provided with the complaint from the representative of “IŽS” a.d.).

**Figure 4.2.2.1:** Center bowl with the foreign material of the tenth wagon

Although there is red soil present in the wider area of the serious accident, similar to the one in Figure 4.2.2.1, photographs from the scene of the serious accident show that the overturning of the tenth wagon occurred on the ballast without visible traces of excavated red soil. Therefore, it is unlikely that the soil entered the center bowl during the serious accident. On the other hand, the probability of this happening during normal operation is even lower, especially since similar occurrences were not observed in the other center bowl. The third possibility is that soil entered the center bowl during the unfastening of the bogies in some workshop, which is also unlikely since the previous revision was performed only three months before the serious accident (on 26.9.2022) in Smederevo, and according to the provided data, there was no extraordinary maintenance from that time until the serious accident.

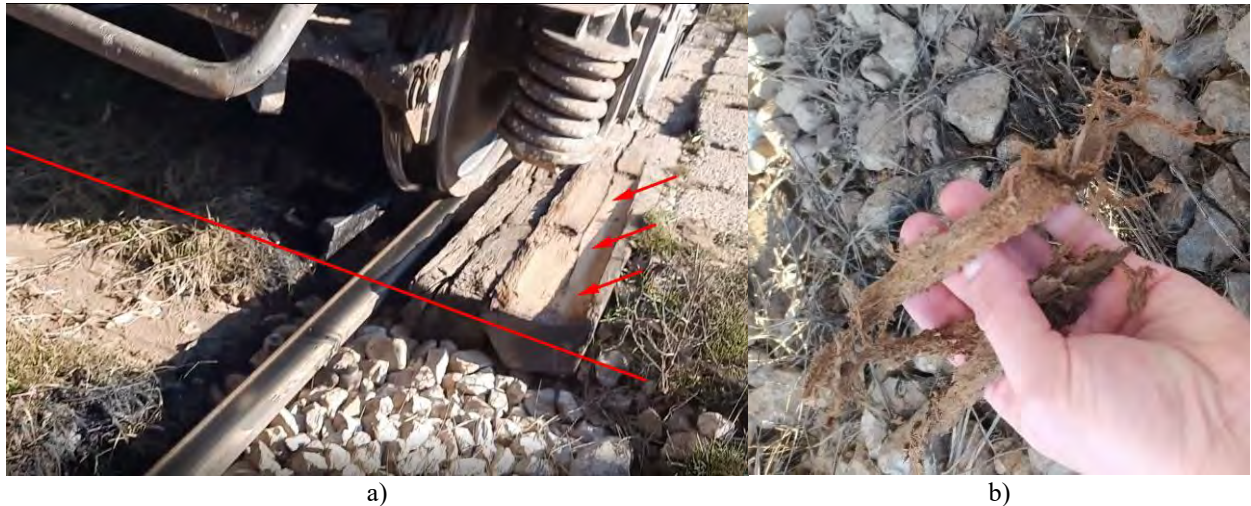
In addition to the level crossing, metal shavings or debris were found (see figure 4.2.5.1.1. b)), most likely originating from the damage.

**Figure 4.2.5.1.1:** Hollowed part of the wooden roadway structure at the level crossing

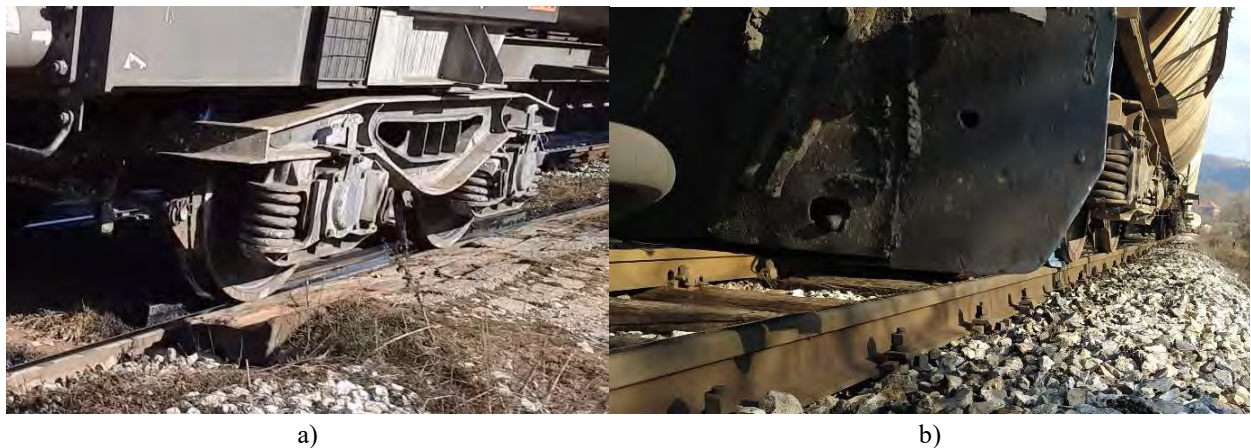
During the on-site inspection and later examinations, no parts that could be so low were found on any of the vehicles in the train. In the picture 4.2.5.1.2. a), taken at the scene, you can see that on the wagon-tanks, the lowest parts of the pedestal housings have their lower surfaces, at approximately 200 mm above the GIŠ, at medium wheel wear. In picture 4.2.5.1.2. b), also taken at the scene, you can see the rear rail cleaner of locomotive 661-249 and the low parts of the wagon-tanks. The rail cleaner, when the wheel are most worn and the springs are at their maximum deflection, can be as low as 80 mm above the GIŠ, but it is normally higher than that.

**Figure 4.2.5.1.2:** Position of the lower parts of the vehicle

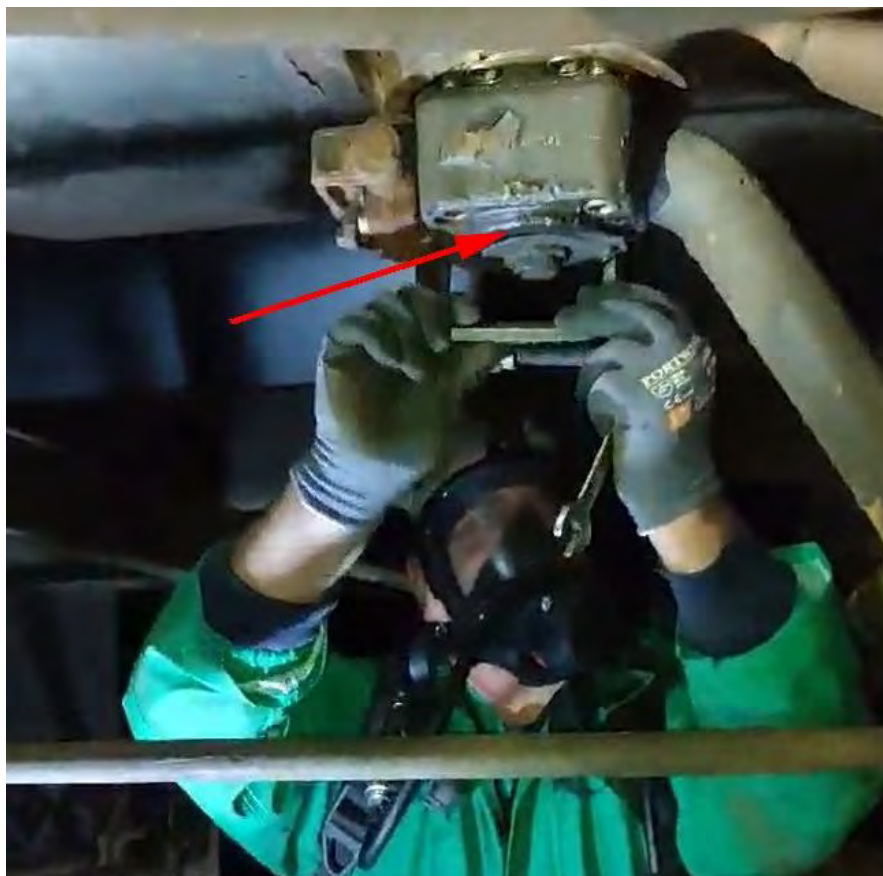
**Figure 4.2.5.2.1:** The point of ammonia leakage on the seventh wagon-tank No. 33 87 7813 561-0

**SR\_10/23** Atir-Rail SA, is to, when receiving a vehicle from a regular repair, perform additional monitoring of the condition of the valves for filling and emptying the cistern, considering that on some cisterns, only a few months after the regular repair, leaks appear on the valves (see point 4.2.5.2.).

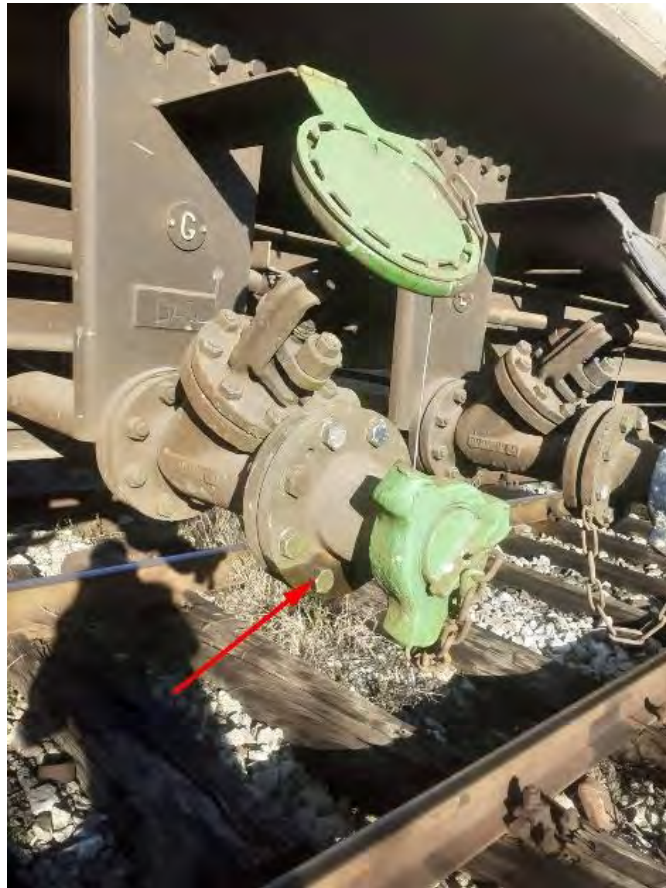
**Figure 4.2.5.2.2:** The point of ammonia leakage on the eighth wagon-tank No. 33 80 7818 092-8

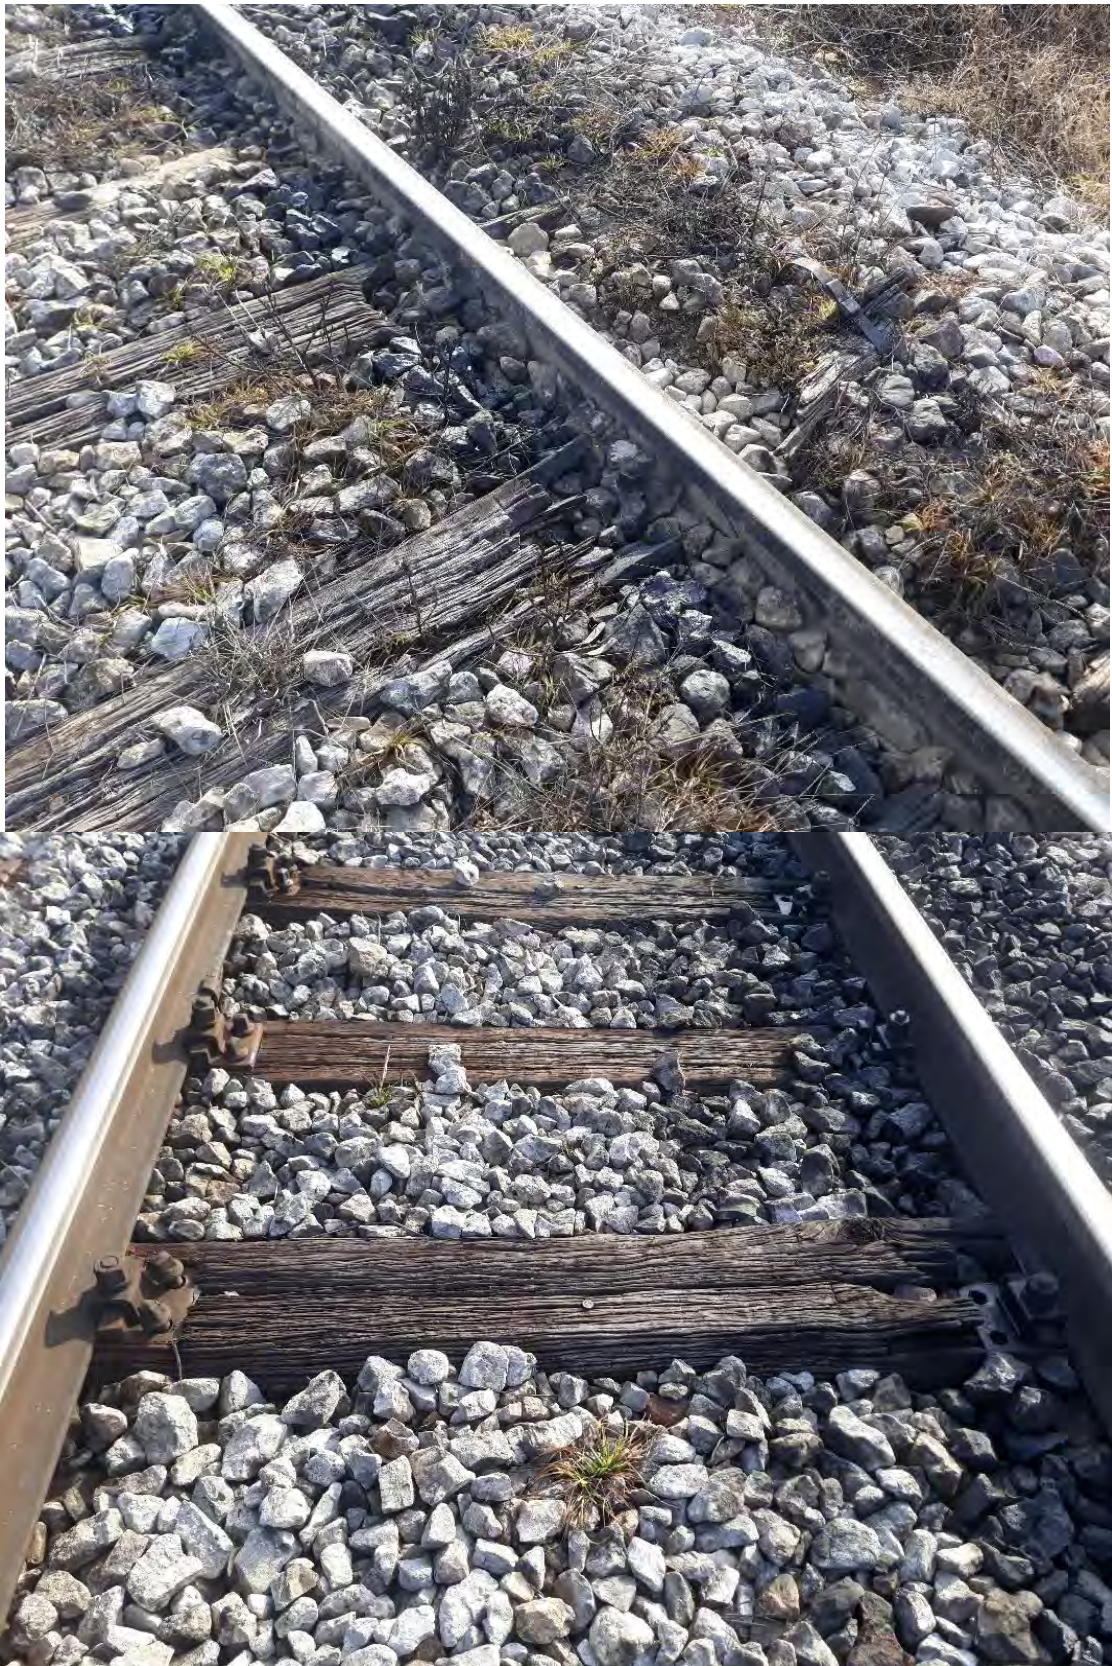
**Figure 4.2.6.1:** Appearance of the wooden sleepers in the serious accident zone (source: “IŽS”a.d.)

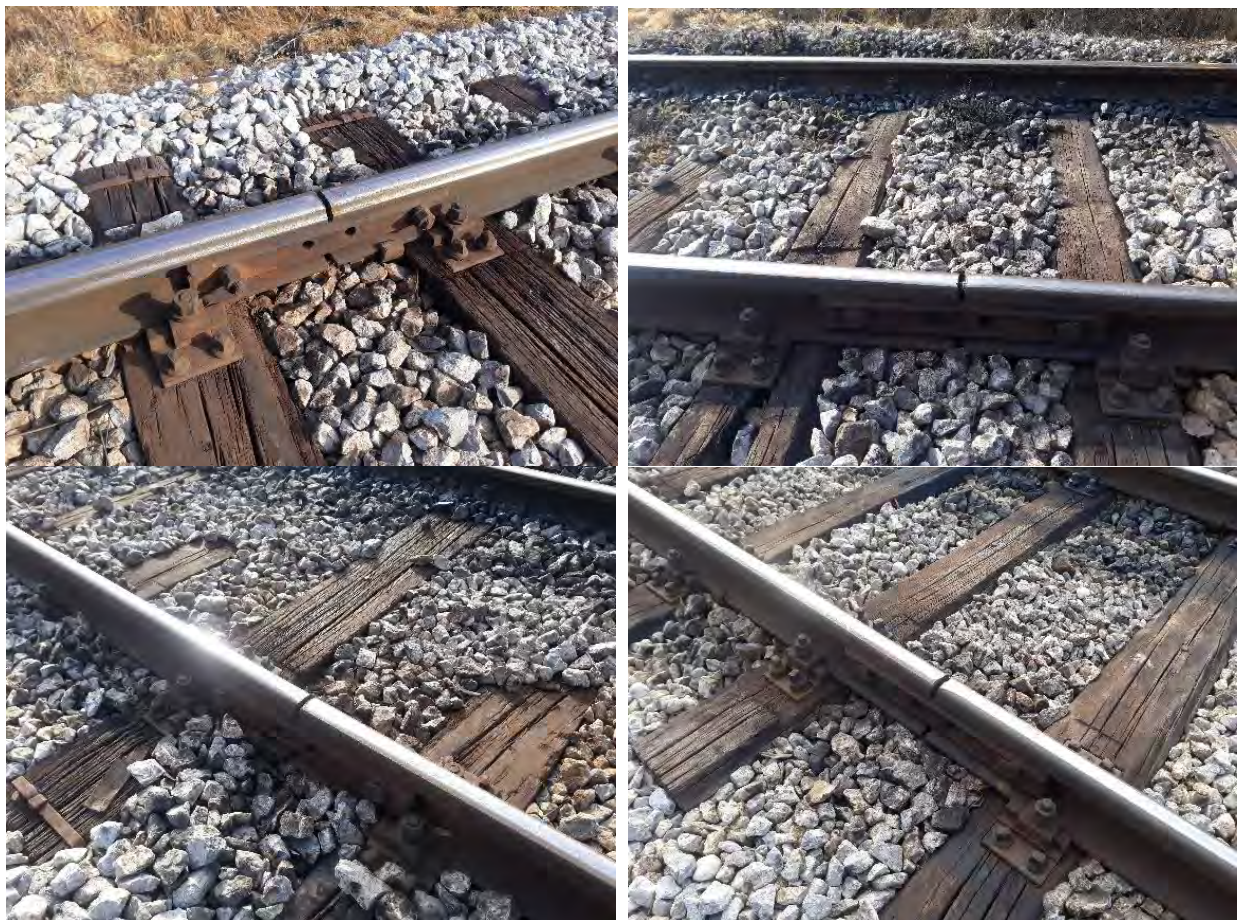
**Figure 4.2.9.6:** The appearance of railway joints in the broader area of the serious accident  
(floating unbalanced joints)

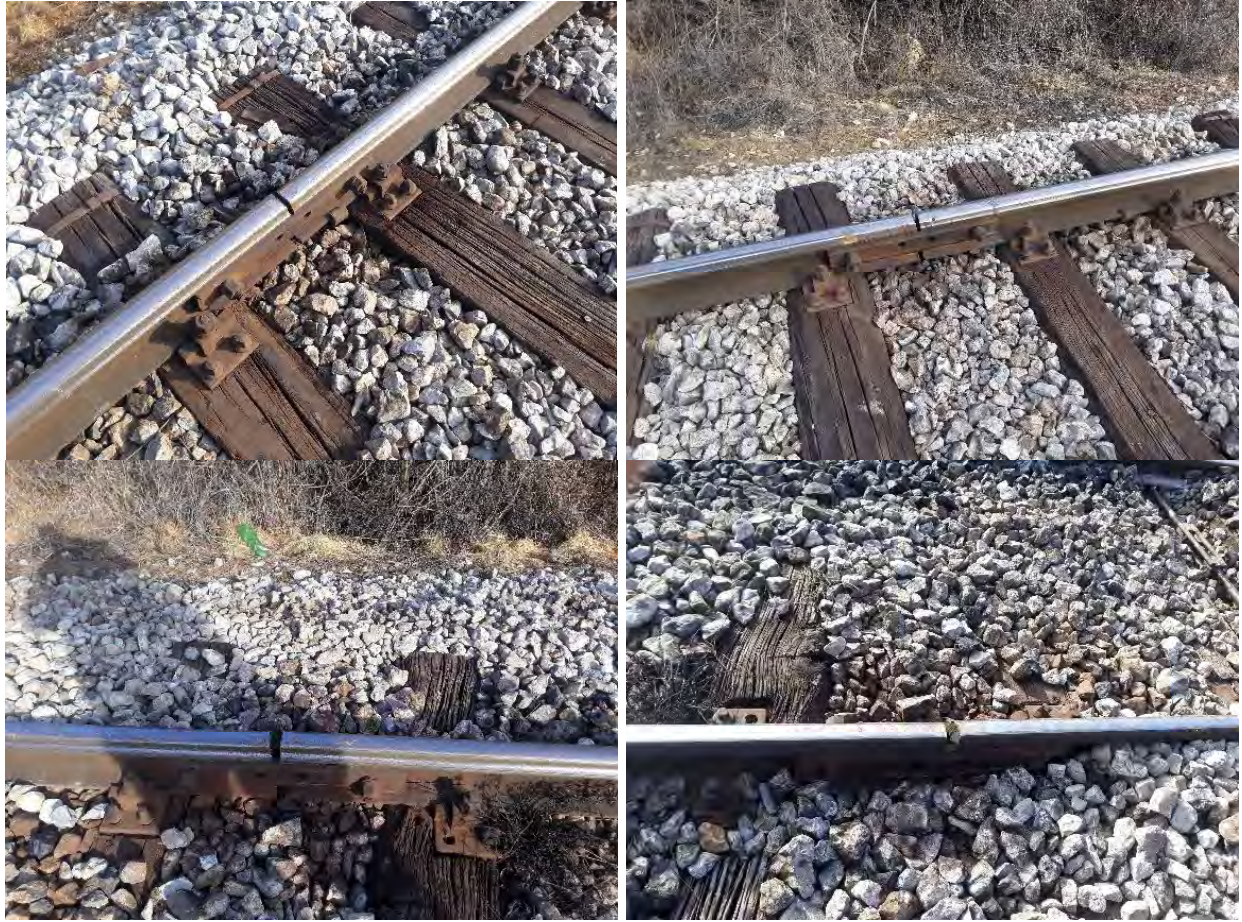
**Figure 4.2.9.7:** The appearance of railway joints in the broader area of the serious accident  
(floating unbalanced joints)
