## **QL-A REPORT: SUBSURFACE UTILITY ENGINEERING (SUE)**

230 The Donway W, North York, ON M3B 2V8

Rev No.	Date	Description	Prepared By	Reviewed by
01	Feb 28, 2023	Issued for Client Review	Manjotdeep	Youssef CHOULLI, P.Eng.

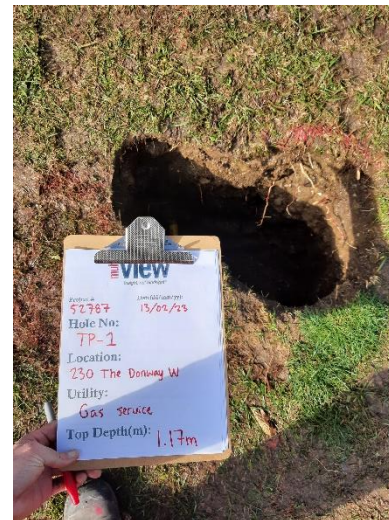
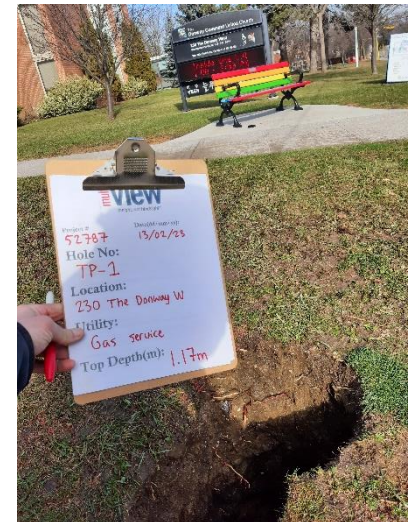
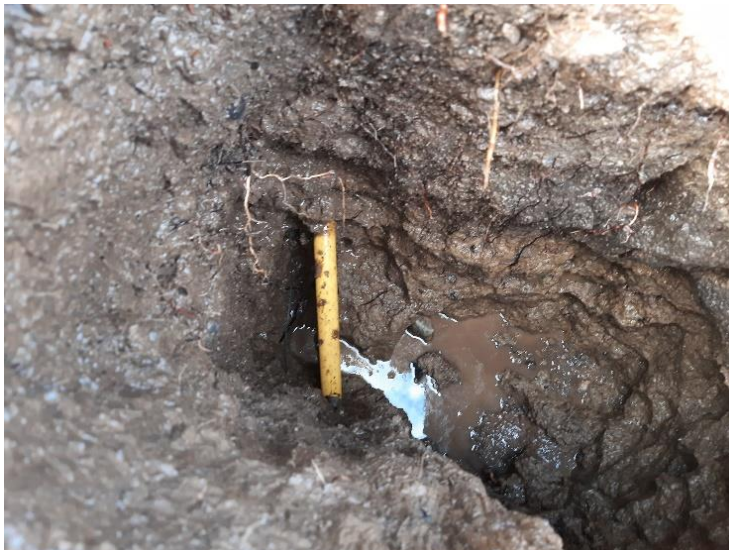
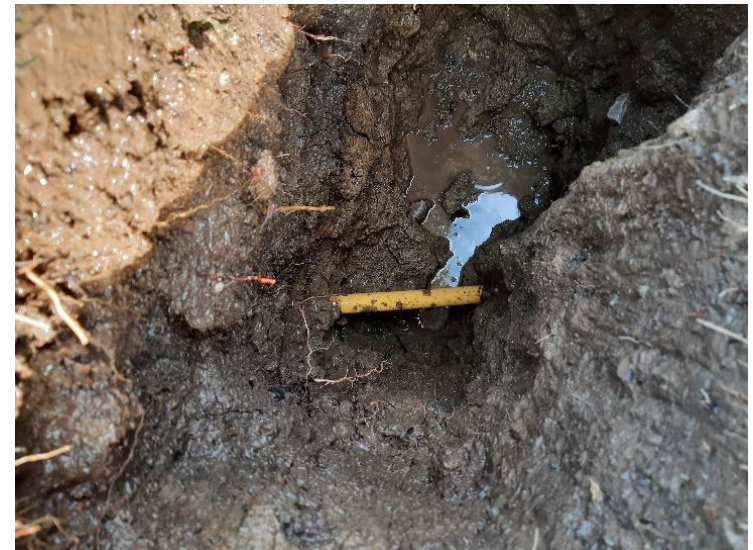
**Date:** Feb 13, 2022  
**Hole No.:** TP-1  
**Location:** 230 Donway W  
**Utility:** Gas Service  
**Surface Material:** Grass  
**Composition:** Unable to Identify  
**Top Depth (m):** 1.17 m  
**Size of Hole (m):** 0.60 x 0.40x 1.25 m  
**Observation:** Found a yellow pipe running E/W.

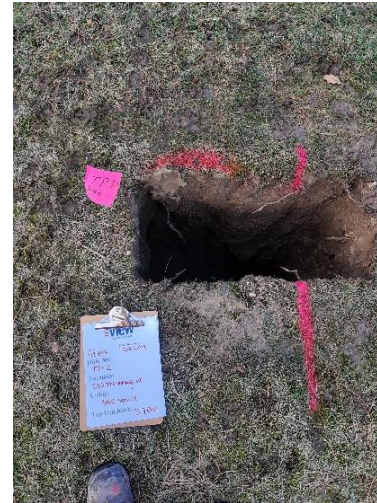
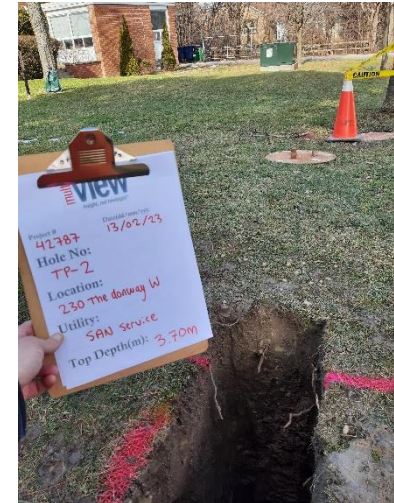
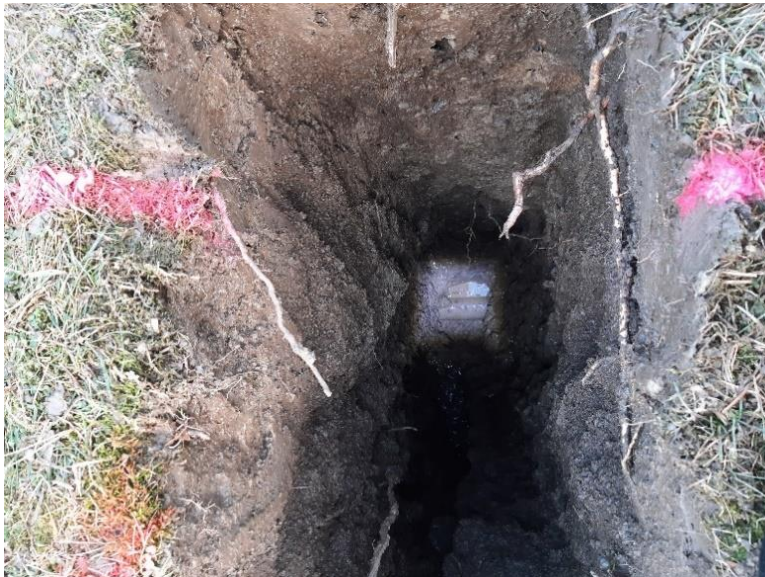
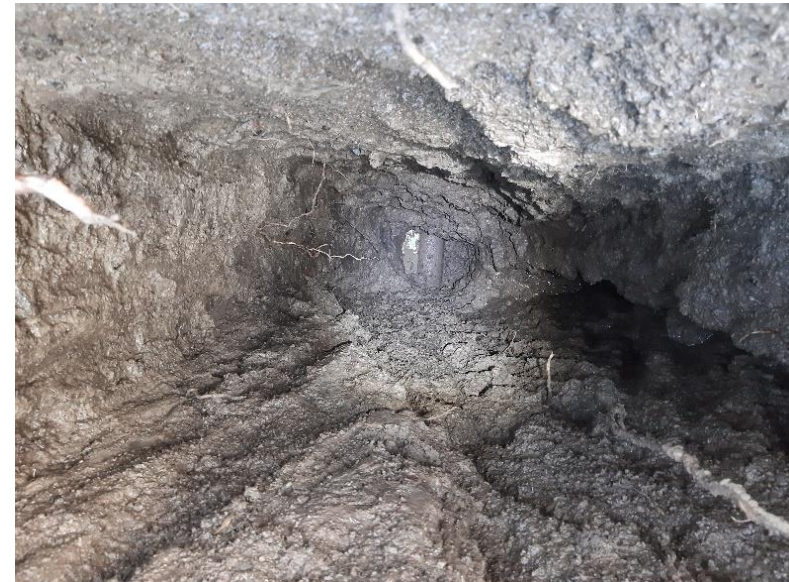
**Date:** Feb 13, 2022  
**Hole No.:** TP-2  
**Location:** 230 Donway W  
**Utility:** SAN Service  
**Surface Material:** Grass  
**Composition** Unable to Identify  
**Top Depth (m):** 3.70 m  
**Size of Hole (m):** 0.75 x 0.40 x 3.8 m  
**Observation:** Found a grey pipe running E/W

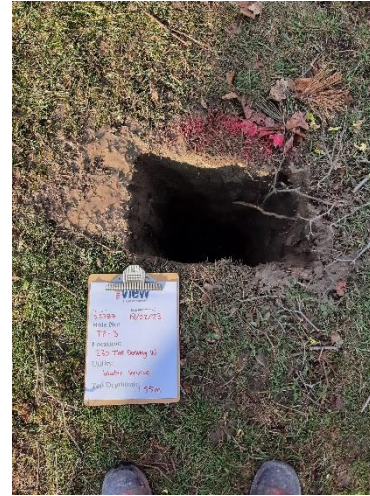
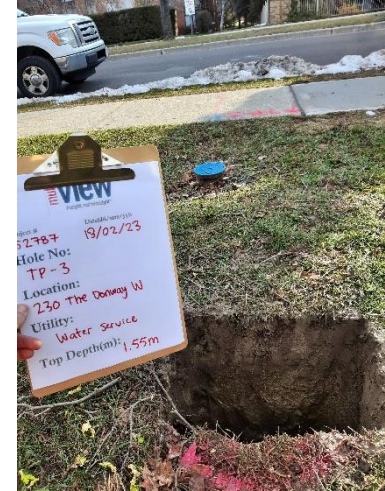
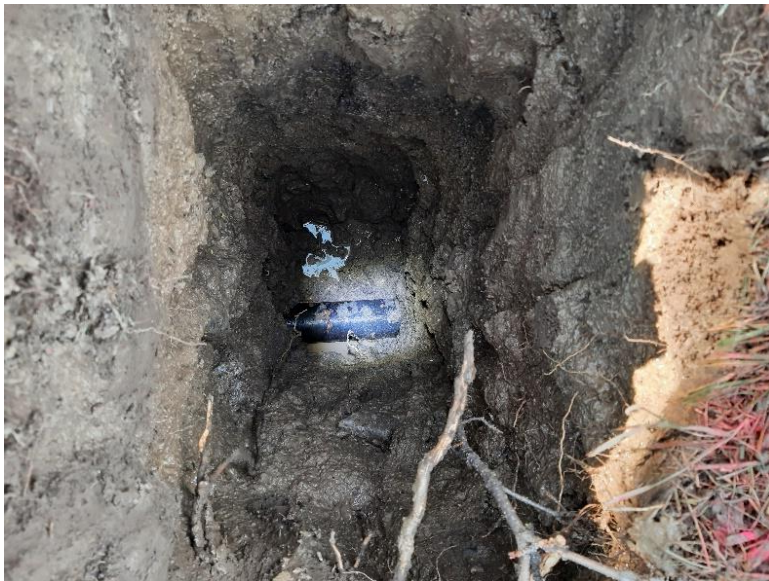
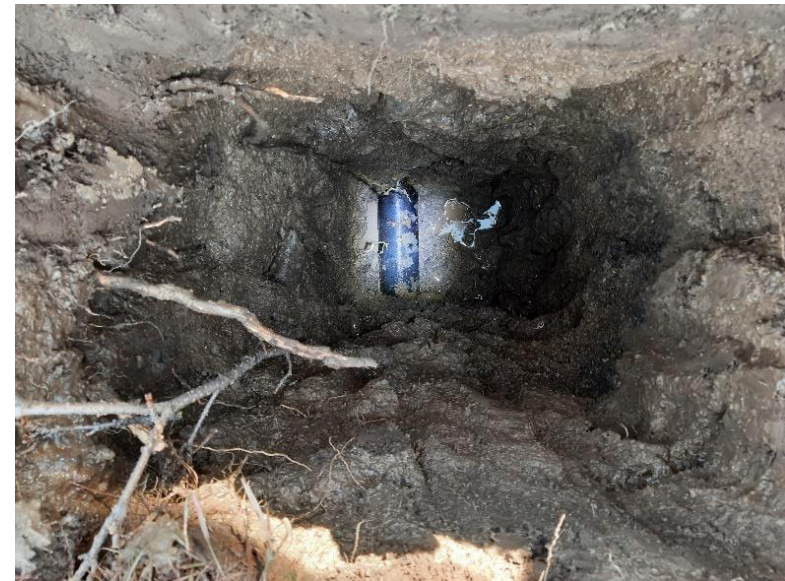
**Date:** Feb 13, 2022  
**Hole No. :** TP-3  
**Location:** 230 Donway W  
**Utility:** Water service  
**Surface Material:** Grass  
**Composition:** Unable to Identify  
**Top Depth (m):** 1.55m  
**Size of Hole (m):** 0.35 x 0.5 x 1.60 m  
**Observation:** Found a grey pipe running E/W

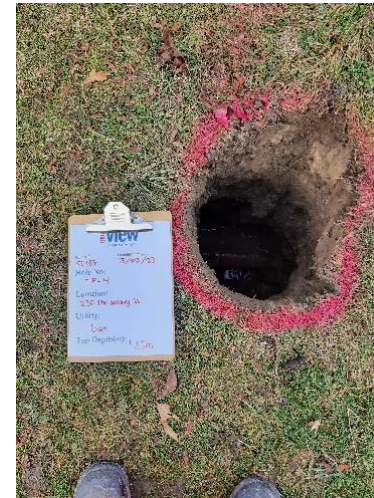
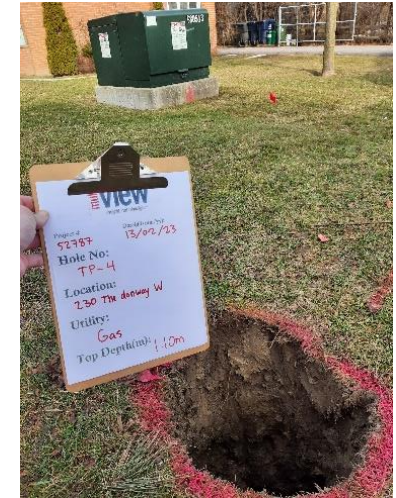
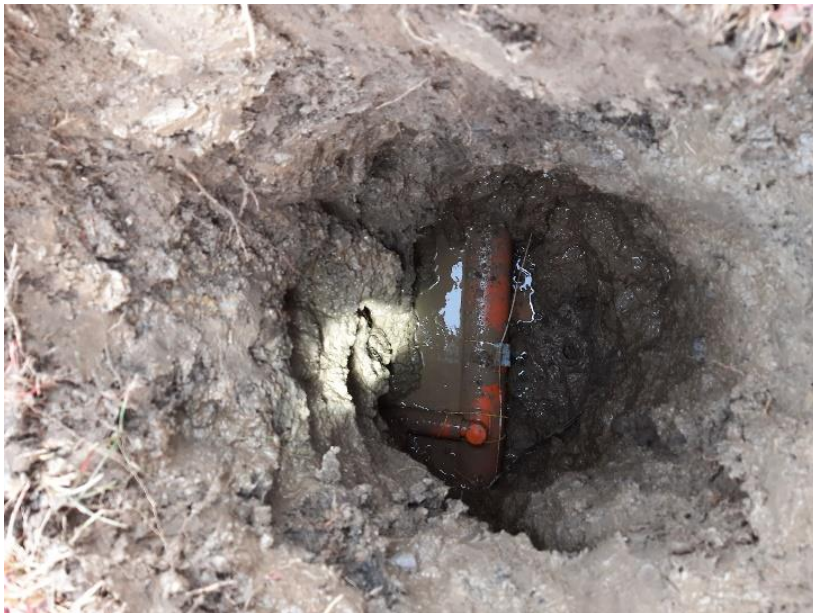
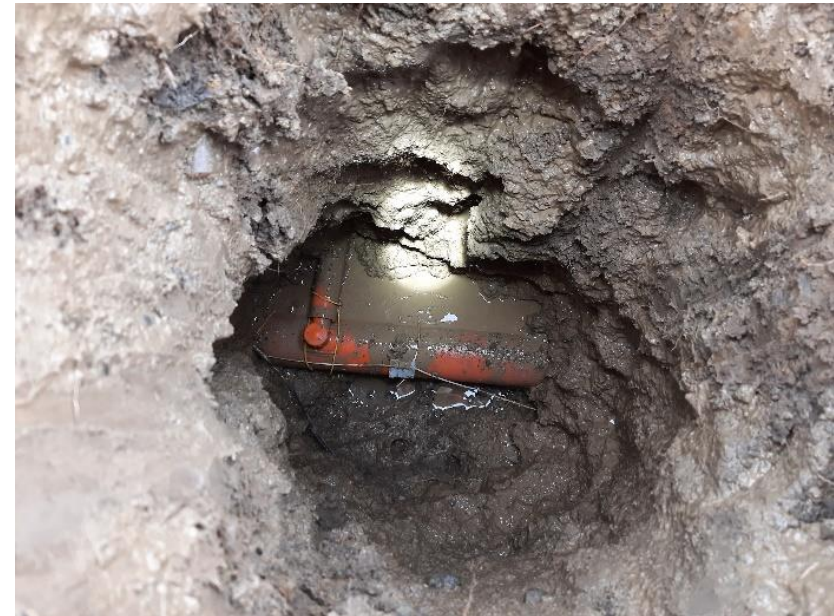
**Date:** Feb 13, 2022  
**Hole No.:** TP-4  
**Location:** 230 Donway W  
**Utility:** Gas  
**Surface Material:** Grass  
**Composition:** Unable to Identify  
**Top Depth (m):** 1.10m  
**Size of Hole (m):** 0.4 x 0.4 x 1.15 m  
**Observation:** Gas main and service exposed at 1.10m

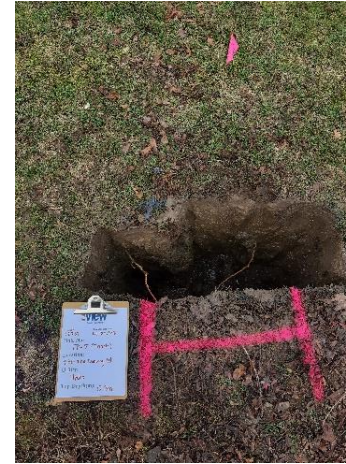
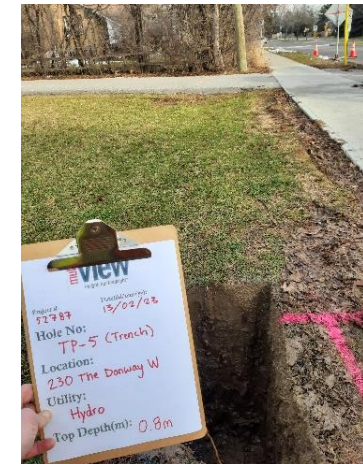
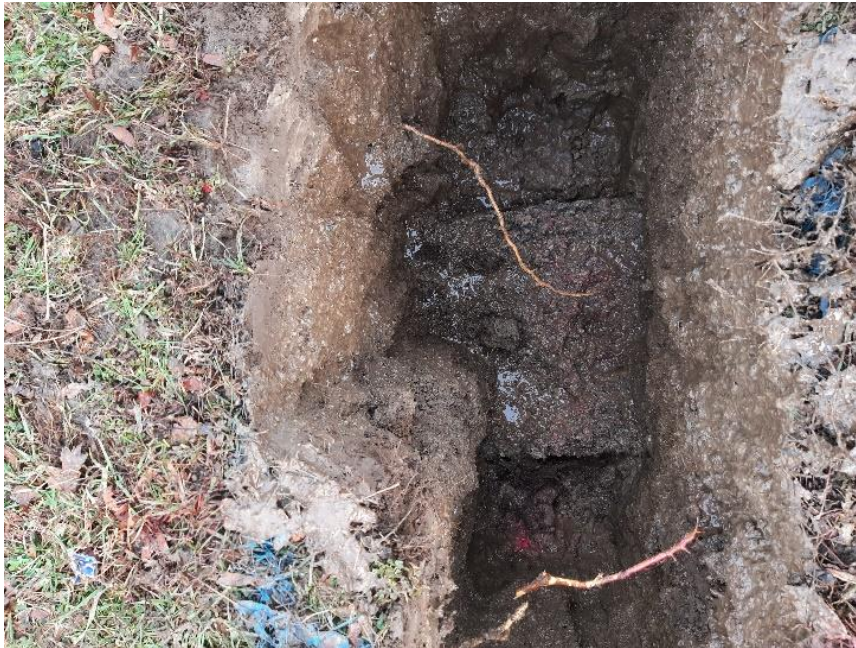
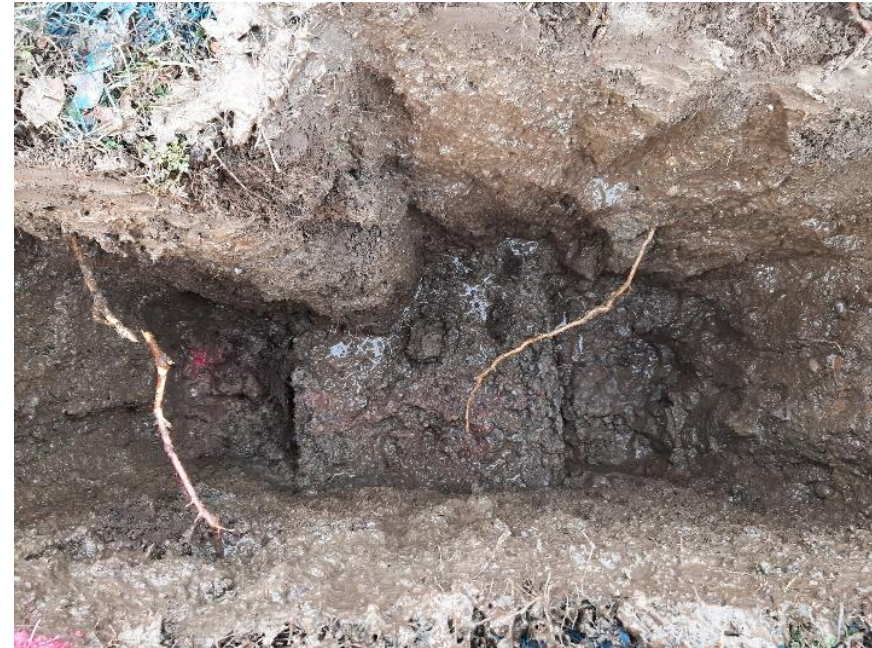
**Date:** Feb 13, 2022  
**Hole No. :** TR-5  
**Location:** 230 Donway W  
**Utility:** Hydro  
**Surface Material:** Grass  
**Composition:** Concrete  
**Top Depth (m):** 0.8 m  
**Size of Hole (m):** 1.0 x 0.4 x 0.8 m  
**Observation:** Found a duct running E/W.
