BANKSY

Valentine's Day Mascara, Margate

Date: 1 August 2023

1.0 Summary

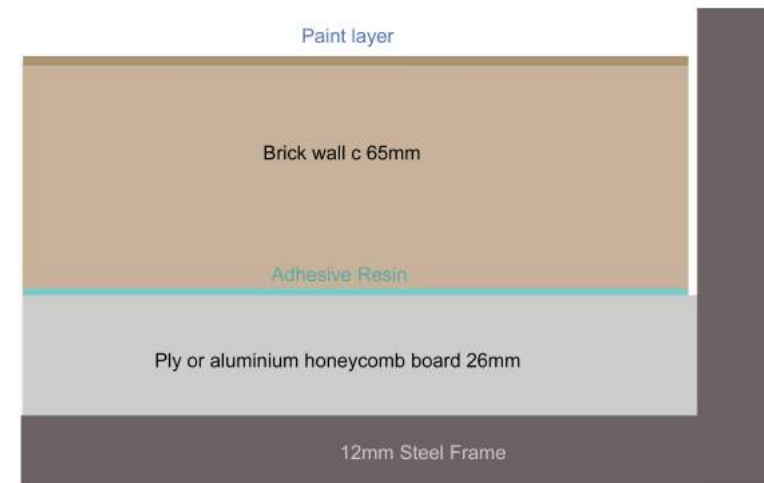
The proposal outlined below was to apply new materials to the reverse of the wall as shown in the drawing to the right. The intention was to include adaptation of the support frame and crate so that transportation and subsequent display is made easier.

3.11 Apply lightweight, dimensionally stable 26.4mm aluminium honeycomb board or ply sheets and resin fix to reverse of the sections. This will ensure that the bricks are individually supported.

3.12 Design, manufacture and apply new frame. The outer edges of the aluminium support board may extend out beyond the painted plaster finish to allow secure fixing to an outer frame. Fill gap between frame and plaster with neutrally toned black finish to provide visual spacer between the mural and its frame. The ground in front of the wall to be reconstructed on a steel supported plate covered with resin-bonded gravel to imitate the original surface on which the chest freezer originally stood and on which it will then be mounted. A dark-grey, powder-coated aluminium frame was chosen.
