SITE CLASSIFICATION REPORT SUMMARY

BLOCK: 1 **SECTION:** 46 **SUBURB:** Denman Prospect
JOB No: 46231.94 **DATE:** January 2018
CLIENT: Indesco Consulting Engineers Pty Ltd

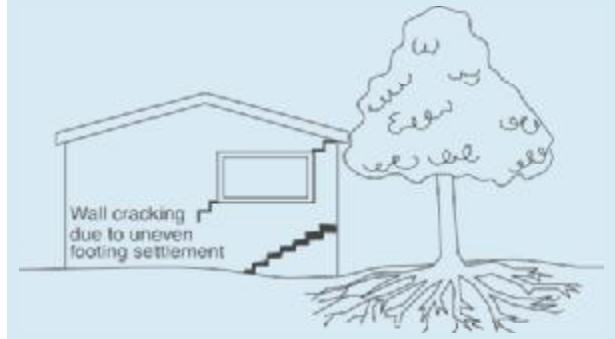
Trees can cause shrinkage and damage

Movement caused by tree roots
