SAFETY ALERT - UPDATE

Incident Ref: INC-00277 Date Issued: 22/10/2021 Safety Alert #: 012A

Subject: Stem Entered Harvester Cabin

Date: 6th October 2021 Location: Kaingaroa Forest

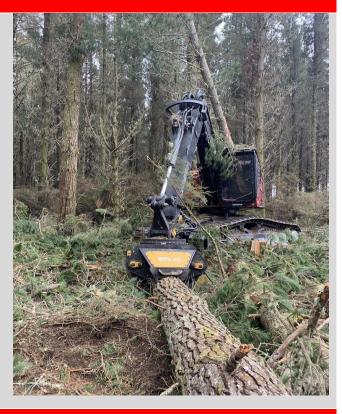
One leader has come down landing close the machine. The second, larger leader, has fallen vertically down into the machine entering the cabin area via the emergency escape hatch, piercing the operators seat. The leader was approximately 740 kg with a sharp tip.

The operator escaped serious injury or death because he had noticed the double leaders had snapped off the main stem of the log. The snapping has prompted the operator to move forward and look up. It is believed the second leader has entered the cab at this point. When the leader entered the cabin, it scratched the operator's back causing relatively minor abrasions.

An investigation into the cause of the incident is ongoing and we are liaising with the machine's manufacturer. The ISO 8083:2006 standard, specific to forestry machines, requires the FOPS guarding to withstand a 227kg object falling from a height of 5.2 metres. The machine appears to have met this standard. However, in this incident a 740kg object fell from a height of 10 metres exerting forces which exceed the current standard.

- The manufacturer has made a strengthened emergency hatch. All Timberpro machines (with escape hatch) operating within the KT estate were stood down until strengthened emergency hatches were fitted.
- Timberlands' harvest managers, together with contractor principals, are reviewing roof escape hatches in other harvesting operational machines.
- A review of the ISO 8083:2006 standard may be required in due course.
