Extension Pins and Log Load Securing Requirements

NOGGIN INC2682 10/08/20 – Medical Treatment Injury.

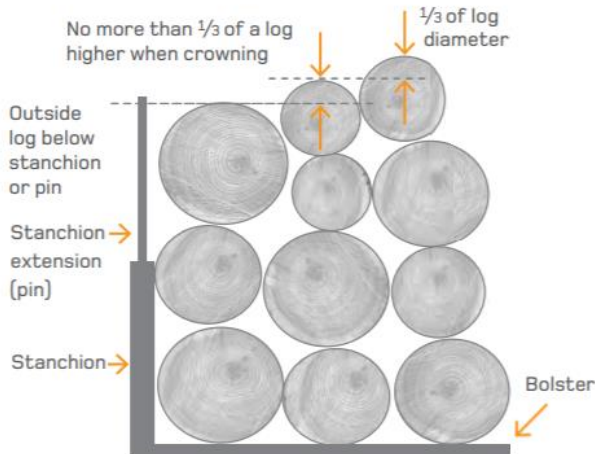
- No part of the **outside** logs of the load shall be loaded above the top of the stanchions or the stanchion extensions.
- Logs loaded in the middle of the load **shall not have more than 1/3 of the diameter** of the log above the adjacent logs.
- The top of the load shall be rounded so that the load-securing device will contact as many logs as possible – see log loading graphic.

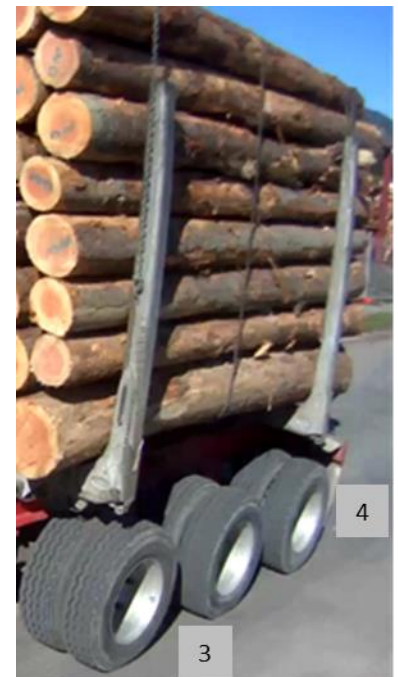
Description – while unchaining the load a driver released the tension on the chains before proceeding to the passenger side of the trailer to hang them up. CCTV footage shows the driver stowing the chain at bolster 4 before moving forward to bolster 3 when the top-log (as pictured) rolled off the bunk. It struck the driver on the shoulder and side of the head, causing minor cuts and heavy bruising.

NOTE: The image is taken as the truck arrives at the Port, as captured by security camera. The extension pin is visible on bolster 4 but not visible on bolster 3, however it was not lowered by the driver. The log that fell is the top-most log pictured in the image. As situated, it is sitting on top of the ‘outside log’ – please compare with the log loading graphic.

The truck was fitted with Patchell bolsters, specifically engineered and time proven. However, the investigation revealed that the extension pins were retrofitted by the original owner of the vehicle, and someone other than Patchells. **Incorrect installation** has allowed the pin to extend beyond its design limit and therefore not lock into place correctly. It has subsequently dropped down into the bolster, at some time during transit.

1. When using new or used equipment both Owners and Operators have duties to ensure that devices are properly installed, can activate or lock-out correctly, and be used safely.
2. PCBU’s that design, manufacture, import, supply and install plant, substances, or structures must ensure such are safe to use and fit for purpose – [HSW Act 2015 s. 36–43](#).
3. Immediately report faulty equipment taking it out of service until corrected or repaired.
4. Use this alert as an occasion to review all safety devices **especially on extension pins**.

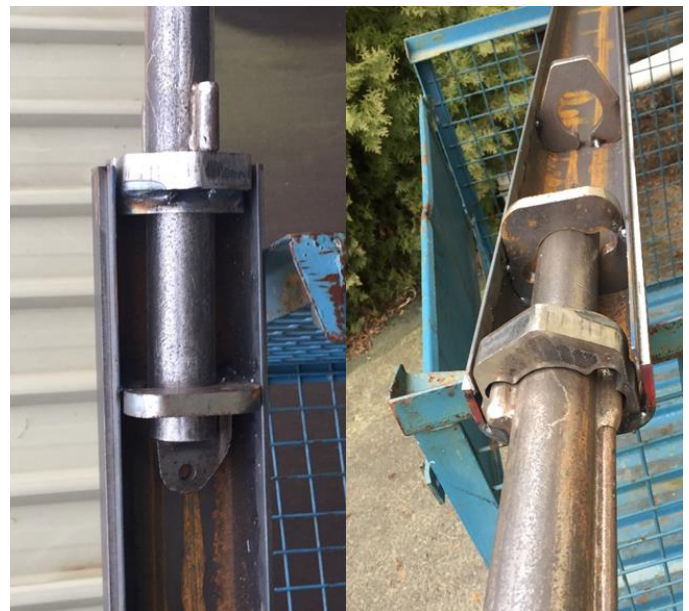
The Patchell ‘extension pin design is robust and sturdy and will perform as intended if fitted according to the manufacturer’s plans – this one was not!

- **Experienced drivers** tell us that using an incorrectly fitted pin, such as the one in this incident, would give a sense (feel) of having the ‘wrong key in the lock’.
- Logs must be loaded according to the **ACOP standards** – no exceptions. Carting a lighter species of logs e.g. Douglas Fir, is not an excuse for overloading or poor loading.
