April 2018

Forestry death

This bulletin provides information about a recent forestry death. Learning from accidents can help prevent future fatalities. WorkSafe thanks the family of the forestry worker for their support with sharing these details.

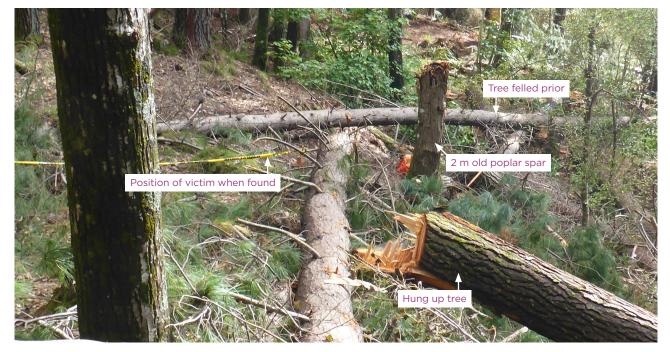
Figure 1 (below) shows the scene of the accident. The old poplar spar has caused the drive tree to 'Gimbal' (Seesaw) and kick backwards striking the victim.

FIGURE 1: Accident scene showing escape route blocked by a tree felled prior to falling the drive tree

The faller drove a tree to clear a hung up tree and in the process the driving tree has hit an old poplar stump/ spar and this has caused the tree to rebound back and strike the victim.

- the drive tree has hit the hung up tree without taking it to the ground
- the drive tree has slid down the right hand side and then struck a 2 m poplar spar (or stump) that was in direct line between the driving tree and hung up tree
- as the driving tree hit the spar it has caused the tree to pivot lifting the butt in the air
- forces from the tree hitting the hung up tree and the poplar stump have caused the butt of the tree to move backwards, approximately 1.8 m behind the stump of the driving tree and hit the victim
- the victim managed to radio for help.

The escape route was blocked by a previously felled tree.

Dead spars need to be removed before the faller begins work in the area.

Establishing escape routes are a critical part of felling technique.
