SAFETY ALERT

Yarder Stabilising Ram Failure Incident

Thunderbird TY50/70 Towers – Rope Retrieval

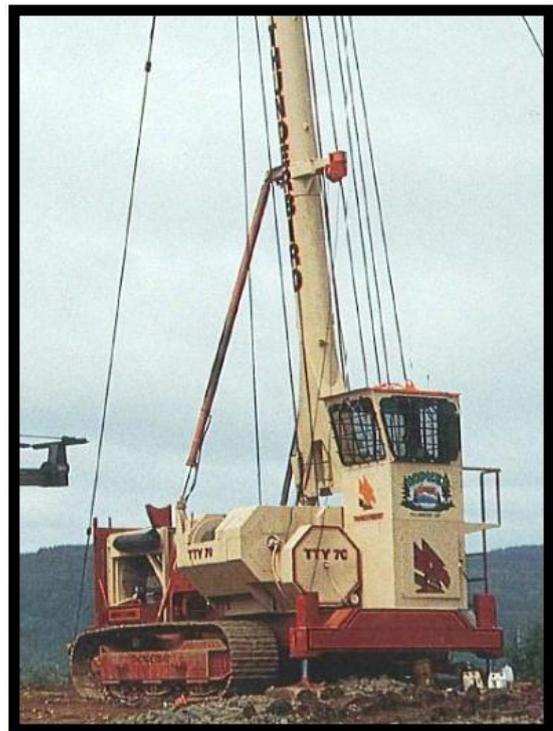
The yarder was being prepared to shift. Running lines and guys had been retrieved. The tower was pushed into vertical position and the stabilising ram locked. The guy ropes were hooked on the chassis and ratcheted up to remove excessive slack. However, during the rope retrieval the tail rope over-spooled or “birdnested”. A plan was then made to untangle the rope and run the tail rope out so it could be correctly fleeted back onto the drum. A grapple operator was positioned in front of the hauler to pull the rope out and then manage rope tension as it was wound back on. Another worker was deployed to sit beside the drum and assist fleeting the bottom layer and a 3rd worker, the

hauler driver, had the tail drum engaged, and idling dead slow in 1st gear. The yarder driver was observing the drum and stabilising ram through the cab side window. The rope was being wound slowly onto the drum, and the first layer was half completed when without warning the spear on the stabilising ram snapped. The broken spear shot forward and landed on the workers hand who had been positioned near the drum. The injury was severe requiring four fingers to be amputated

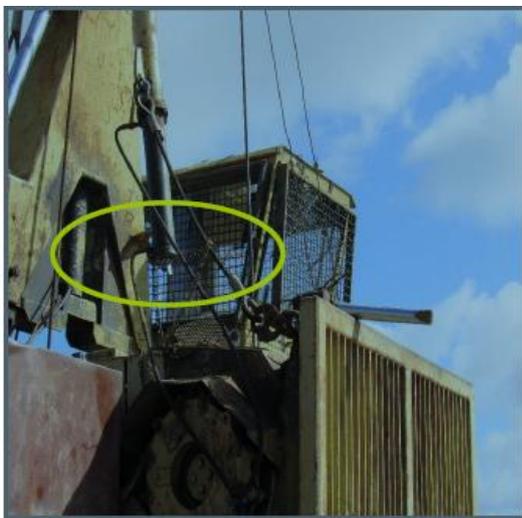
- The investigation revealed that the incident was the result of a stabilising ram failure.
- It identified that the Thunderbird manual prescribes the slackening of all guylines before rope recovery, therefore the tower was not supported by guylines when the stabilising ram failed.
- Also, the stabilising ram spear had been replaced with induction-hardened steel rather than the original mild steel design. Induction hardened steel provides excellent wear resistance and strength but does not have the same ductile microstructure of mild steel, which allows it to deform (bend or stretch) significantly under stress before fracturing, it absorbs energy well.

Figure 2. Close up of the hauler showing snapped spear

- 1. GUYLINE SAFETY:** While Thunderbird manuals allow slackening all guylines and locking the pole before rope recovery, it is recommended to keep at least one rear guyline in place to prevent tower collapse if the stabiliser ram fails.
- 2. STABILISING RAM SPEAR:** Owners must verify the steel grade of stabiliser ram spears. It is recommended that a replacement spear should be consistent with the original mild steel composition with good energy absorbing ductile properties.
- 3. LAGGED DRUMS:** Rope fleeting exposes workers for 15–20 minutes. Lagging drums reduces this risk. Owners should consider replacing at least the front drum when machines undergo major servicing.
- 4. ANNUAL INSPECTIONS:** Towers must be inspected annually by CBIP-certified inspectors. Inspectors should be briefed on the Kohurau incident and the importance of spear verification and ram integrity.
