Baseline Riparian Vegetation Monitoring Report Finniss Lithium Project

CORE LITHIUM

Job	EZ22099
Document ID	215635-54
Author(s)	Nicole Clark, Anna Lemon

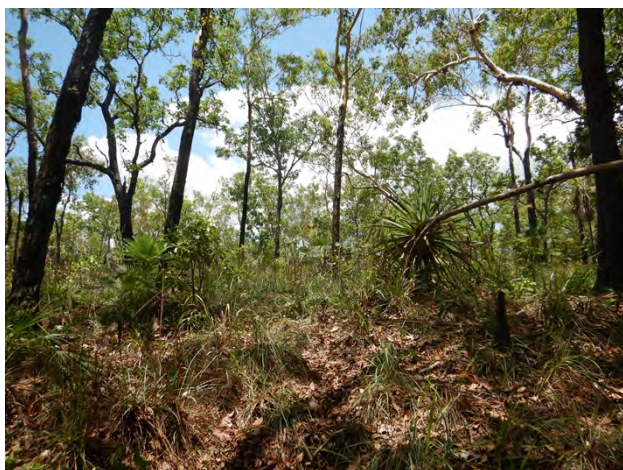
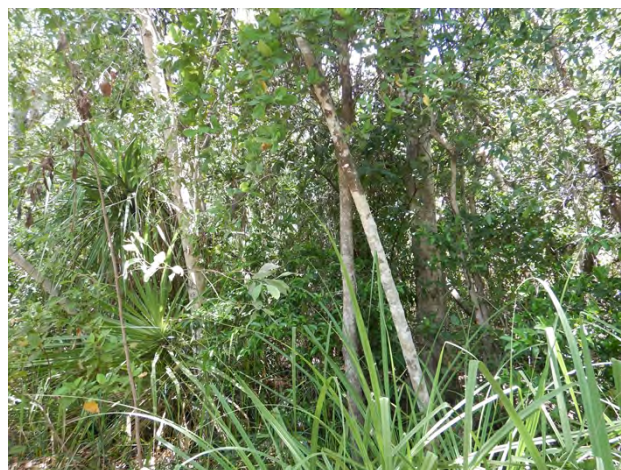
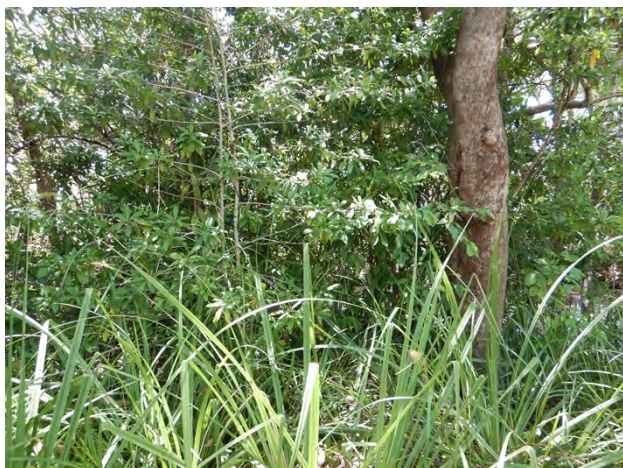
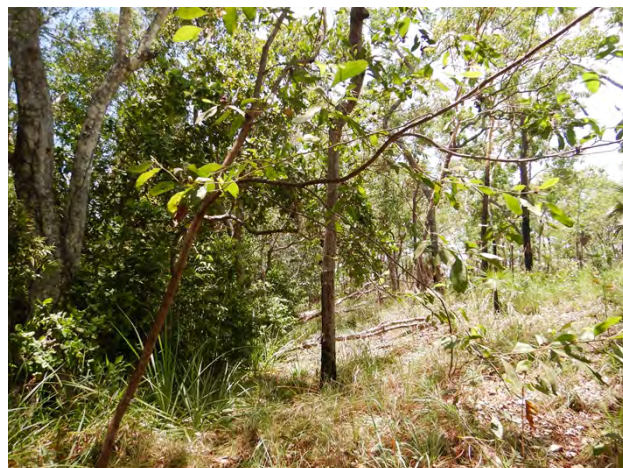
Figure 4-7. Photographs of the habitat at RVS4 using cardinal-directions for riparian monitoring

No standing water present within creek. The last fire was observed <1 year ago.

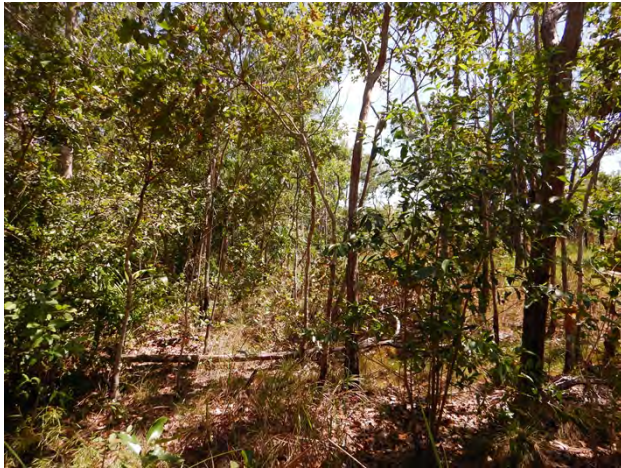
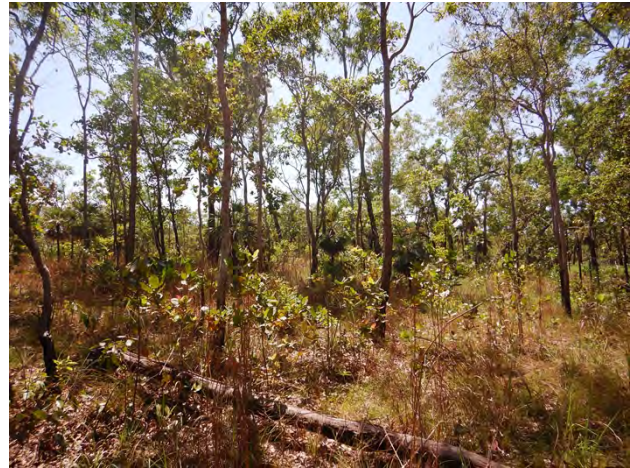
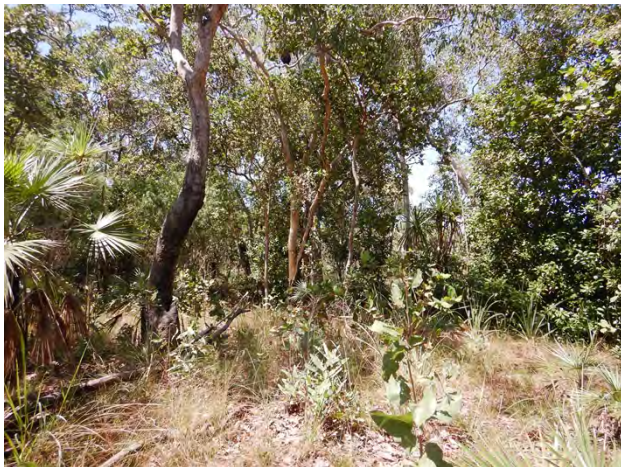
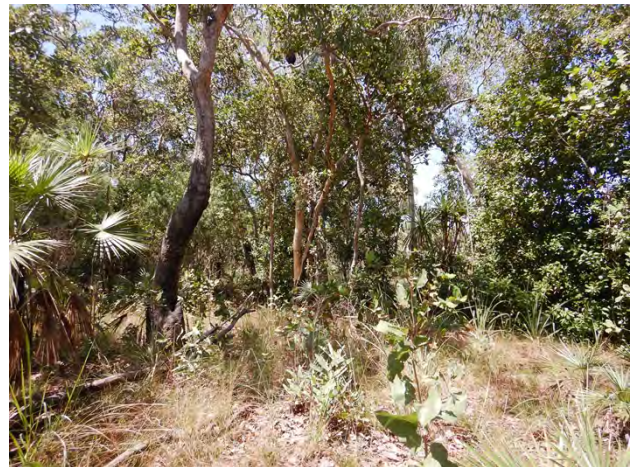
Figure 4-9. Photographs of the habitat at RVS5 using cardinal-directions for riparian monitoring

No standing water present within creek. The last fire was observed <1 year ago.

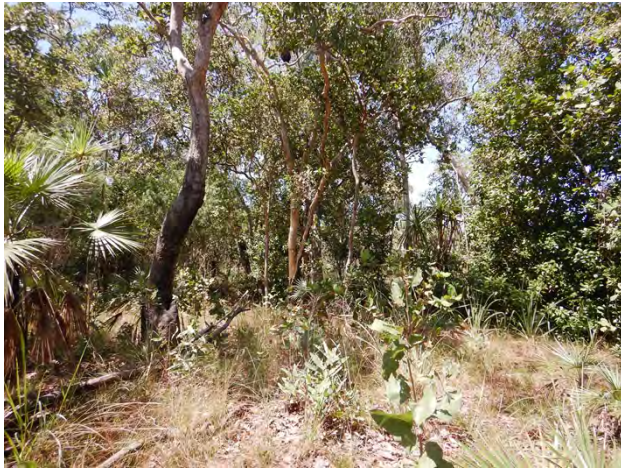
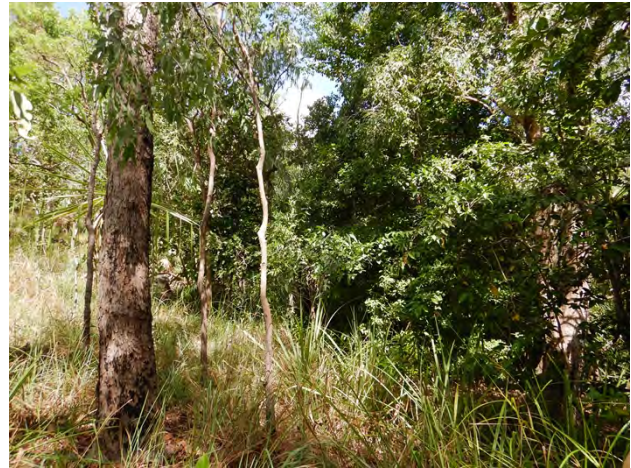
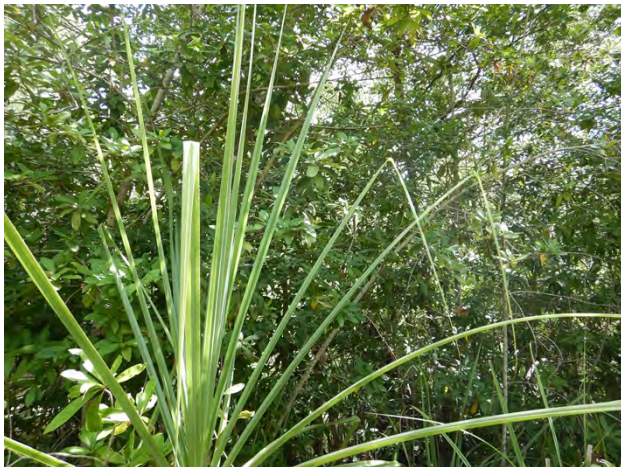
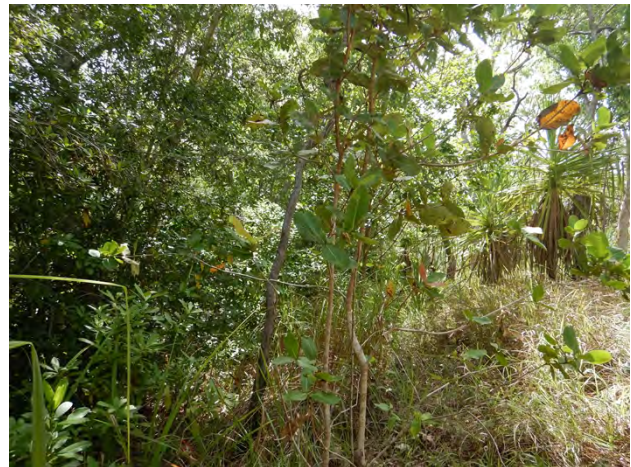
Figure 4-11. Photographs of the habitat at the reference site using cardinal-directions for riparian monitoring

Two aquatic plants – *Eriocaulon* sp. and *Nymphaea* sp. – were both observed within the creek and biofilms were observed on the waters' surface along the edges of the system. Standing water was stagnant, with no apparent sedimentation present.

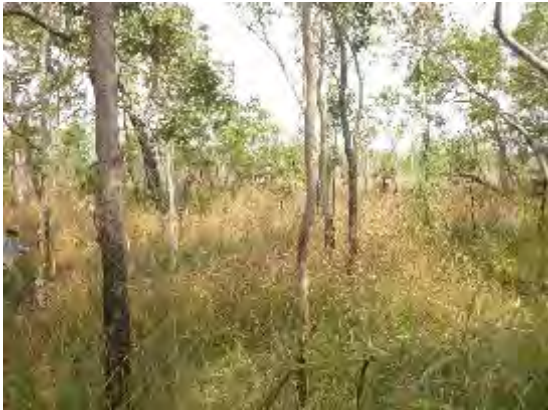
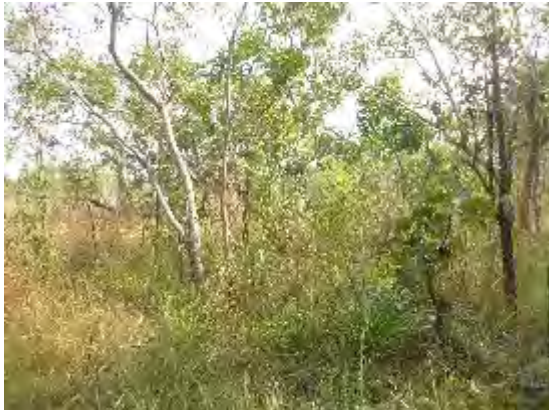
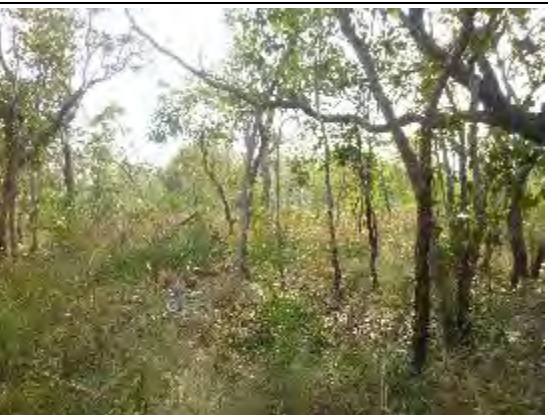
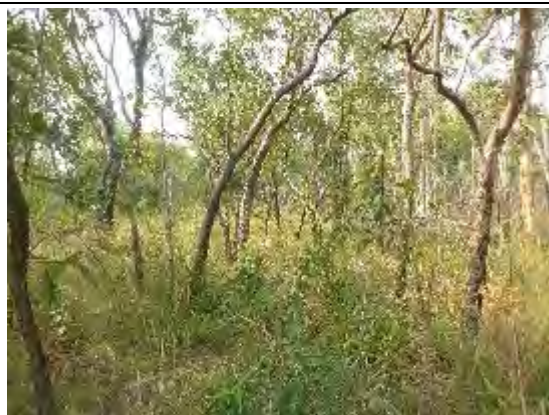
Site SVS3 – <i>Melaleuca viridiflora</i>, <i>Erythrophleum chlorostachys</i> and <i>Corymbia polycarpa</i> mid woodland over <i>Lophostemon lactifluus</i> mid open shrubland over <i>Sorghum intrans</i> mid tussock grassland	
NVIS Code: T7i	
Location (GDA94, z52): 693708E, 8600969N	
Upper 1: Mid woodland dominated by <i>Melaleuca viridiflora</i> , <i>Erythrophleum chlorostachys</i> and <i>Corymbia polycarpa</i>	
Mid 1: Mid open shrubland dominated by <i>Lophostemon lactifluus</i> , <i>Clerodendrum floribundum</i> and <i>Denhamia obscura</i>	
Ground 1: Mid open tussock grassland dominated by <i>Sorghum intrans</i> , <i>Aristida</i> sp. and <i>Pandanus spiralis</i>

Other species Upper stratum (U1): - Mid stratum (M1): <i>Alphitonia excelsa</i> , <i>Grevillea decurrens</i> Ground stratum (G1): - <i>Germainia grandiflora</i> , <i>Acacia difficilis</i> , Fern sp., <i>Themeda</i> sp., <i>Wrightia saligna</i> , <i>Livistona humilis</i> , <i>Osbeckia australiana</i> , <i>Dianella odorata</i> , <i>Brachychiton megaphyllus</i> , Fern sp.1, <i>Antidesma ghesaembilla</i>

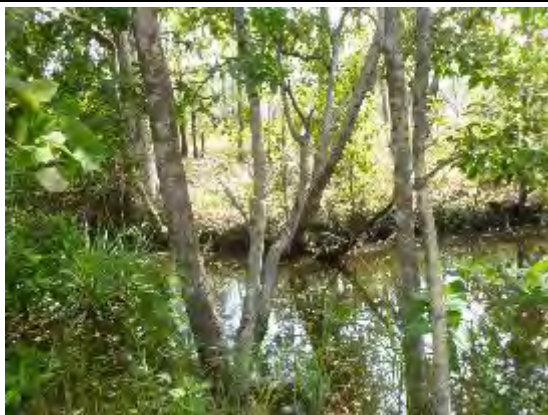
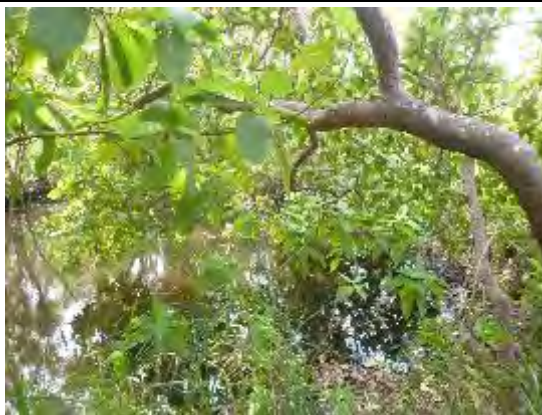
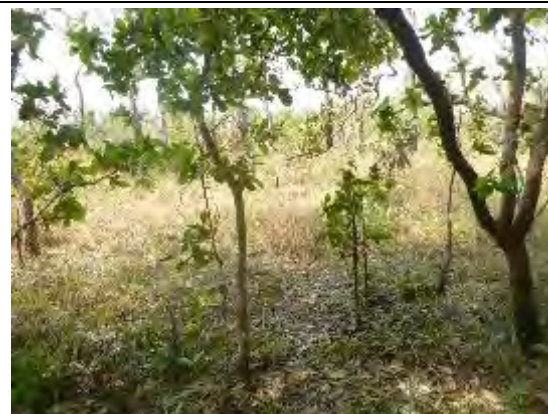
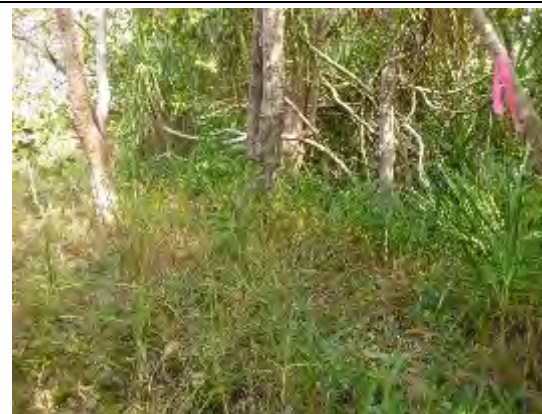
Site RVS4 – *Syzygium armstrongii* and *Xanthostemon eucalyptoides* mid open woodland over *Pandanus spiralis* mid shrubland over *Scleria lingulata* mid open tussock grassland

NVIS Code: T7r
Location (GDA94, z52): 695055E 8594164N
Upper 1: Mid open woodland dominated by <i>Syzygium armstrongii</i> and <i>Xanthostemon eucalyptoides</i>
Mid 1: Mid shrubland dominated by <i>Pandanus spiralis</i> , <i>Flagellaria indica</i> and <i>Helicia australasica</i>
Ground 1: Mid open tussock grassland dominated by <i>Scleria lingulata</i> , <i>Sorghum intrans</i> and <i>Eriachne trisetata</i>

Other species
Upper stratum (U1): <i>Lophostemon lactifluus</i>
Mid stratum (M1): <i>Myrsine benthamiana</i> , <i>Melicope elleryana</i> , <i>Cyclophyllum schultzei</i> , <i>Carallia brachiata</i> , <i>Gmelina australis</i> , <i>Grevillea pluricaulis</i>
Ground stratum (G1): <i>Melastoma malabathricum</i> (polyanthum), <i>Themeda triandra</i> , <i>Eulalia mackinlayi</i> , <i>Osbeckia australiana</i> , <i>Dianella odorata</i> , <i>Cheilanthes</i> sp
Land unit (Greater Darwin 25K) – 5b1: Drainage System
Landform: Flat, adjacent to creek channel
Soils: Black clay in channel
Drainage: Poorly drained
Fire history: Very recent adjacent (other side of the creek) but 2+ years since last fire at the site
Weeds: None
Disturbance: Some pig damage
Hydrology: Site situated adjacent to large pool (approximately 8 m x 15 m) 40 cm ~ 1m deep, steep bank (0.5 m).

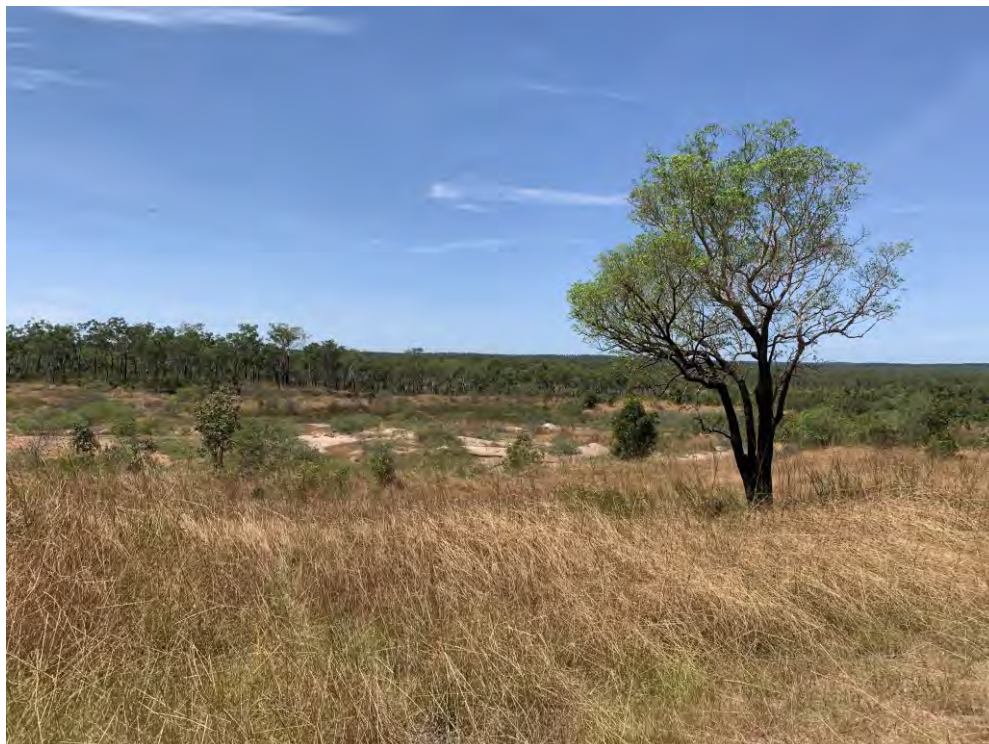
Figure 3.1 - OHD upper catchment

OHD is located adjacent to the proposed BP33 area and receives runoff from a largely undisturbed catchment area of 94 ha. There are no defined drainage lines in the upper OHD catchment. The upper catchment has a slope between 1% to 2%. Figure 3.1 shows the upper OHD catchment area, which appears to be well vegetated.

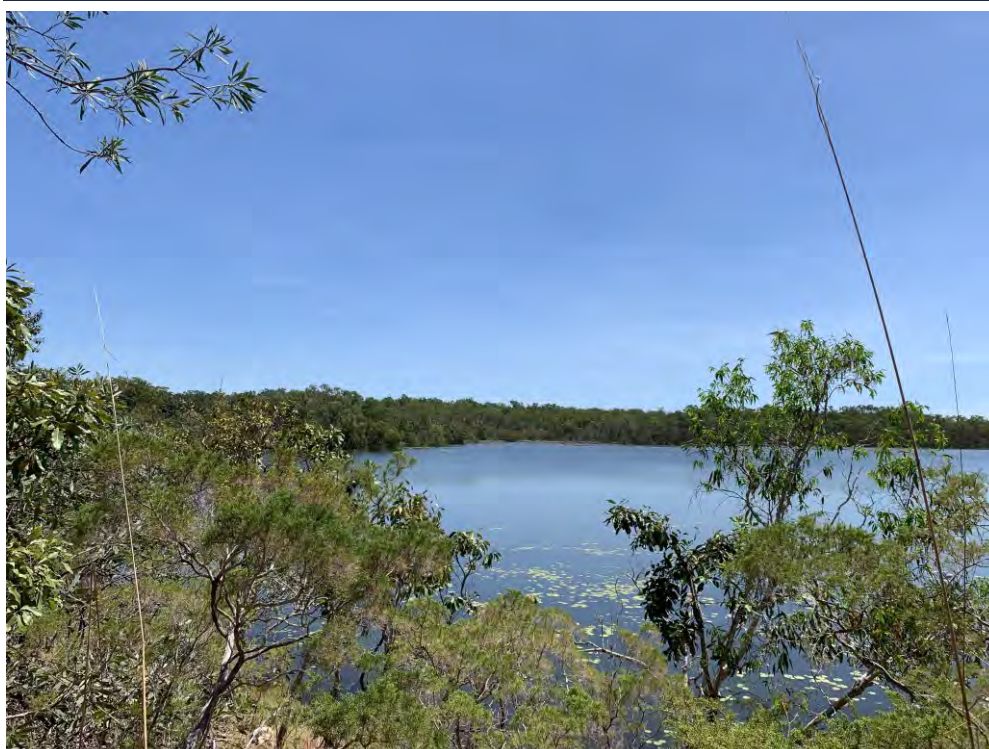
Figure 3.2 - OHD water surface

Figure 3.2 shows the OHD water surface and surrounding vegetation. This photograph shows that the area around OHD is well vegetated.

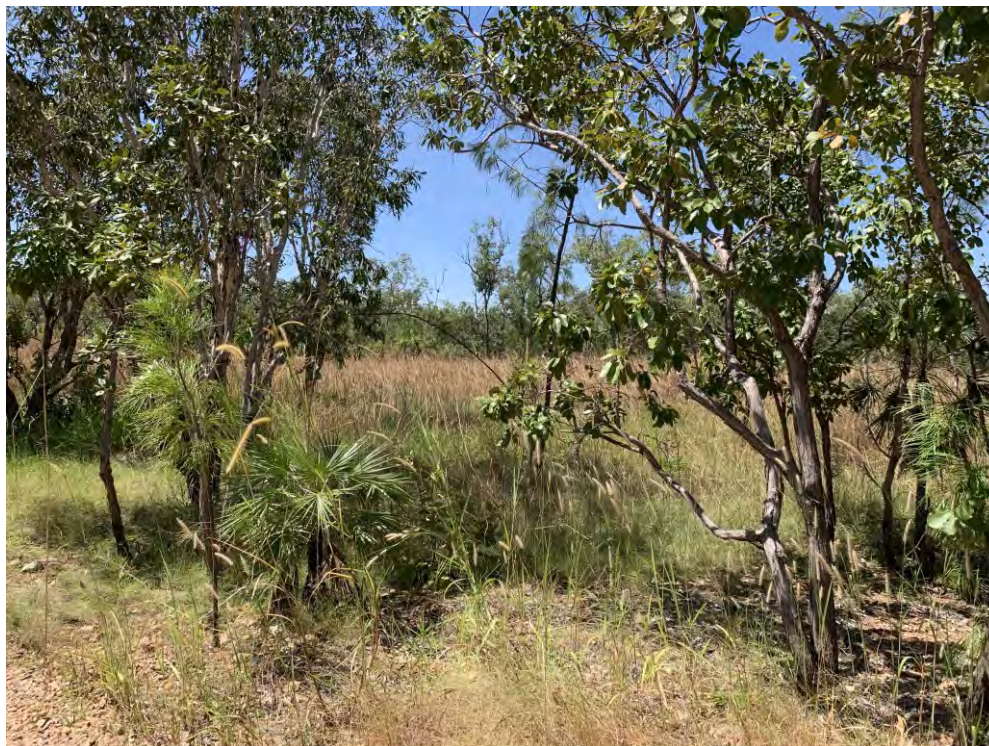
Figure 3.4 - Drainage Line BP1 channel

Drainage Line BP1 has a catchment area of approximately 298 ha and 365 ha to the BPUS SW1 and BPDS SW2 monitoring locations respectively (shown in Figure 3.6). Of this catchment area, 93.8 ha would be impounded by OHD. The catchment is mostly natural with some grassed areas that were cleared by preliminary exploration activities. The channel is poorly defined, particularly in the upper section of the reach. The channel banks are vegetated with grasses, shrubs and small trees, as shown in Figure 3.4.

Drainage Line BP1 has a catchment area of approximately 298 ha and 365 ha to the BPUS SW1 and BPDS SW2 monitoring locations respectively (shown in Figure 3.6). Of this catchment area, 93.8 ha would be impounded by OHD. The catchment is mostly natural with some grassed areas that were cleared by preliminary exploration activities. The channel is poorly defined, particularly in the upper section of the reach. The channel banks are vegetated with grasses, shrubs and small trees, as shown in Figure 3.4.

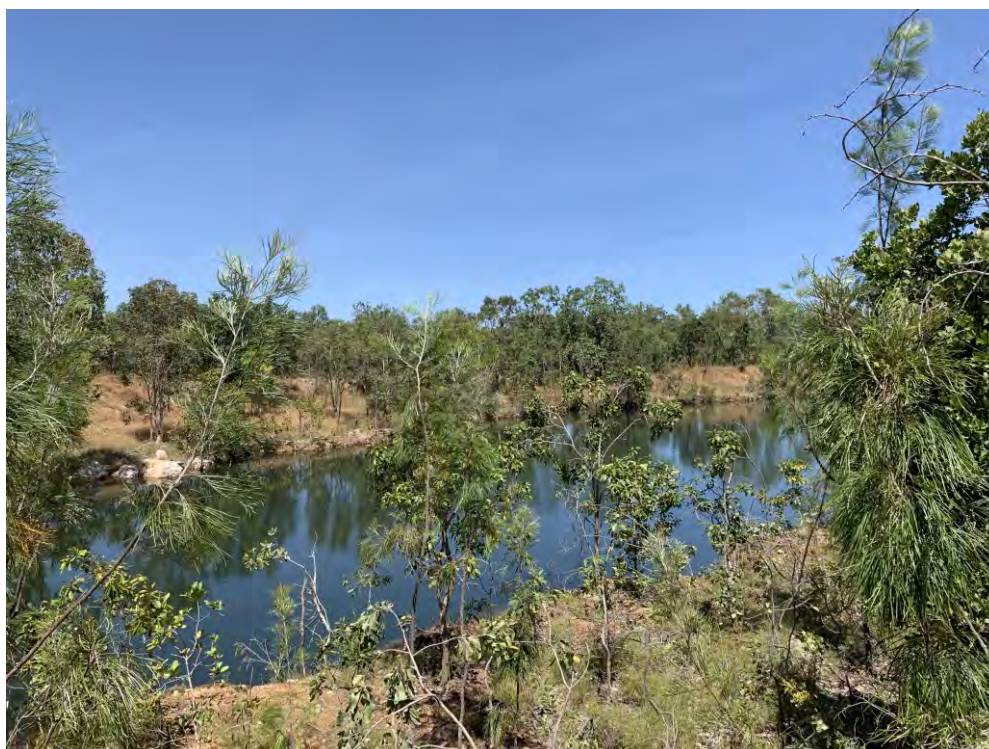
Figure 3.5 - Drainage Line BP1 exploration void

There is a small exploration pit void adjacent to the Drainage Line BP1 channel, downstream of BPUS SW1 (shown in Figure 3.5). The void has filled with water. The void is surrounded by an embankment approximately 1 m high, which may constrict flows in this location.

There is a small exploration pit void adjacent to the Drainage Line BP1 channel, downstream of BPUS SW1 (shown in Figure 3.5). The void has filled with water. The void is surrounded by an embankment approximately 1 m high, which may constrict flows in this location.

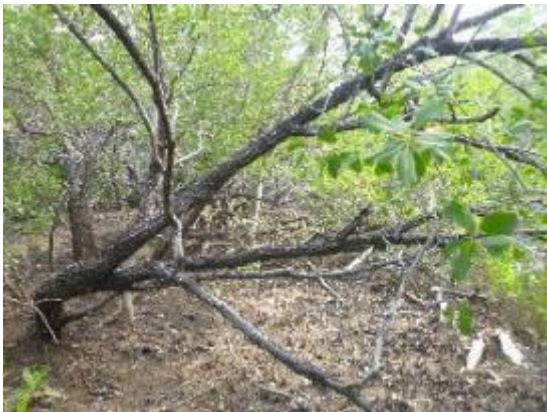
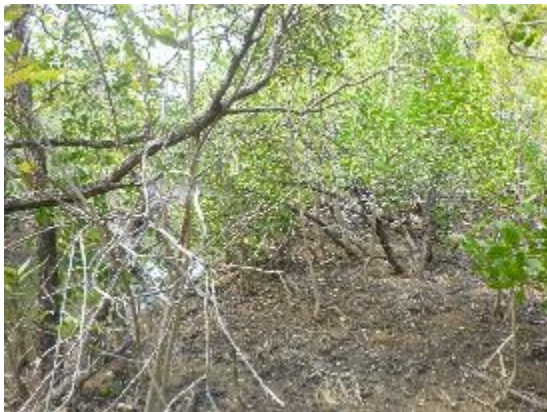
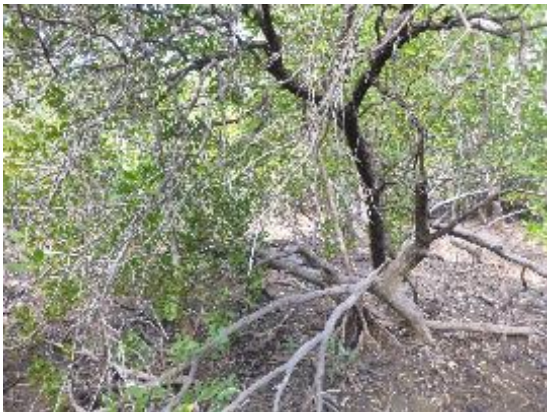
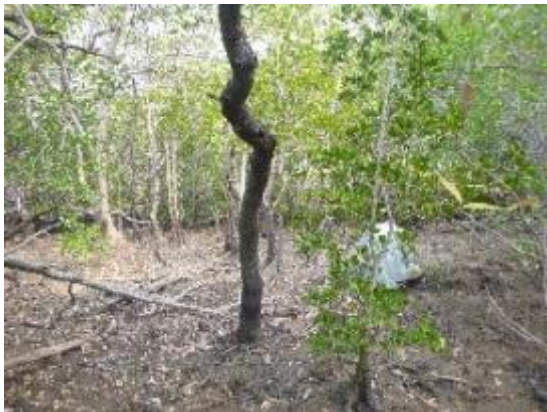
Site MVS1 – <i>Lumnitzera racemosa</i>, <i>Bruguiera exaristata</i>, <i>Avicennia marina</i> low open forest over <i>Fimbristylis</i> sp. and <i>Xerochloa imberbis</i> mid sparse tussock grassland	
NVIS Code: T6c	
Location (GDSA94, z52): 694035E, 8601220N	
Upper 1: Mid open forest dominated by <i>Lumnitzera racemose</i> and <i>Avicennia marina</i>	
Mid 1: <i>Bruguiera exaristata</i> , <i>Avicennia marina</i> with isolated <i>Excoecaria ovalis</i>	
Ground 1: Sparse tussock grassland dominated by <i>Fimbristylis</i> sp. and <i>Xerochloa imberbis</i>

Other species Upper stratum (U1): - Mid stratum (M1): Ground stratum (G1): -	
Land unit (Greater Darwin 25K) – 9b Marine	
Landform: Mangrove flat near tidal creek	
Soils: Brown sandy clay surface soils, some pebbles present ranging in size (2 – 6 cm)	
Drainage: Very poorly drained	
Fire history: No fire impact	
Weeds: Absent	
Disturbance: None

Hydrology: tidal, towards upper tide limit. Large pool located adjacent to vegetation assessment site – approximately 4 m wide.

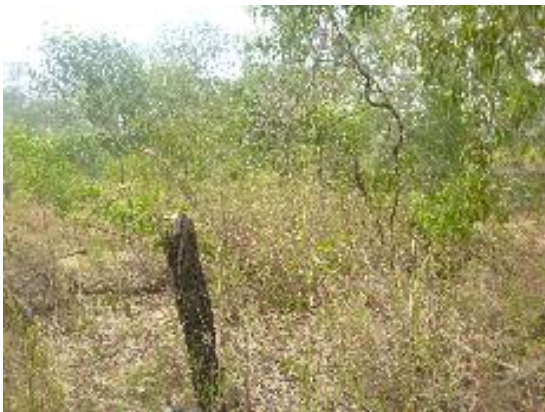
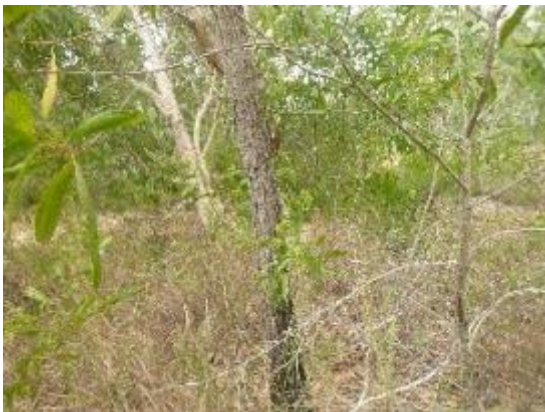
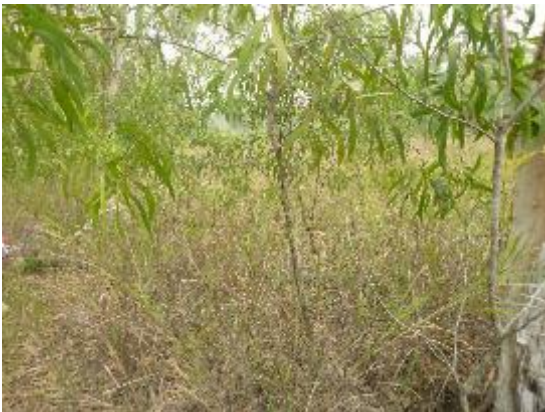
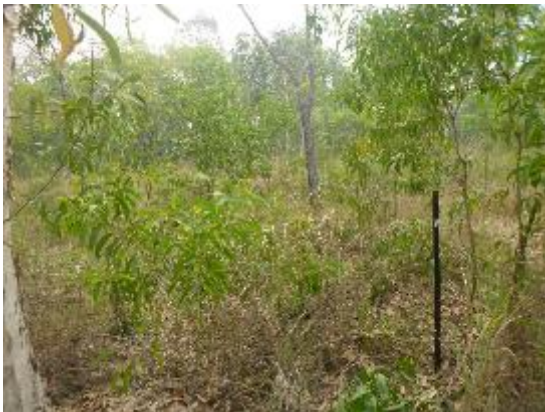
Site RVS2 – <i>Melaleuca viridiflora</i> mid woodland over <i>Acacia plectocarpa</i> mid open shrubland over <i>Germainia grandiflora</i> mid tussock grassland	
NVIS Code: T7i	
Location (GDA94, z52): 693834E 8601132N	
Upper 1: Mid woodland dominated by <i>Melaleuca viridiflora</i>	
Mid 1: Mid open shrubland dominated by <i>Acacia plectocarpa</i> , <i>Lumnitzera racemosa</i> (on the edge of creek) and <i>Avicennia marina</i> (in creek channel)	
Ground 1: Mid tussock grassland dominated by <i>Germainia grandiflora</i> , <i>Dapsilanthus</i> sp. and <i>Xerochloa imberbis</i>

Other species Upper stratum (U1): - Mid stratum (M1): <i>Thespesia populneoides</i> Ground stratum (G1): - <i>Asteraceae</i> sp., <i>Wrightia saligna</i> , <i>Flagellaria indica</i> , <i>Acrostichum speciosum</i> , <i>Gymnanthera nitida</i> , <i>Lindernia lobelioides</i> , <i>Diospyros littorea</i>	
Land unit (Greater Darwin 25K) – 6b Drainage system

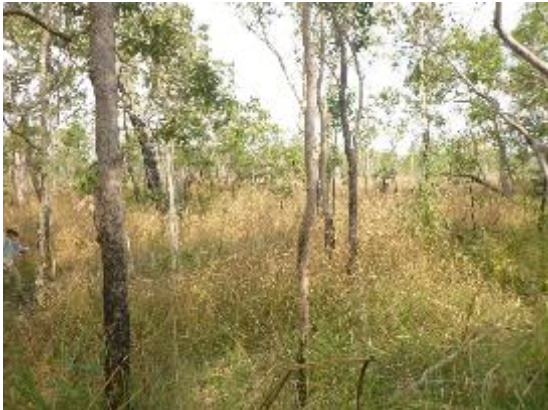
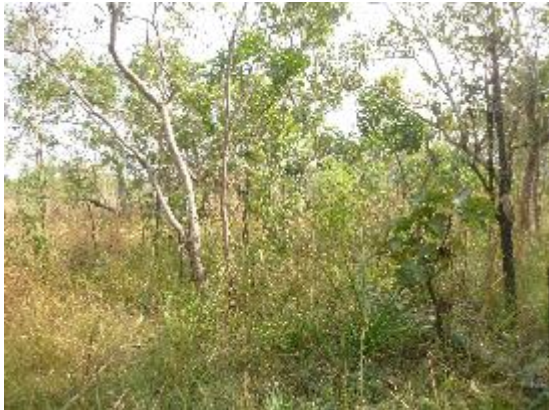
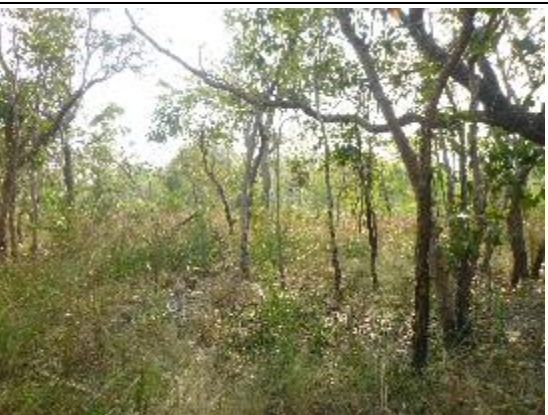
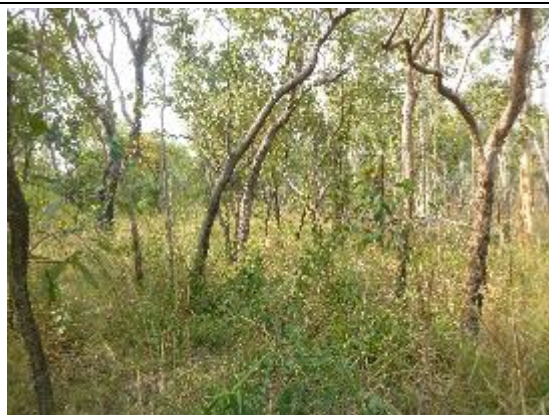
Site SVS3 – <i>Melaleuca viridiflora</i>, <i>Erythrophleum chlorostachys</i> and <i>Corymbia polycarpa</i> mid woodland over <i>Lophostemon lactifluus</i> mid open shrubland over <i>Sorghum intrans</i> mid tussock grassland	
NVIS Code: T7i	
Location (GDA94, z52): 693708E, 8600969N	
Upper 1: Mid woodland dominated by <i>Melaleuca viridiflora</i> , <i>Erythrophleum chlorostachys</i> and <i>Corymbia polycarpa</i>	
Mid 1: Mid open shrubland dominated by <i>Lophostemon lactifluus</i> , <i>Clerodendrum floribundum</i> and <i>Denhamia obscura</i>	
Ground 1: Mid open tussock grassland dominated by <i>Sorghum intrans</i> , <i>Aristida</i> sp. and <i>Pandanus spiralis</i>

Land unit (Greater Darwin 25K) – 6b: Drainage system	
Landform: Lower slope, flat open depression	
Soils: Brown sandy loam. Some quartz present near creek	
Drainage: Poorly drained – some wet season inundation	
Fire history: Last year (relatively low impact fire)	
Weeds: Annual mission grass scattered near site. Patches of <i>Hyptis suaveolens</i> , <i>Calopogonium mucunoides</i> and <i>Passiflora foetida</i> recorded nearby	
Disturbance: None	
Hydrology: Wet season inundation

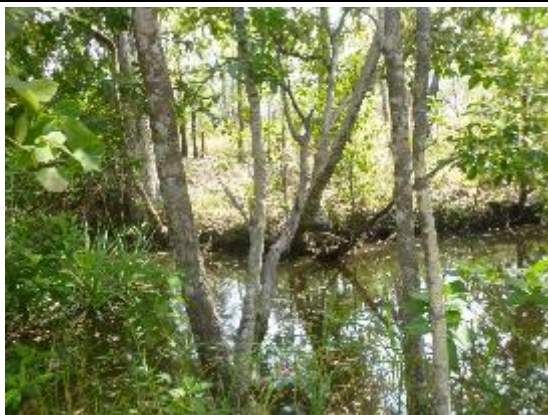
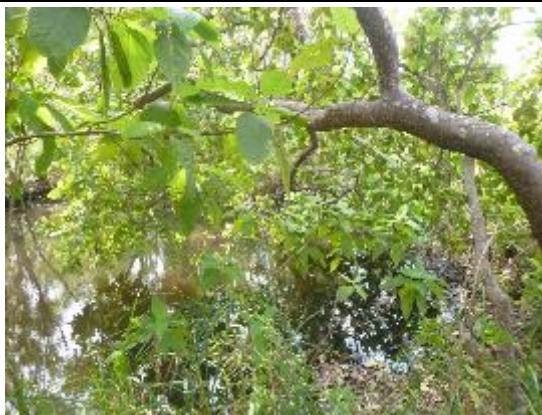
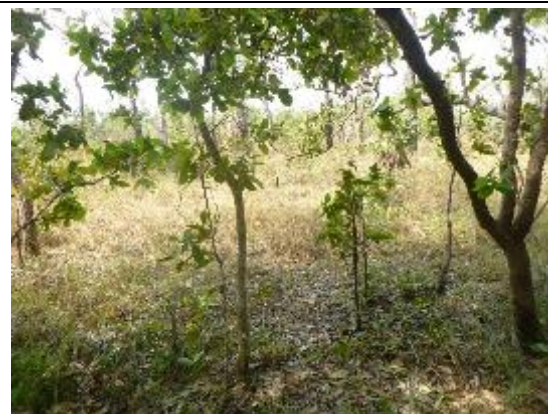
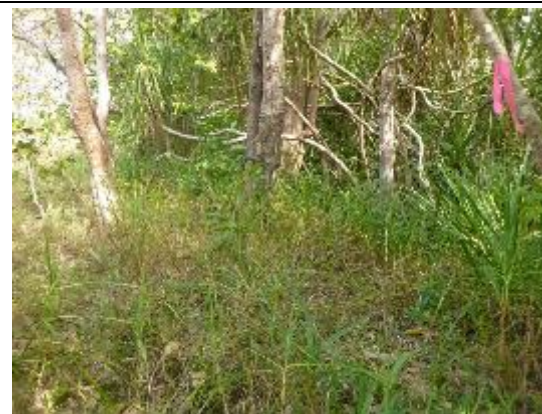
Site RVS4 – *Syzygium armstrongii* and *Xanthostemon eucalyptoides* mid open woodland over *Pandanus spiralis* mid shrubland over *Scleria lingulata* mid open tussock grassland

NVIS Code: T7r
Location (GDA94, z52): 695055E 8594164N
Upper 1: Mid open woodland dominated by <i>Syzygium armstrongii</i> and <i>Xanthostemon eucalyptoides</i>
Mid 1: Mid shrubland dominated by <i>Pandanus spiralis</i> , <i>Flagellaria indica</i> and <i>Helicia australasica</i>
Ground 1: Mid open tussock grassland dominated by <i>Scleria lingulata</i> , <i>Sorghum intrans</i> and <i>Eriachne trisetata</i>

Other species
Upper stratum (U1): <i>Lophostemon lactifluus</i>
Mid stratum (M1): <i>Myrsine benthamiana</i> , <i>Melicope elleryana</i> , <i>Cyclophyllum schultzei</i> , <i>Carallia brachiata</i> , <i>Gmelina australis</i> , <i>Grevillea pluricaulis</i>
Ground stratum (G1): <i>Melastoma malabathricum</i> (polyanthum), <i>Themeda triandra</i> , <i>Eulalia mackinlayi</i> , <i>Osbeckia australiana</i> , <i>Dianella odorata</i> , <i>Cheilanthes</i> sp
Land unit (Greater Darwin 25K) – 5b1: Drainage System
Landform: Flat, adjacent to creek channel
Soils: Black clay in channel
Drainage: Poorly drained
Fire history: Very recent adjacent (other side of the creek) but 2+ years since last fire at the site
Weeds: None
Disturbance: Some pig damage
Hydrology: Site situated adjacent to large pool (approximately 8 m x 15 m) 40 cm ~ 1m deep, steep bank (0.5 m).

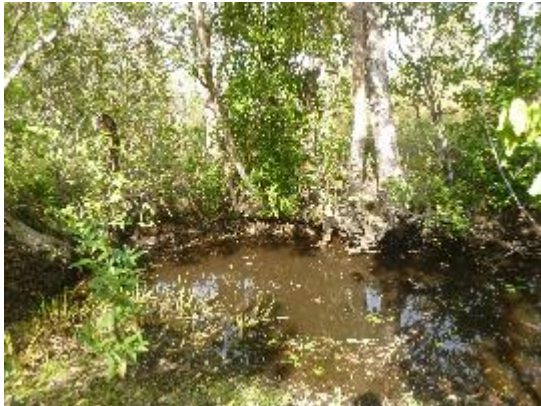
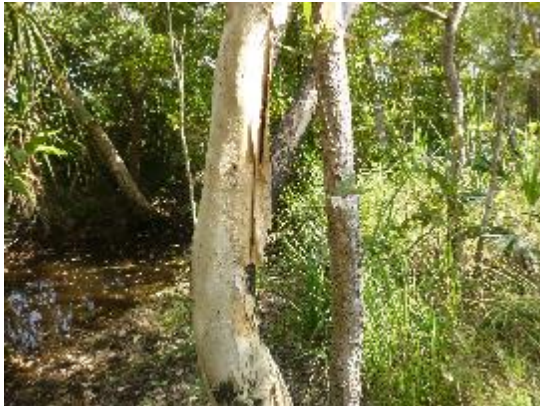
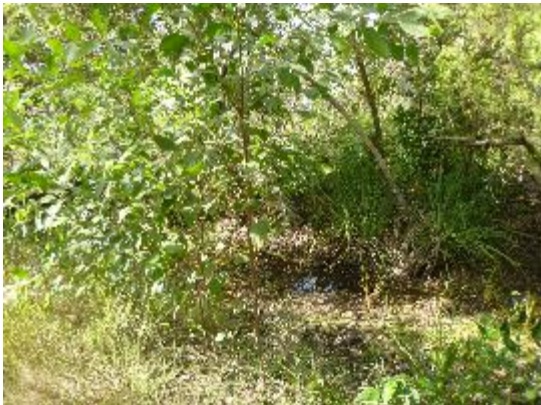
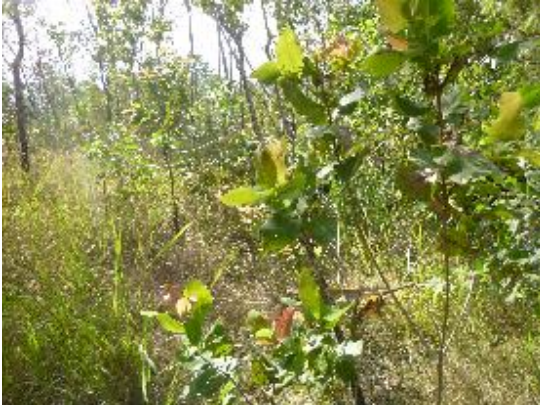
Site RVS5 – <i>Xanthostemon eucalyptoides</i> mid woodland over <i>Leptospermum madidum</i> mid open shrubland over <i>Eriachne trisetia</i> mid tussock grassland	
NVIS Code: T6d	
Location (GDA94, z52): 694646E 8593887N	
Upper 1: Mid woodland dominated by <i>Xanthostemon eucalyptoides</i> ; <i>Syzygium armstrongii</i> ; and <i>Melaleuca viridiflora</i>	
Mid 1: Mid shrubland dominated by <i>Leptospermum madidum</i> ; <i>Helicia australasica</i> ; <i>Carallia brachiata</i> and <i>Cyclophyllum schultzei</i>	
Ground 1: Mid tussock grassland dominated by <i>Eriachne trisetia</i> , , <i>Fern sp.2</i> and <i>Mnesithea rottboellioides</i>

Land unit (Greater Darwin 25K) – 5b1: Drainage System	
Landform: open depression (watercourse/gully)	
Soils: Brown loam sand. Clay in channel	
Drainage: Poorly-very poorly drained	
Fire history: unburnt-fire nearby	
Weeds: Absent	
Disturbance: Some pig disturbance	
Hydrology: Some pools nearby, inundated with freshwater during wet season

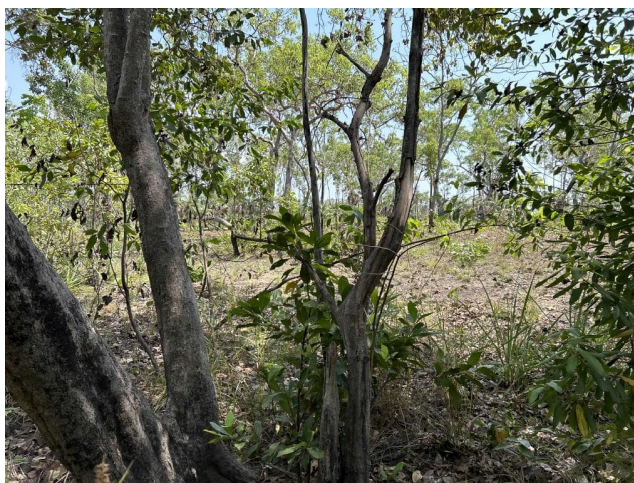
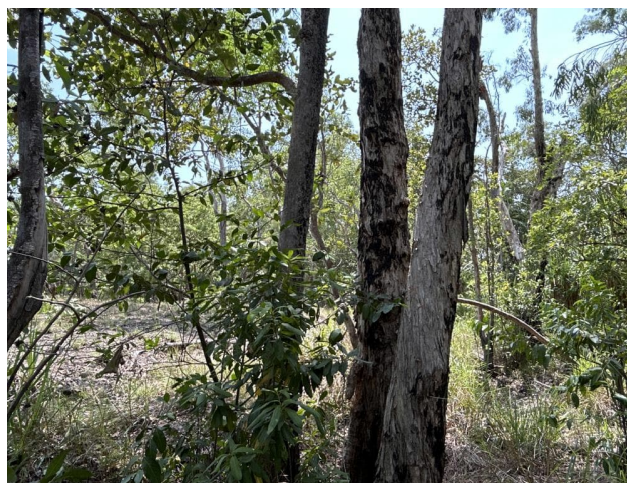
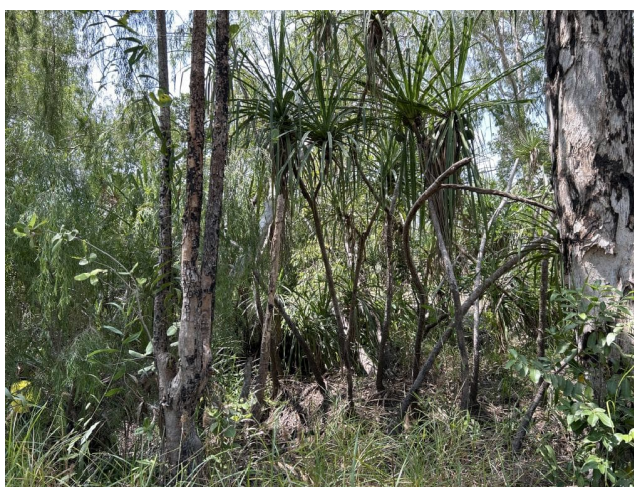
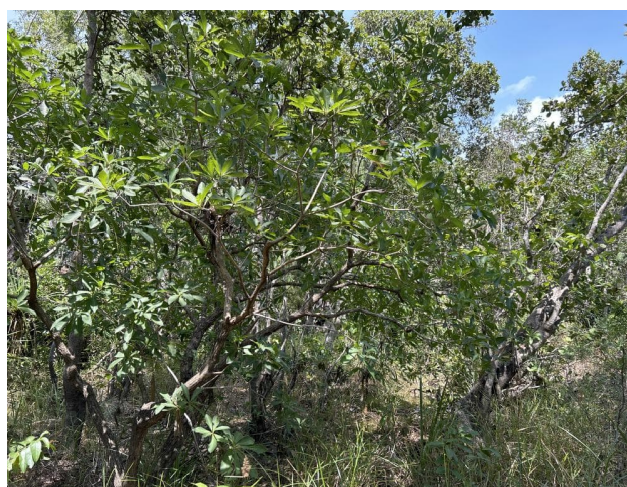
Figure 3-1. Photographs of the habitat at RSV1 using cardinal-directions for riparian monitoring

Figures 3-1 to 3-3 below provide imagery of RSV1.

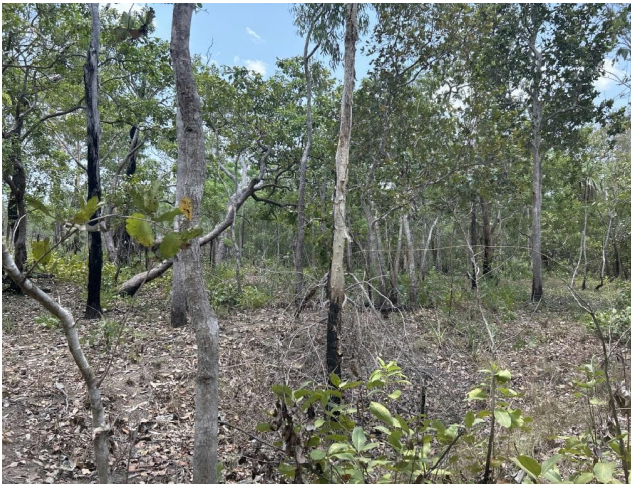
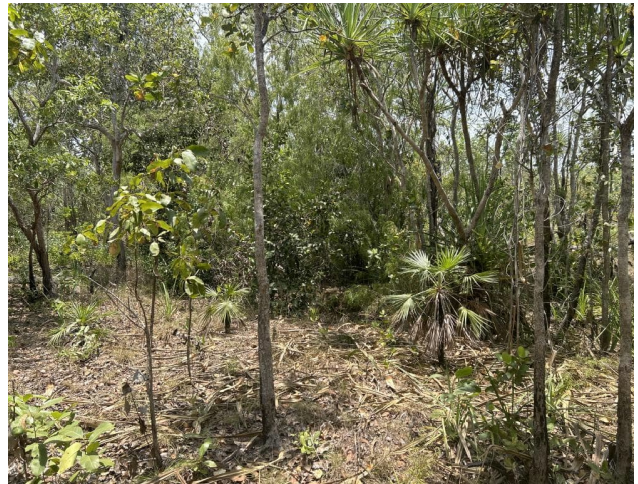
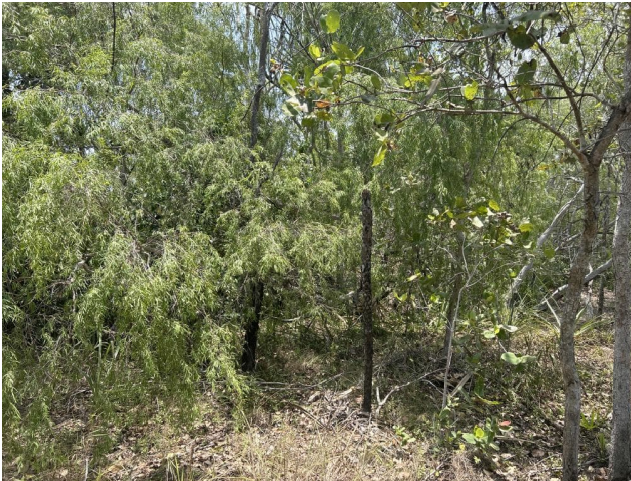
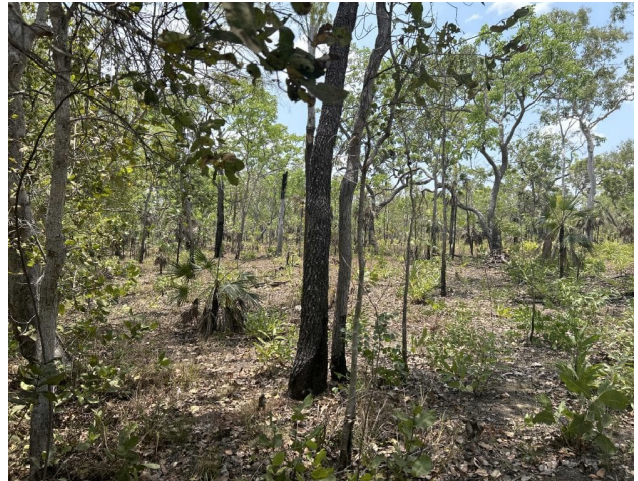
Figure 3-4. Photographs of the habitat at RVS2 using cardinal-directions for riparian monitoring

Figures 3-4 to 3-6 below provide imagery of RSV2.

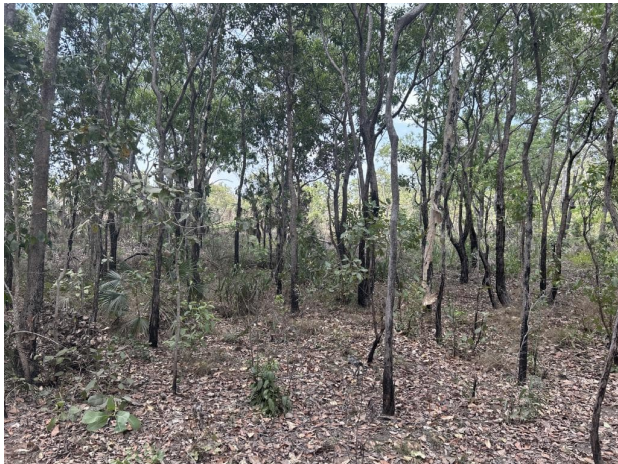
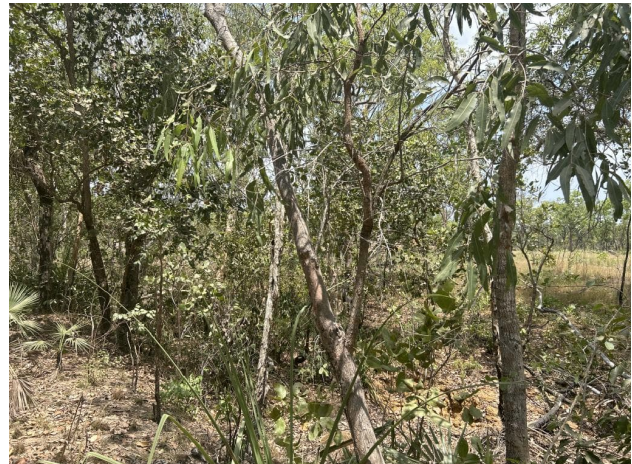
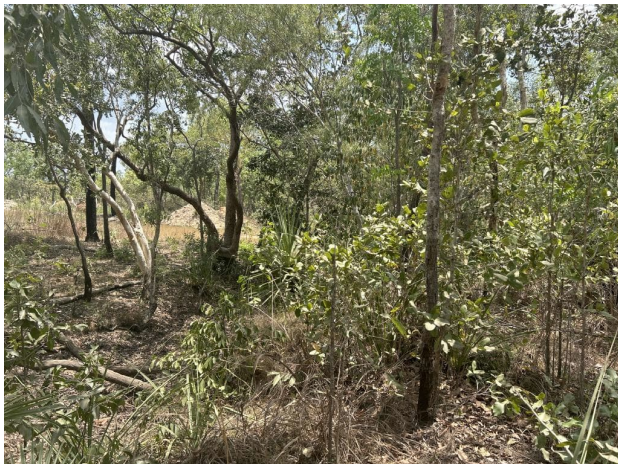
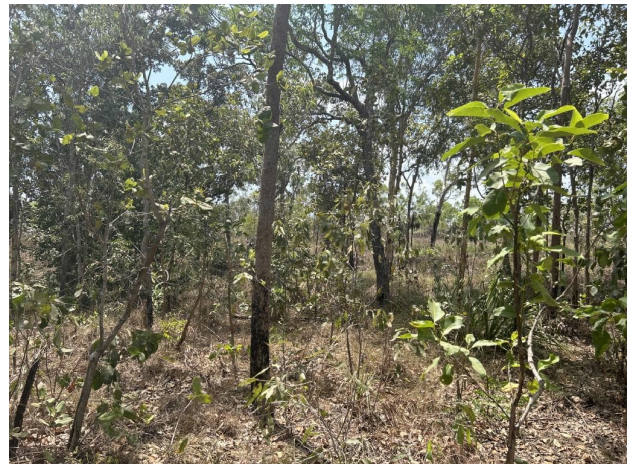
Figure 3-7. Photographs of the habitat at RVS3 using cardinal-directions for riparian monitoring

Figures 3-7 to 3-9 below provide imagery of RSV3.

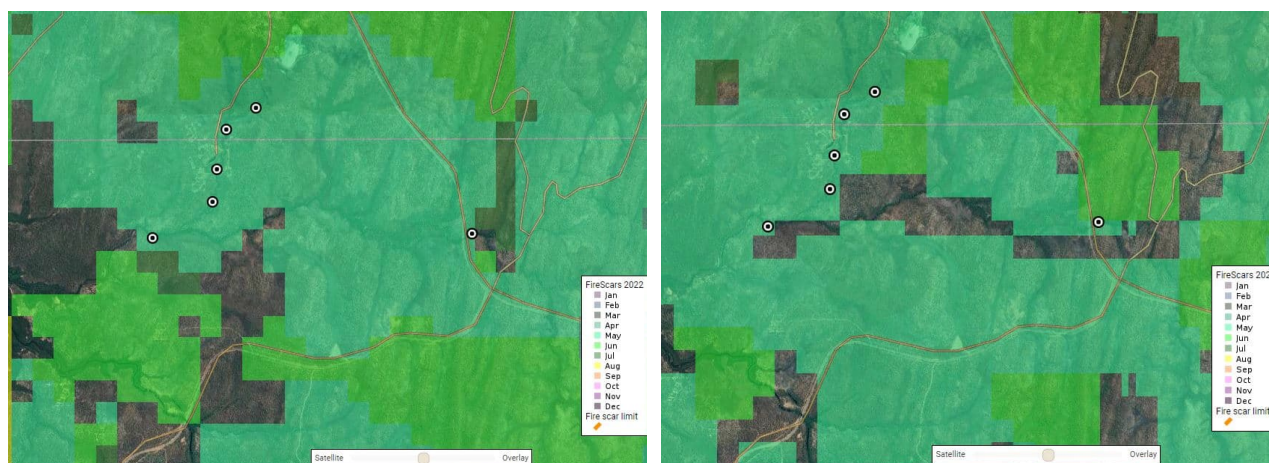
Figure 3-19. Fire scar mapping based on 2022 and 2023 monthly data (NAFI 2023)

The NAFI website was visited to investigate frequencies and severity across the mapped riparian area (specifically the vegetation). Though not all riparian sites recorded fire during field investigations, NAFI indicates early burns occurred in May across most of the study area, for both years (Figure 3-19).

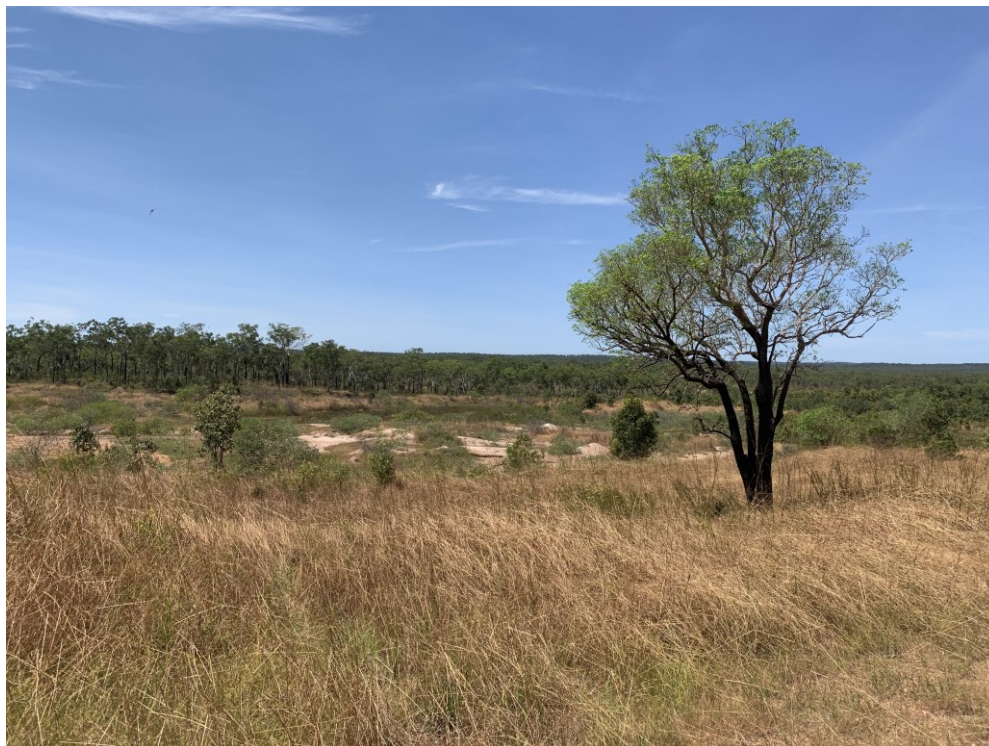
Figure 3.1 - OHD upper catchment

OHD is located adjacent to the proposed BP33 area and receives runoff from a largely undisturbed catchment area of 94 ha. There are no defined drainage lines in the upper OHD catchment. The upper catchment has a slope between 1% to 2%. Figure 3.1 shows the upper OHD catchment area, which appears to be well vegetated.

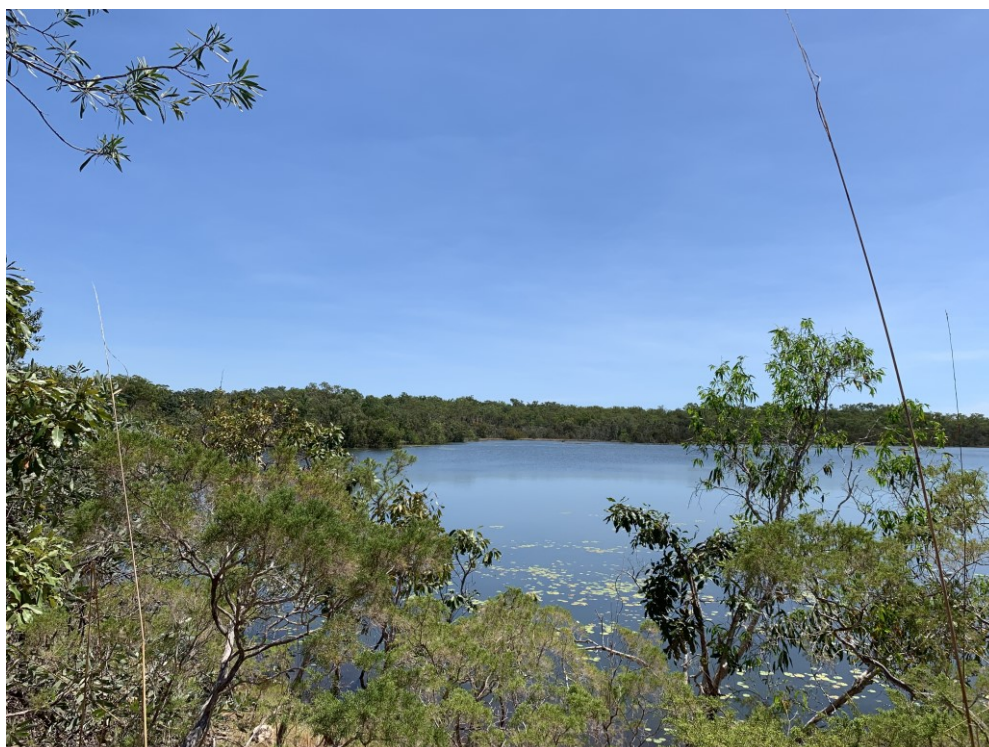
Figure 3.2 - OHD water surface

Figure 3.2 shows the OHD water surface and surrounding vegetation. This photograph shows that the area around OHD is well vegetated.
