Baseline Riparian Vegetation Monitoring Report Finniss Lithium Project

CORE LITHIUM

Job	EZ22099
Document ID	215635-54
Author(s)	Nicole Clark, Anna Lemon

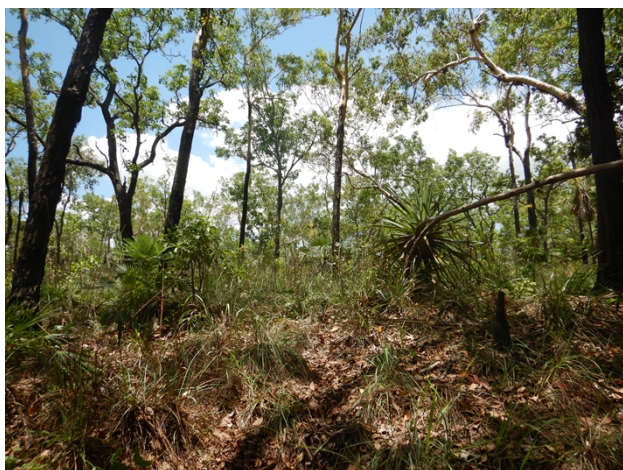
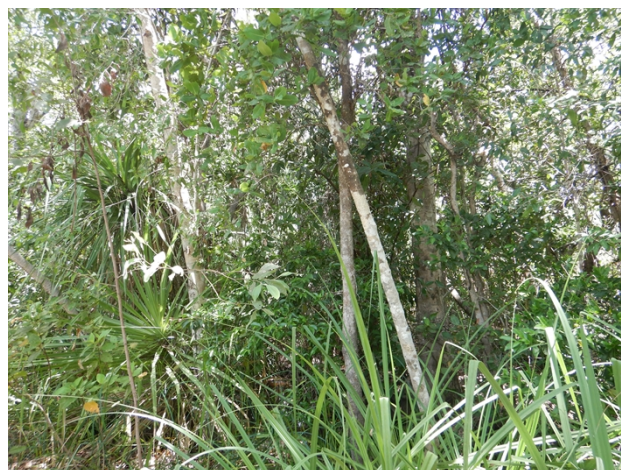
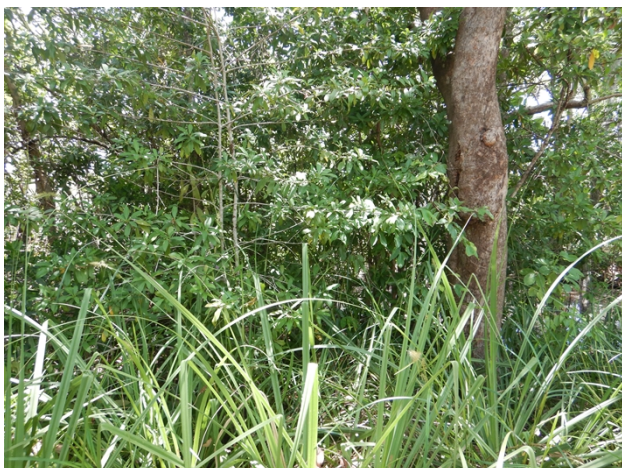
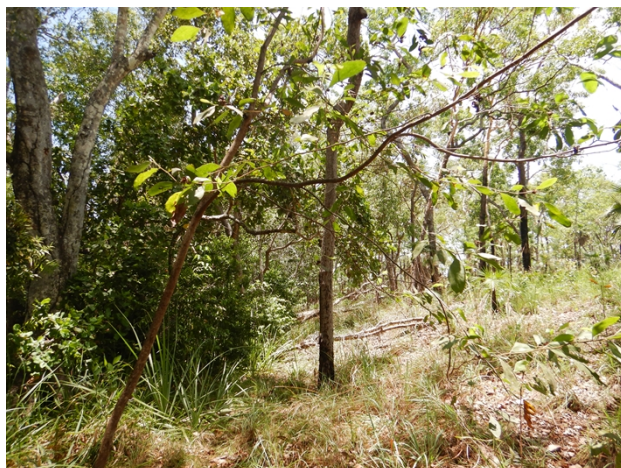
Figure 4-7. Photographs of the habitat at RVS4 using cardinal-directions for riparian monitoring

No standing water present within creek. The last fire was observed <1 year ago.

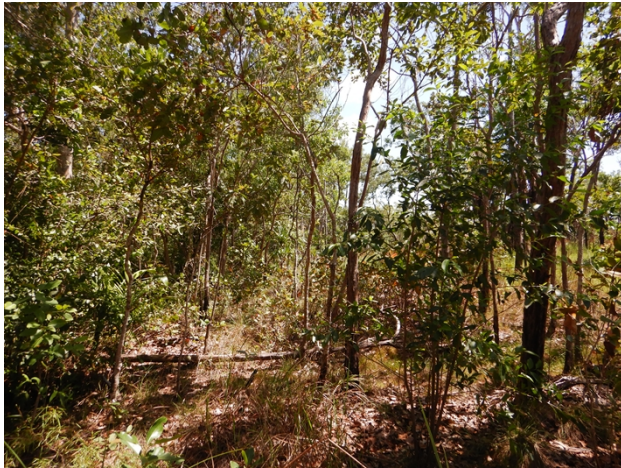
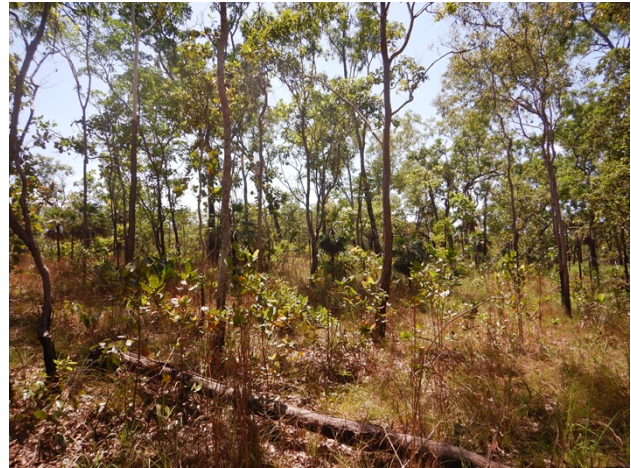
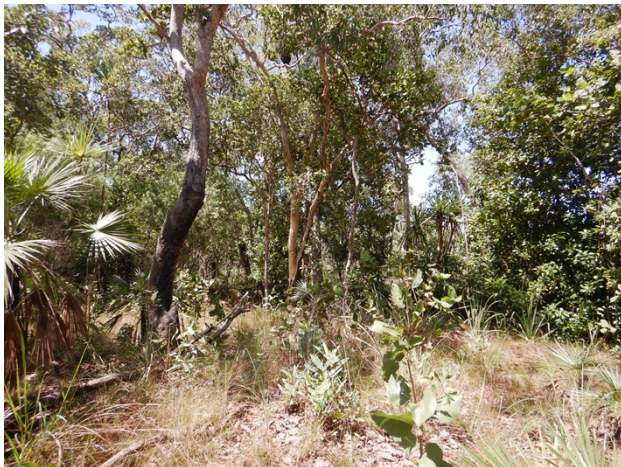
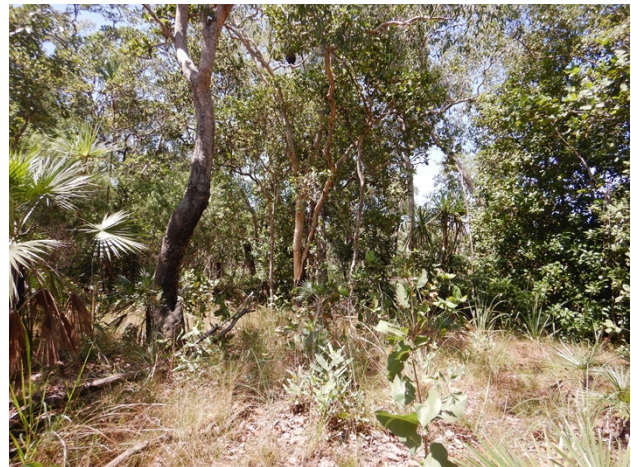
Figure 4-9. Photographs of the habitat at RVS5 using cardinal-directions for riparian monitoring

No standing water present within creek. The last fire was observed <1 year ago.

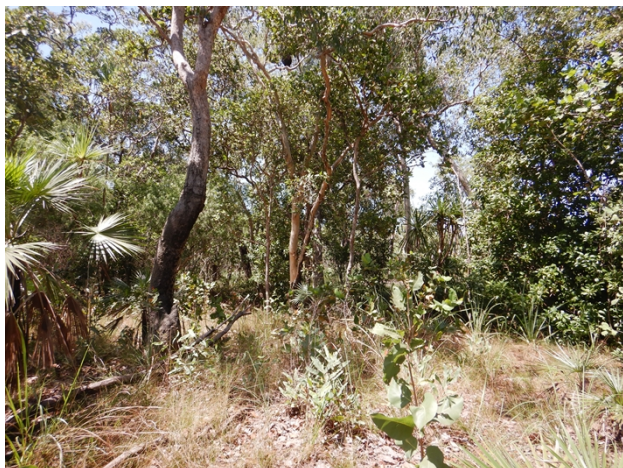
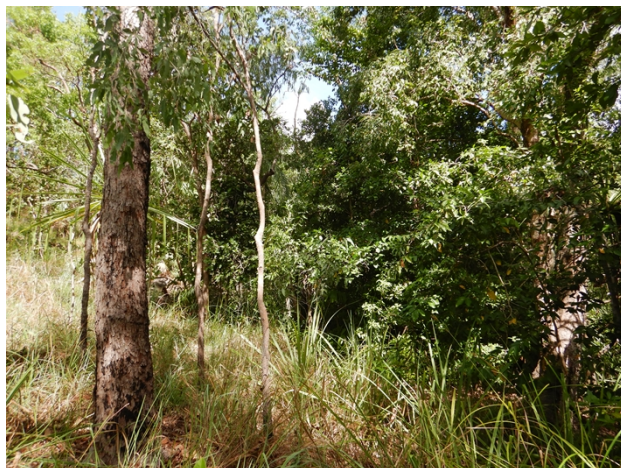
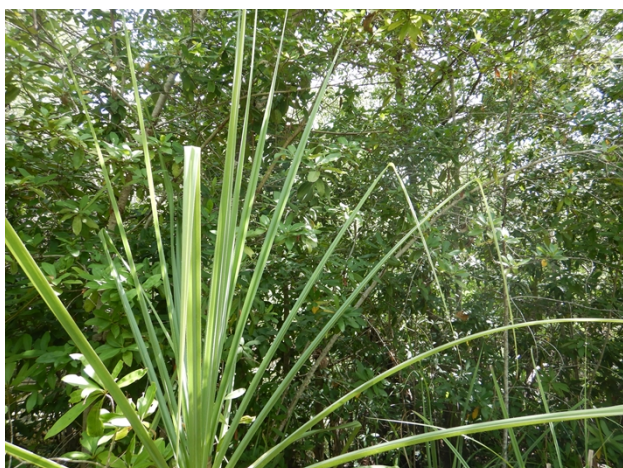
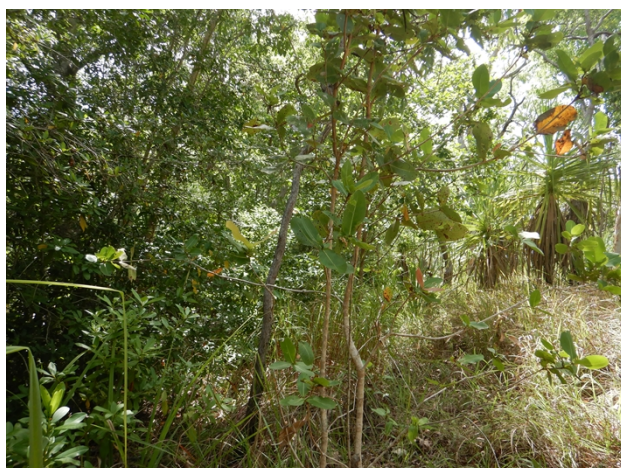
Figure 4-11. Photographs of the habitat at the reference site using cardinal-directions for riparian monitoring

Two aquatic plants – *Eriocaulon* sp. and *Nymphaea* sp. – were both observed within the creek and biofilms were observed on the waters' surface along the edges of the system. Standing water was stagnant, with no apparent sedimentation present.
