NORTHERN TERRITORY OF AUSTRALIA
LICENCE TO TAKE OR USE SURFACE WATER
Pursuant to section 45 of the *Water Act*

Licence No: 8151018

Mangrove and Riparian Vegetation Assessment Grants Lithium Project Core Lithium

Riparian Vegetation Monitoring Report – post dry-season 2023 Finniss Lithium Project CORE LITHIUM

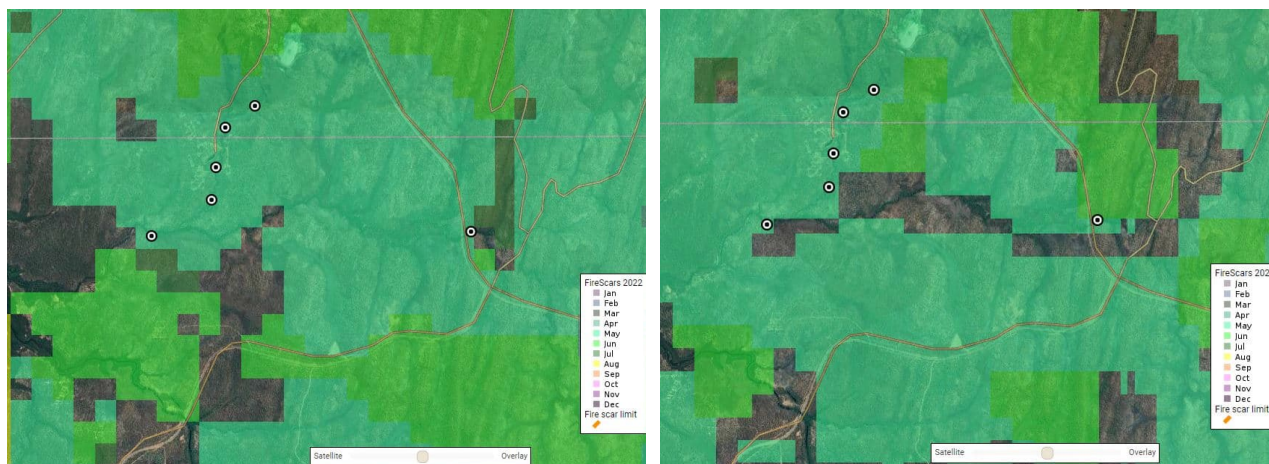
Figure 3-19. Fire scar mapping based on 2022 and 2023 monthly data (NAFI 2023)

The NAFI website was visited to investigate frequencies and severity across the mapped riparian area (specifically the vegetation). Though not all riparian sites recorded fire during field investigations, NAFI indicates early burns occurred in May across most of the study area, for both years (Figure 3-19).
