Service Advisory

SA 2024-01

Subject: 4-Car Rear Upper Slider Reinforcement

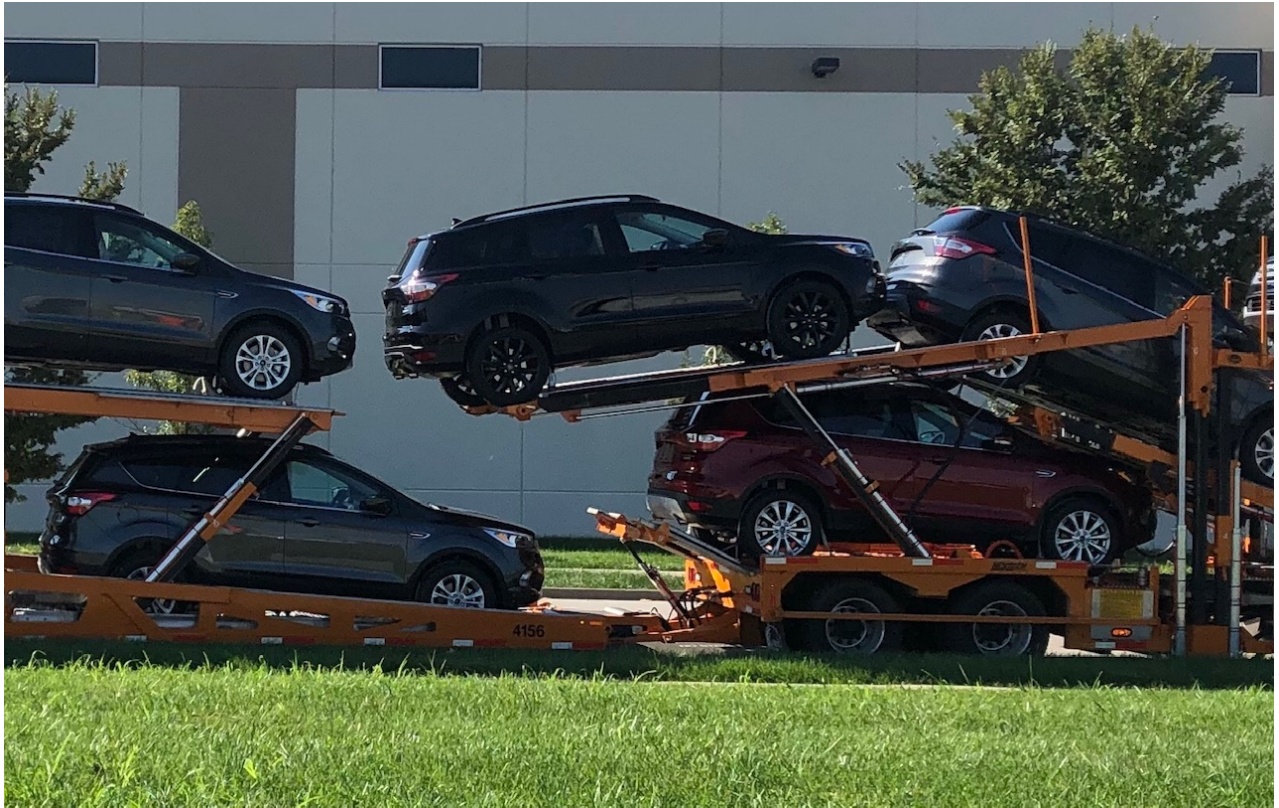
We have determined a possibility exists that the rear upper slider on certain 4-car headramps could yield under extreme loading scenarios. See enclosed Photo 1 showing a sample of an extreme loading scenario. Note that the unit positioned on the rear upper headramp is extended further out than on a more typical load. See also enclosed Photo 2 showing deformation of the rear upper slider that may occur under the sort of extreme loading scenario pictured in Photo 1.

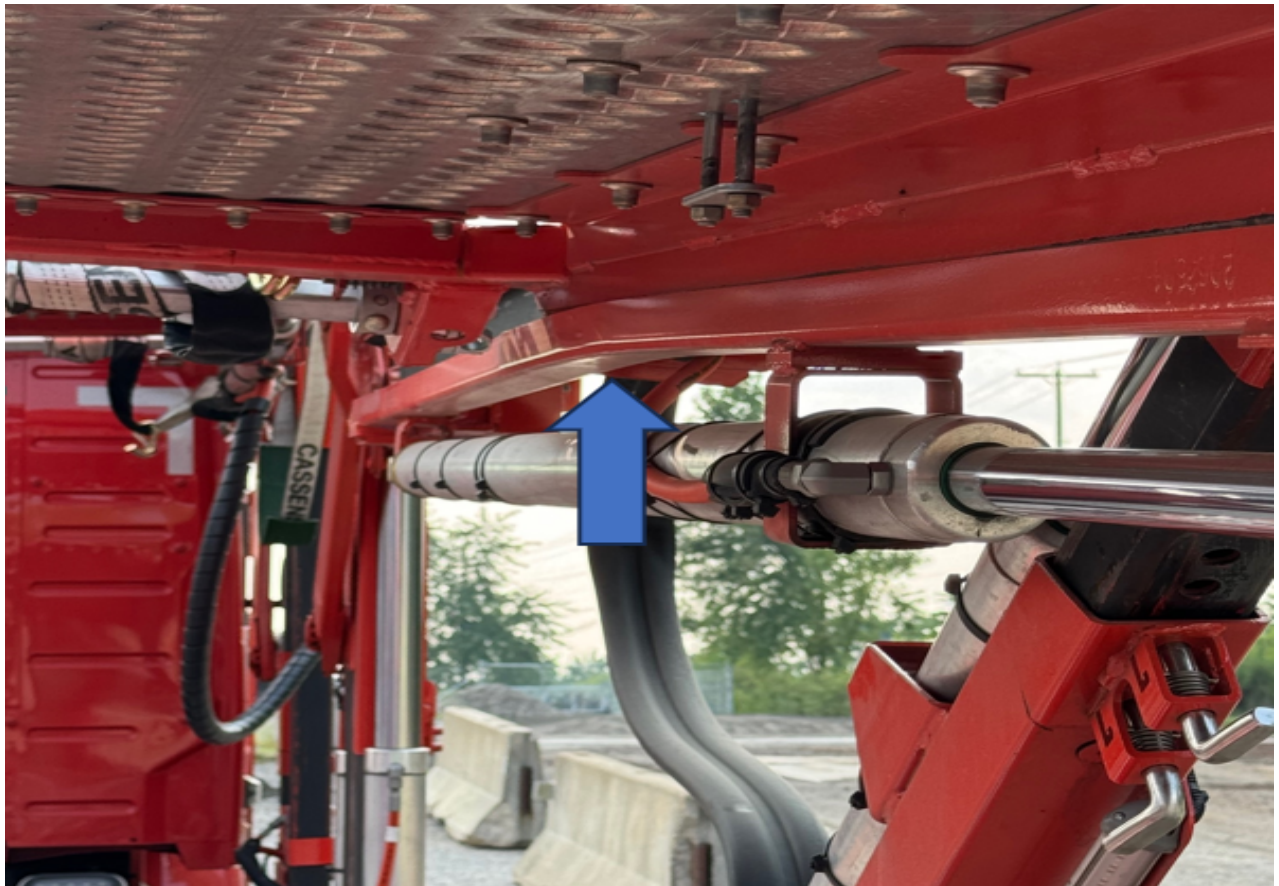
Photo 2

1. Inspect the rear upper slider on your headramp(s) to determine if any deformation is present (refer to Photo 2). If any deformation is present, we will ship a repair kit to you free of charge to reinforce the area at issue consistent with the enclosed drawings.
2. If no deformation is present but you believe there is a possibility that you may one day have a load similar to what is seen in Photo 1, we will ship a repair kit to you free of charge to reinforce the area at issue consistent with the enclosed drawings.
3. Even if no deformation is present and you do not believe there is a possibility that you may ever have a load similar to what is seen in Photo 1 (with the rear upper unit in an extended position), but you would still like to receive a repair kit, we will ship one to you free of charge to reinforce the area at issue consistent with the enclosed drawings.

If any of the above 3 paragraphs apply to you, please email us at the email address below providing the number of repair kits needed along with the address of your repair shop or authorized repair facility where you would like the repair to be performed. We will ship the needed repair kit(s) to that location free of charge.
