# CLD500

Application Note: CLD09v01

**Transient NO<sub>x</sub> measurements from in-service Euro V and VI buses**

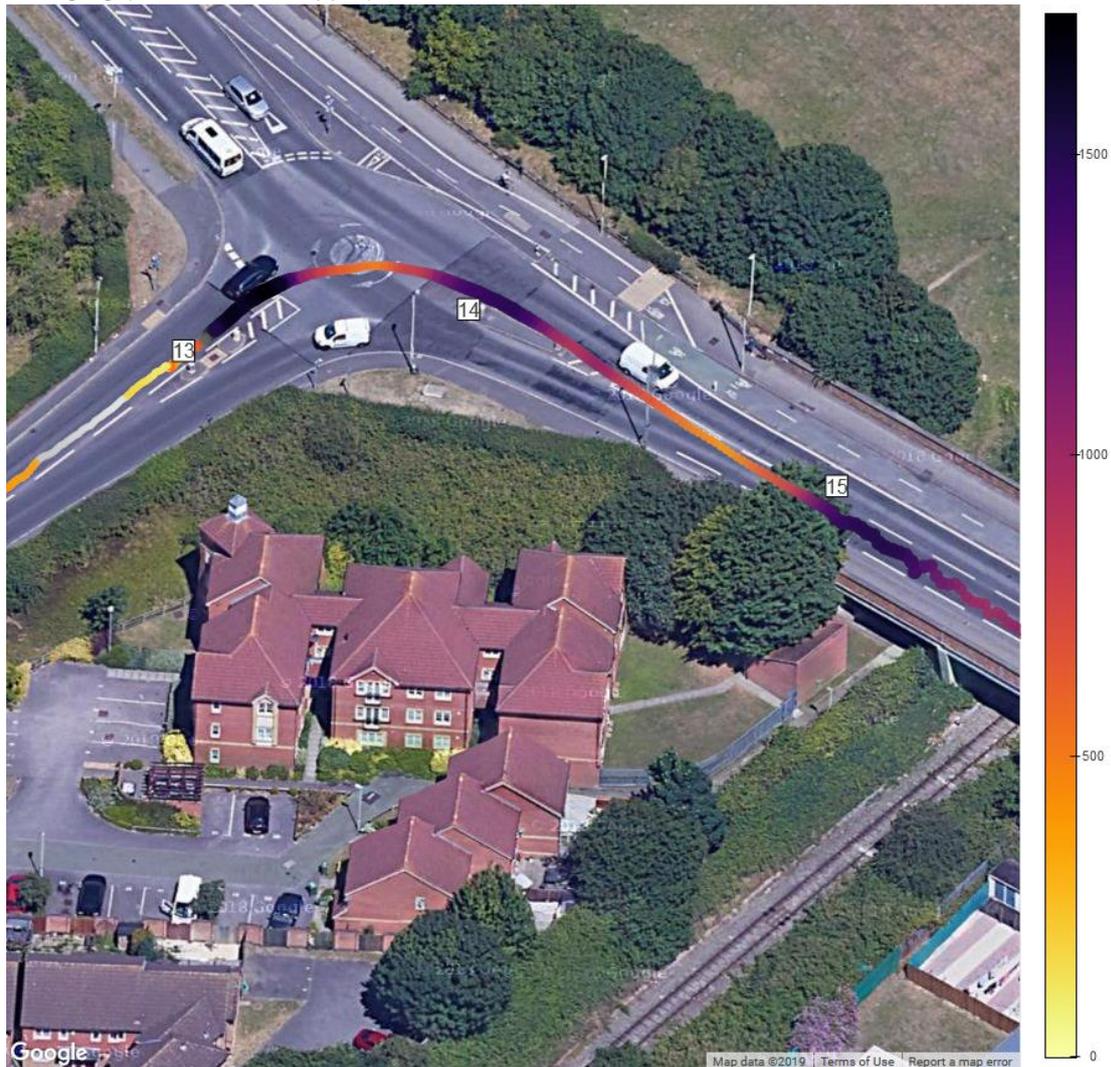
**Figure 1: Location of Euro VI bus NO<sub>x</sub> emissions at mini-roundabout**

A joint project between [Cambustion](#), [Oxford University Engineering Science Dept](#), the [Oxford Bus Company](#) and [Oxford City Council](#) was undertaken following conversations between Dr. Felix Leach (Oxford Univ) and Mai Jarvis (Oxford City Council) about Oxford’s clean air zone. In the UK, buses have access to city centres where the presence of urban NO<sub>x</sub> “hot spots” might have a negative impact on local air quality and the use of Cambustion’s fast response NO<sub>x</sub> analysers combined with accurate GPS allowed for the accurate measurement and positioning of the sites where significant NO<sub>x</sub> “spikes” were emitted. The example in **Figure 1** shows tailpipe NO<sub>x</sub> when pulling on to a mini-roundabout, accelerating away and gear changing (colours denote ppm).

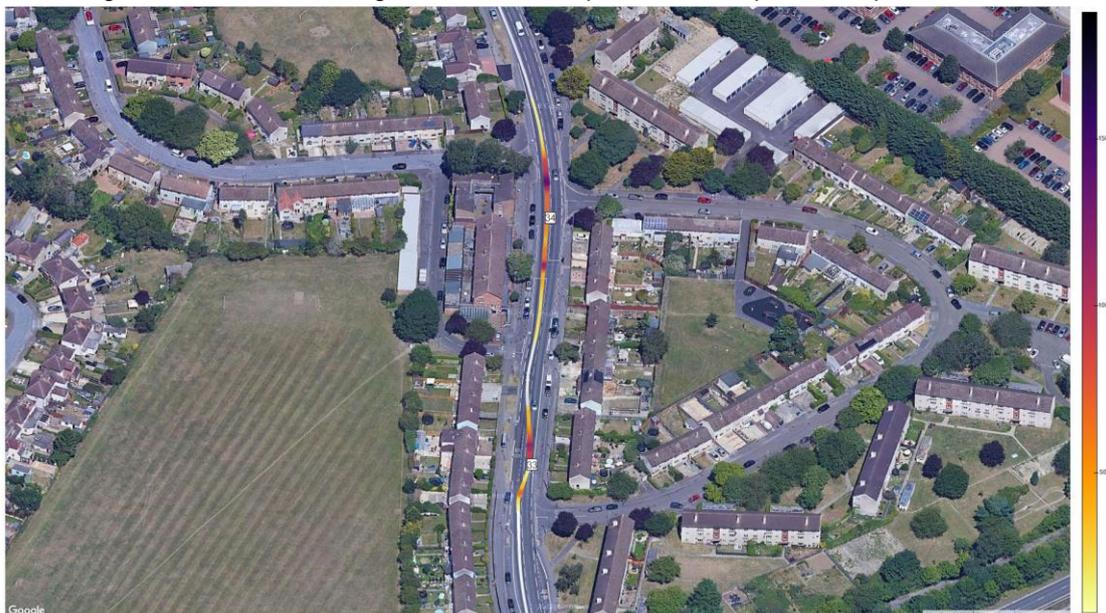
**Figure 4: NO<sub>x</sub> levels produced by the Euro VI bus negotiating parked cars and congestion**

A correlation was noted between the position of bus stops and high levels of NO<sub>x</sub> but also with the general transient driving associated with parked cars, speed bumps etc.

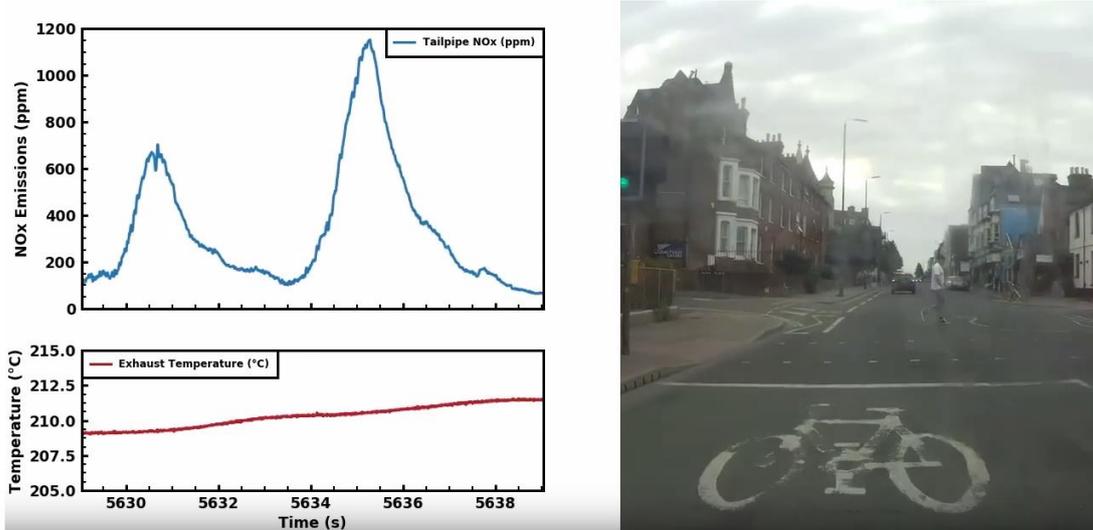
**Figure 5: NO<sub>x</sub> spikes caused by pull-away from bus-stop; 2nd spike caused by gear change.**

...and the subsequent spikes of NO<sub>x</sub> produced at pull-away from the bus stop:
