# SAFETY ALERT

## SA-255 – Ladder slides out from under Painter

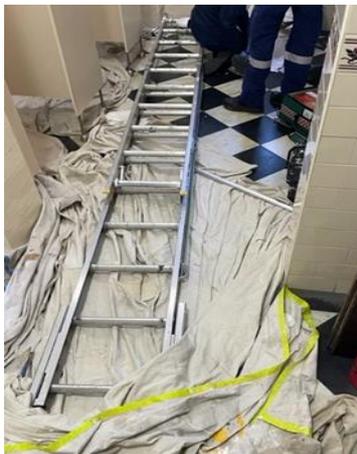
The floor was covered with drop sheets and the first coat was cut in from the extension ladder set up on top of the drop-sheet with the light cut in and ceiling rolled from the floor using a long roller pole.

After lunch, the Painter climbed the ladder to cut in the second coat and as they neared the top the ladder, the ladder slid out at the base and the painter has fallen about 2.5 - 3m to the floor landing on top of the ladder. The impact caused them to hit their head and they also received a laceration just below the knee requiring 8 stitches to close.

An extension ladder must never be set up on drop sheets especially on a slippery surface.

As specified in the “Extension Ladder use SWMS, a second person must always be used to foot an extension ladder that cannot be secured, to prevent movement of the top and the bottom.

The additional use of a ladder footing device such as the Ladder ‘T’ (pictured below) on such a slippery surface would have removed nearly all possibility of the ladder sliding out injuring one of our team.
