NORTHERN ROAD
FAIRBAIRN

CONSTRUCTION AND
OPERATIONS STRATEGY

MAY 2020

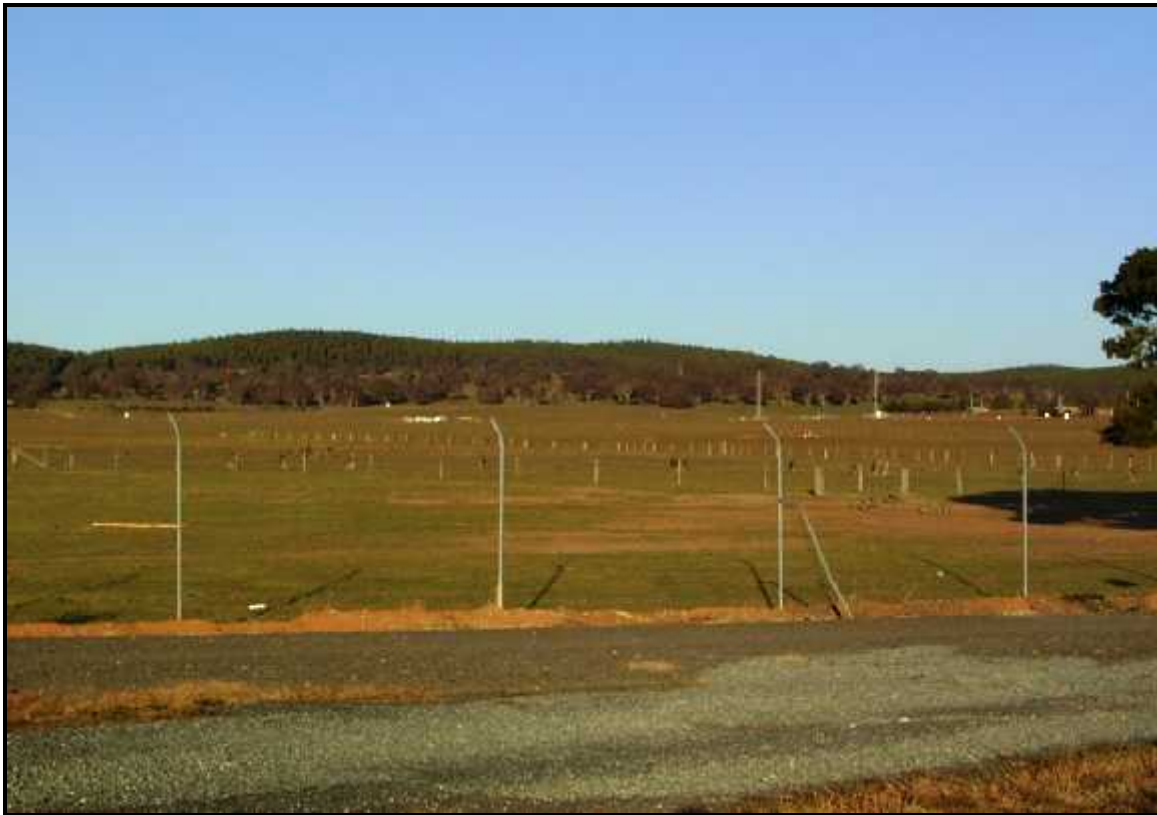
Photograph 1. July 2007. Study site from western boundary. Airport security fence in foreground, pines near dam at right. Note very short grass, extensive bare patches, kangaroos, roosting ducks. Shows part of same area as Photographs 2 and 3.

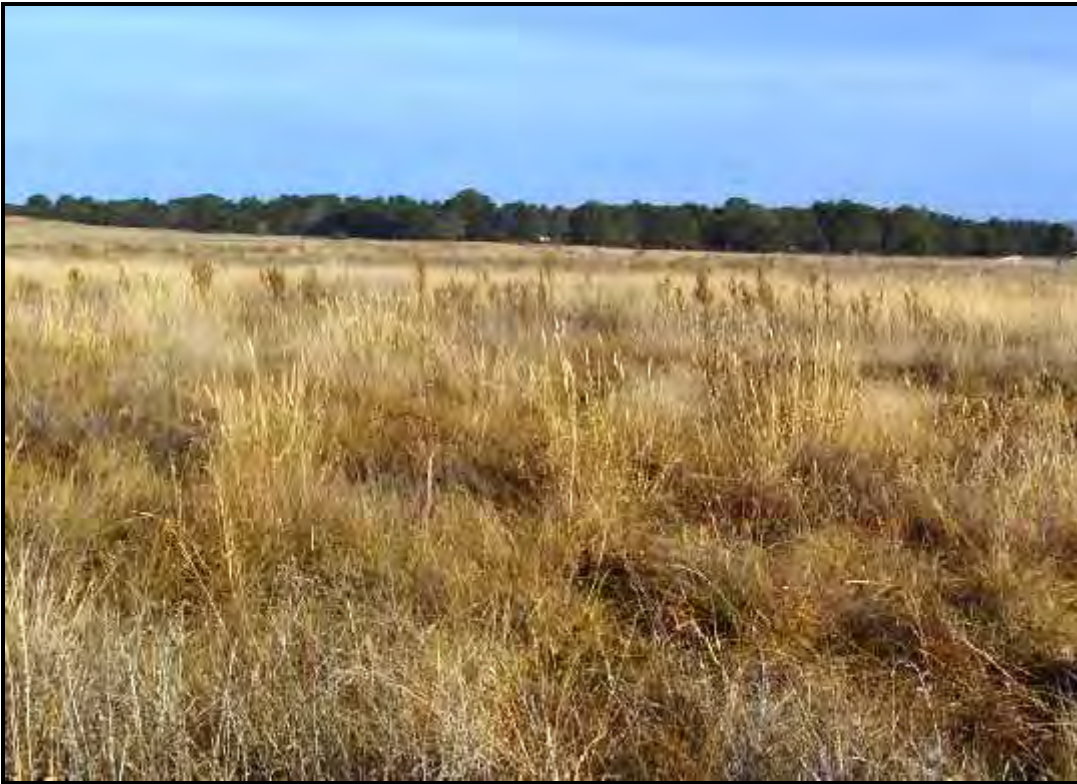
Photograph 2: May 2011, from centre of site facing SSE. Tall dense exotic dominated grassland with patches of Phalaris, Paspalum, tall weeds, Tall Speargrass. Fence hidden by vegetation.

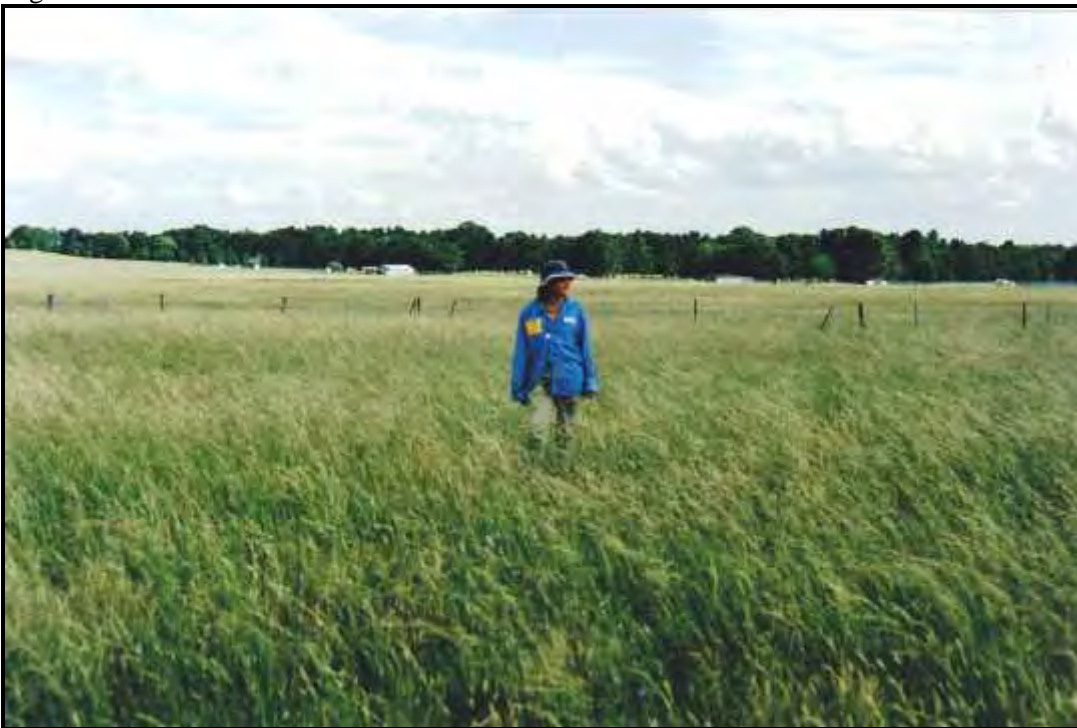
Photograph 3. December 2003, same photopoint: showing medium height (fence visible) and medium density native pasture, with Tall Speargrass and Wallaby Grasses, few weeds.

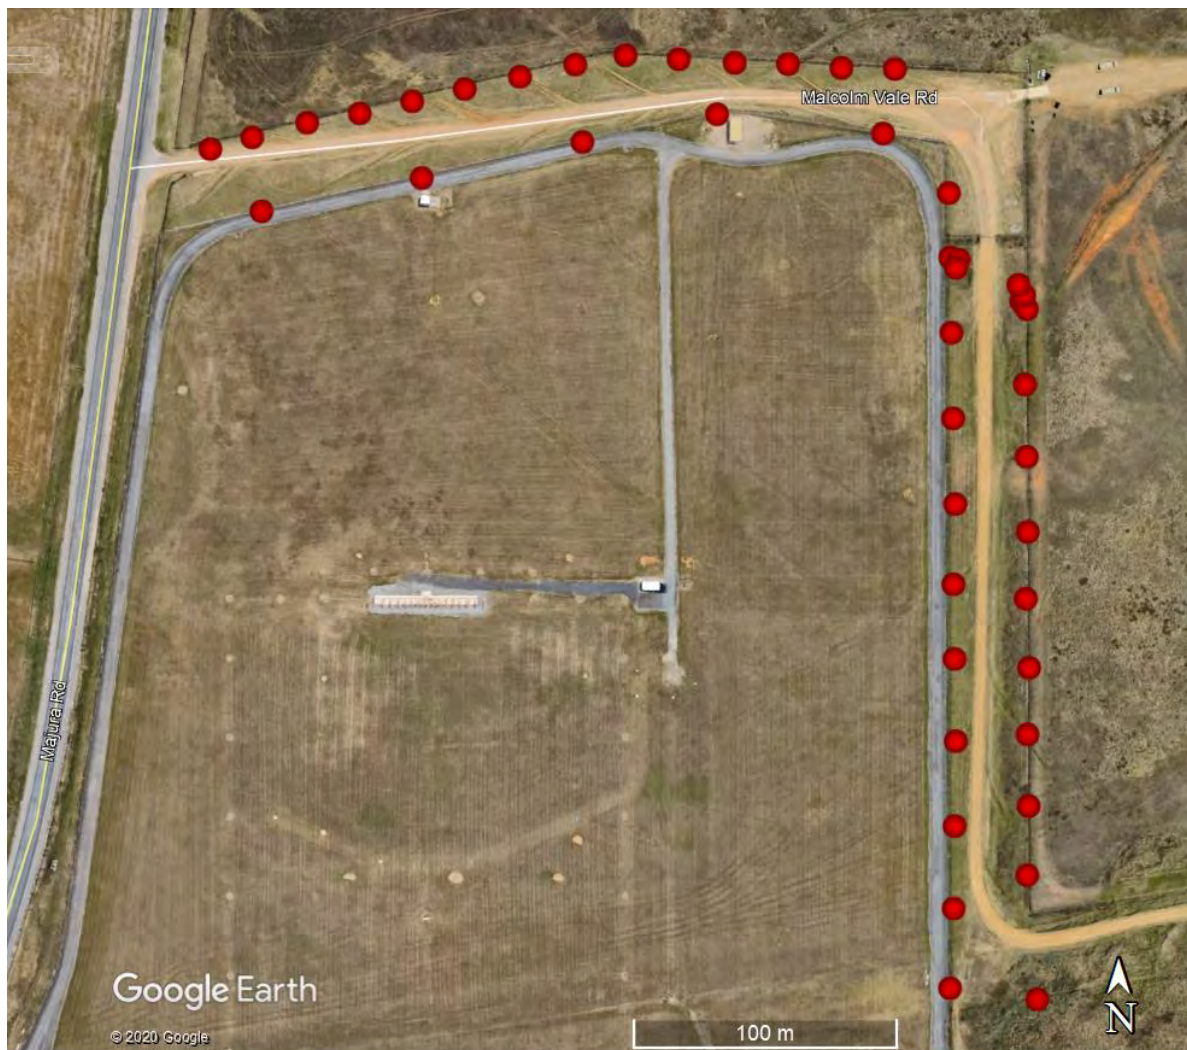
Figure 2. Tile locations on northern section of route.
Red = tiles

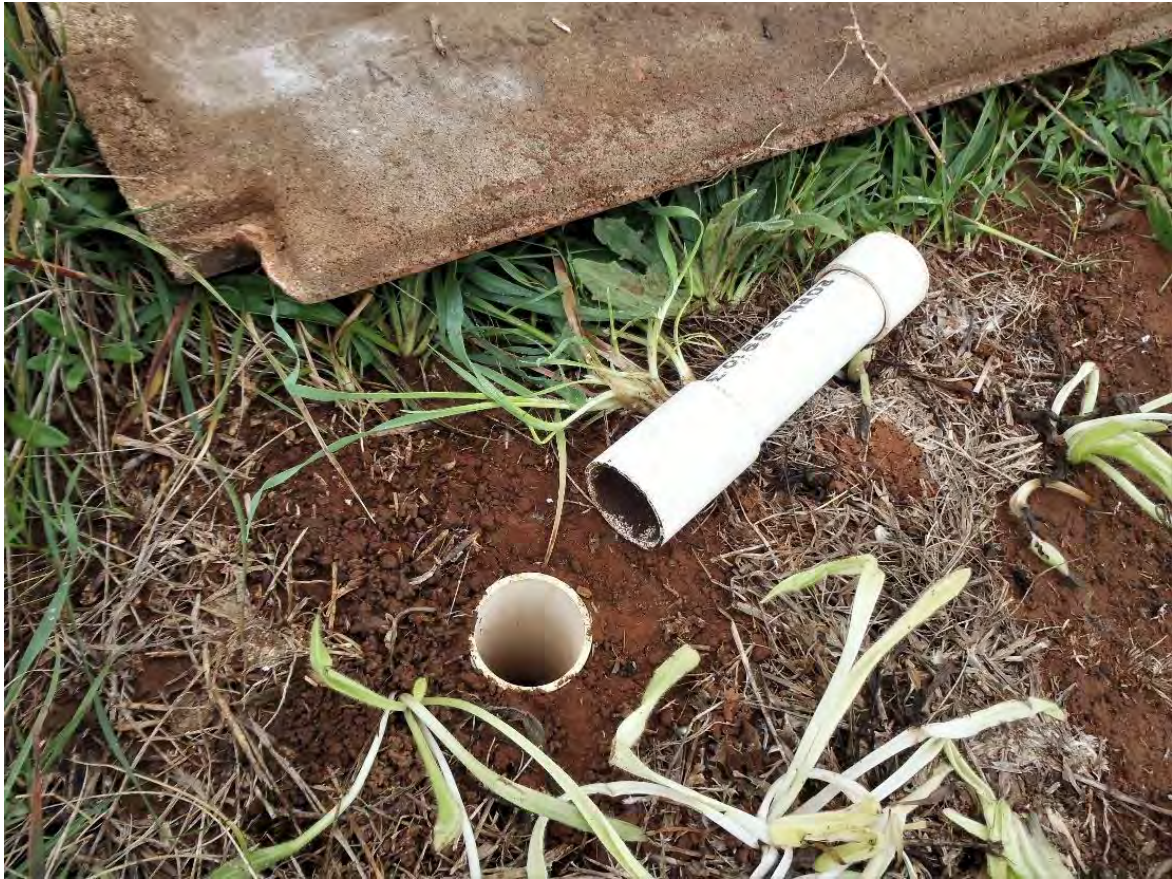
Photograph 1. Artificial burrow (tube) under tile, insert removed.
Insert has drainage hole at base and a roughened lining which allows animals to enter and leave.

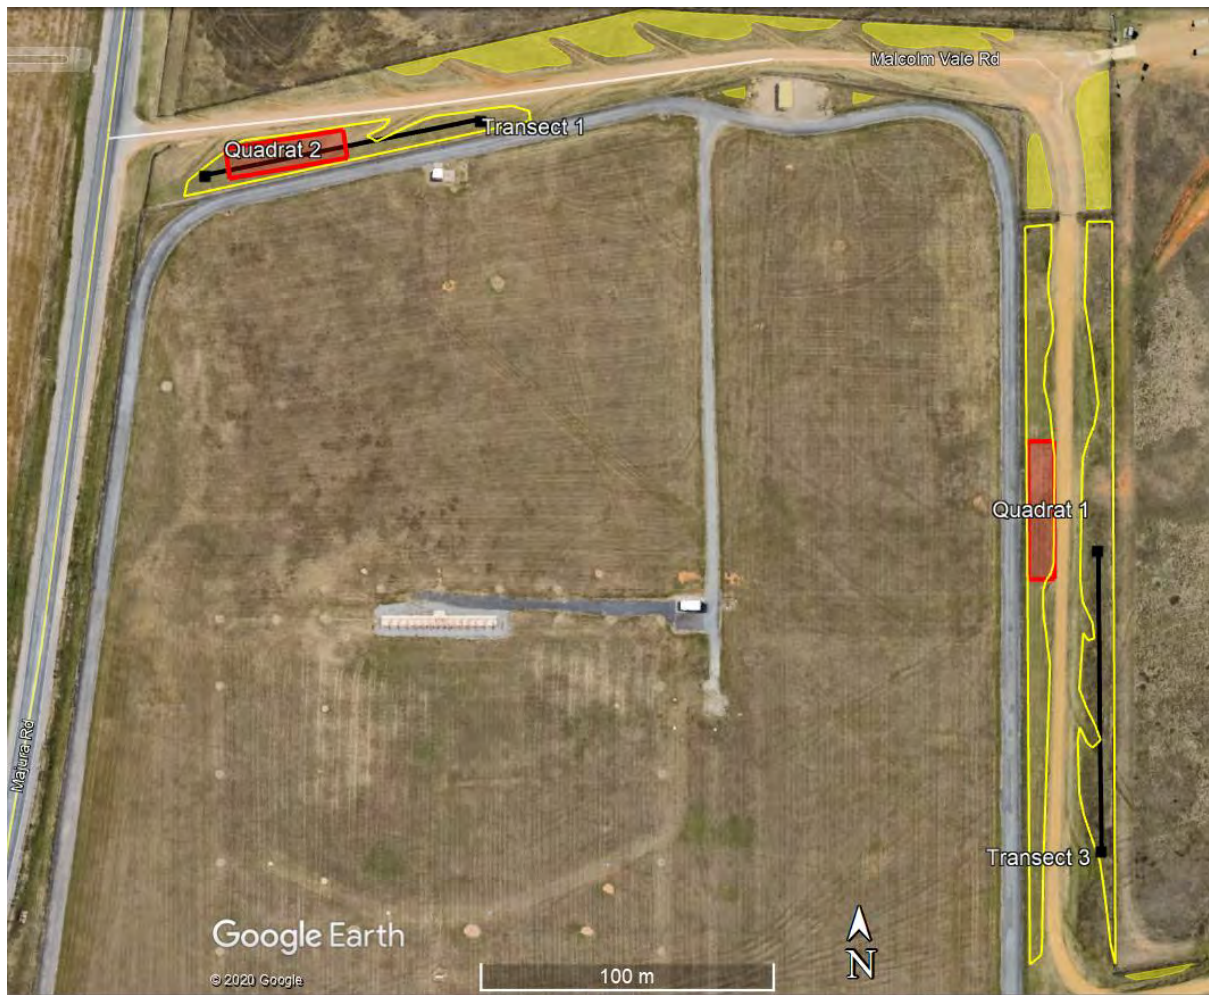
Figure 4. Vegetation communities and Transect and Quadrat locations, northern section.
Yellow = high to very high quality NTG

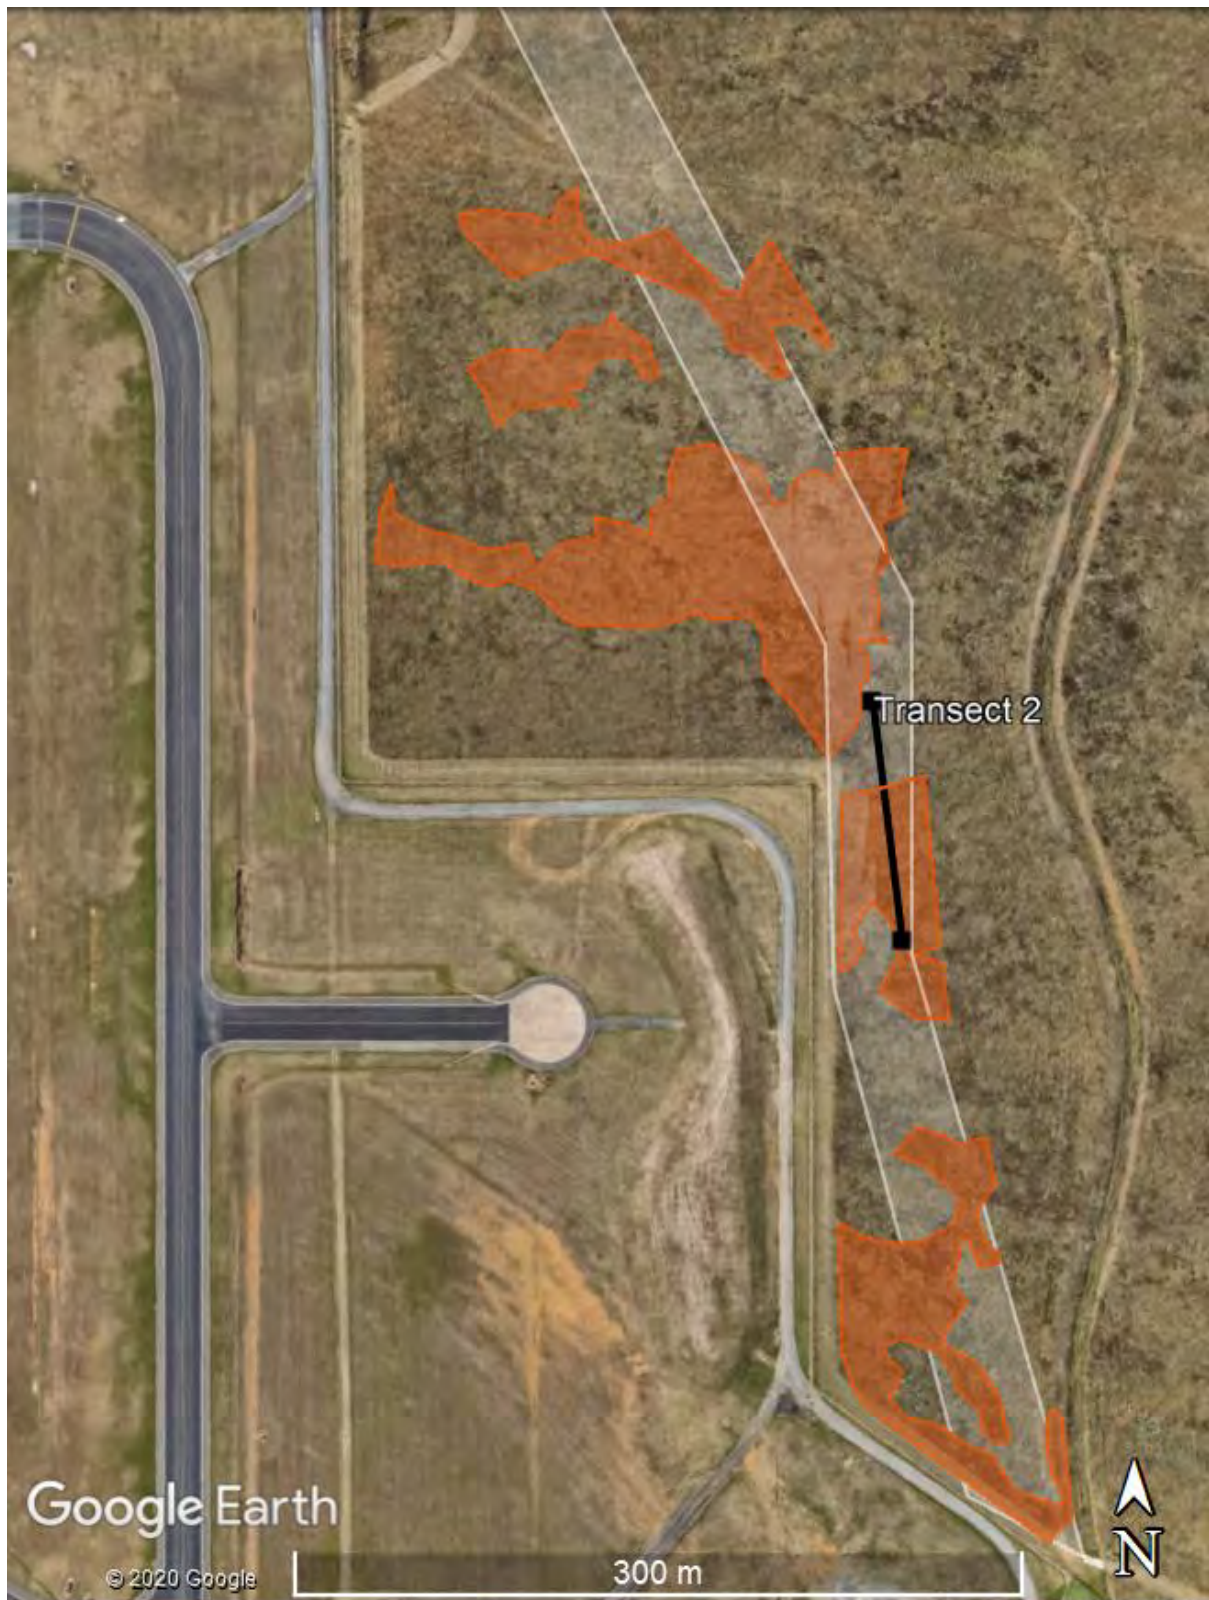
Figure 5. Vegetation and transect in southern section.
Orange = mixed native-exotic grassland with moderate cover of Tall Speargrass (not NTG)

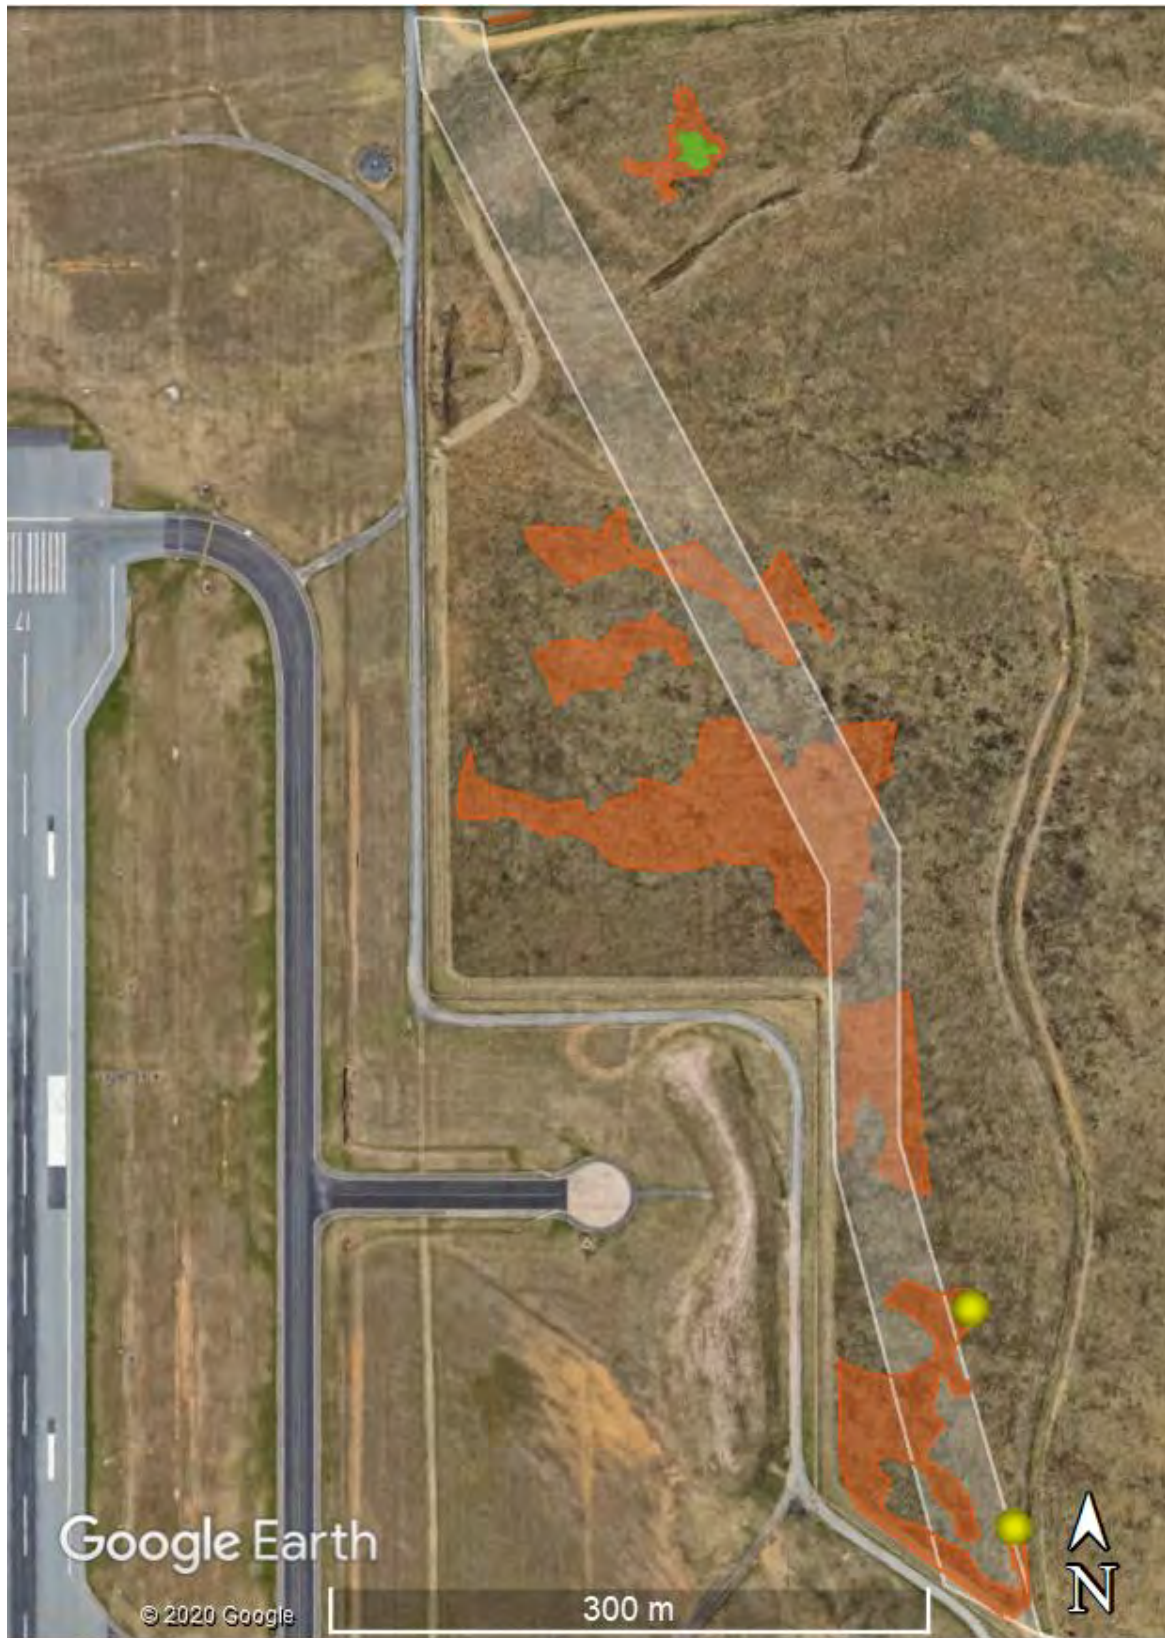
Figure 7. Golden Sun Moth habitat on southern part of route.

Yellow = GSM pupal case locations, 2019/2020

Table 4.1 recommends “12,500m² (enclosed land on southern part of route, low quality habitat created within 5-6 years of completion)” be managed within the Malcolmvale west land, outside the construction zone and adjoining NTG within the Airport to replace the 5,320 m² of very low quality and/or transit GED habitat. Please refer to Rowell’s Figure 7.

Much of the 5.7 ha of grassland enclosed between the eastern Airport boundary fence and the Northern Road route south of Malcolmvale Road (Figures 1 and 7) has potential for rehabilitation as GSM habitat as it contains mostly poor soils and parts have a moderate cover of Tall Speargrass and some bare ground in drought years (Photographs 11, 12 and 15). The 1.25 ha of this area shown as low quality GSM habitat in Figure 7 probably currently contains a sparse GSM population, based on habitat condition and the presence of GSM pupal cases in 2020, but is likely to become unsuitable for occupation by GSM in wetter years due to its high cover of tall exotic species (63% of vegetative cover on Transect 2 was exotic in 2020).

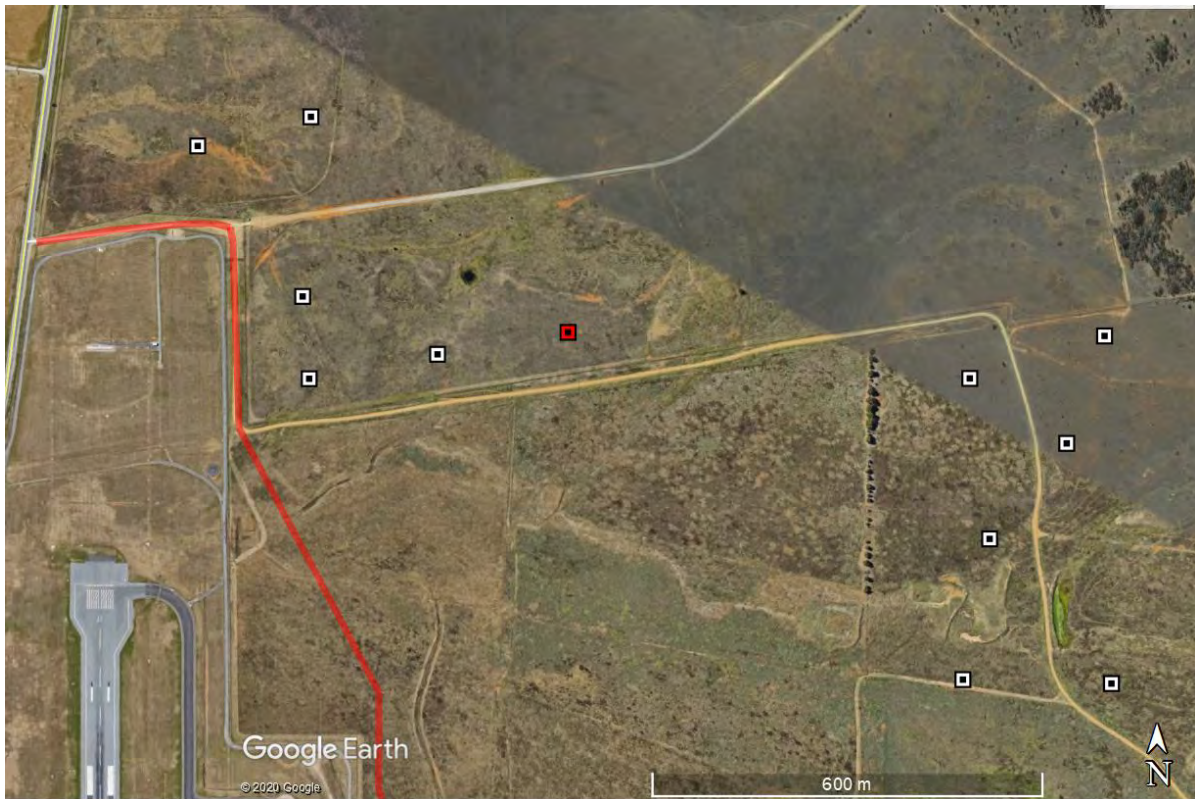
Figure 8. Location of existing tile/block grids checked.
 Red square = shed skin of SLL White squares = no SLL

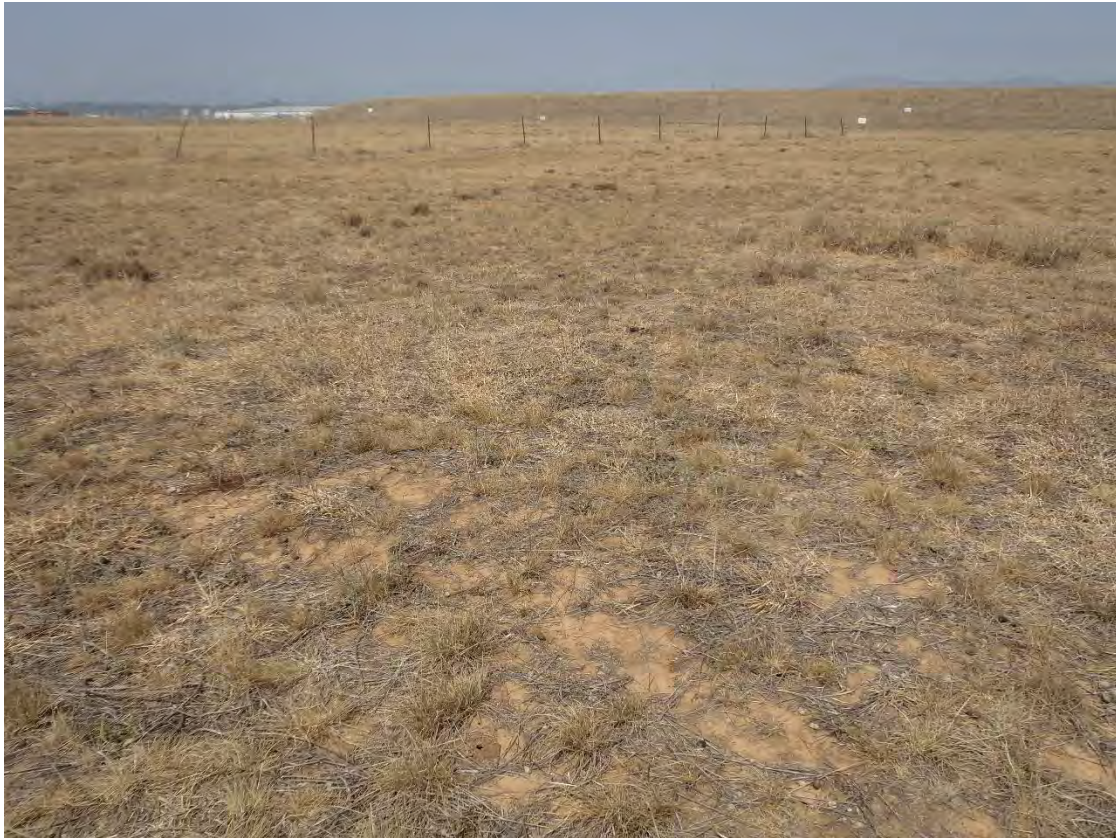
Photograph 15. Mixed native/exotic grassland in low biomass state near southern end of Northern Road route, December 2019.

There are historic records of GED to the east of the southern section of the Northern Road route, but the vegetation on the former Malcolmvale grazing lease has degraded since stock were removed in about 2007, becoming denser and weedier and less suitable for GED. It is considered unlikely that GED would currently be present on or near the southern part of the Northern Road easement. This is because the habitat structure is only suitable (patchy and with low biomass) in extended drought periods when GED numbers are typically low, and GED is then most likely to be restricted to core areas of much better habitat in NTG at MTA and Canberra Airport. After wetter years when GED population numbers increase, the species is also not likely to move through or occupy the mixed native-exotic grassland due to the high biomass of pasture grasses and tall weed species after rain. These contrasting habitat states are illustrated in Photographs 15 and 16.

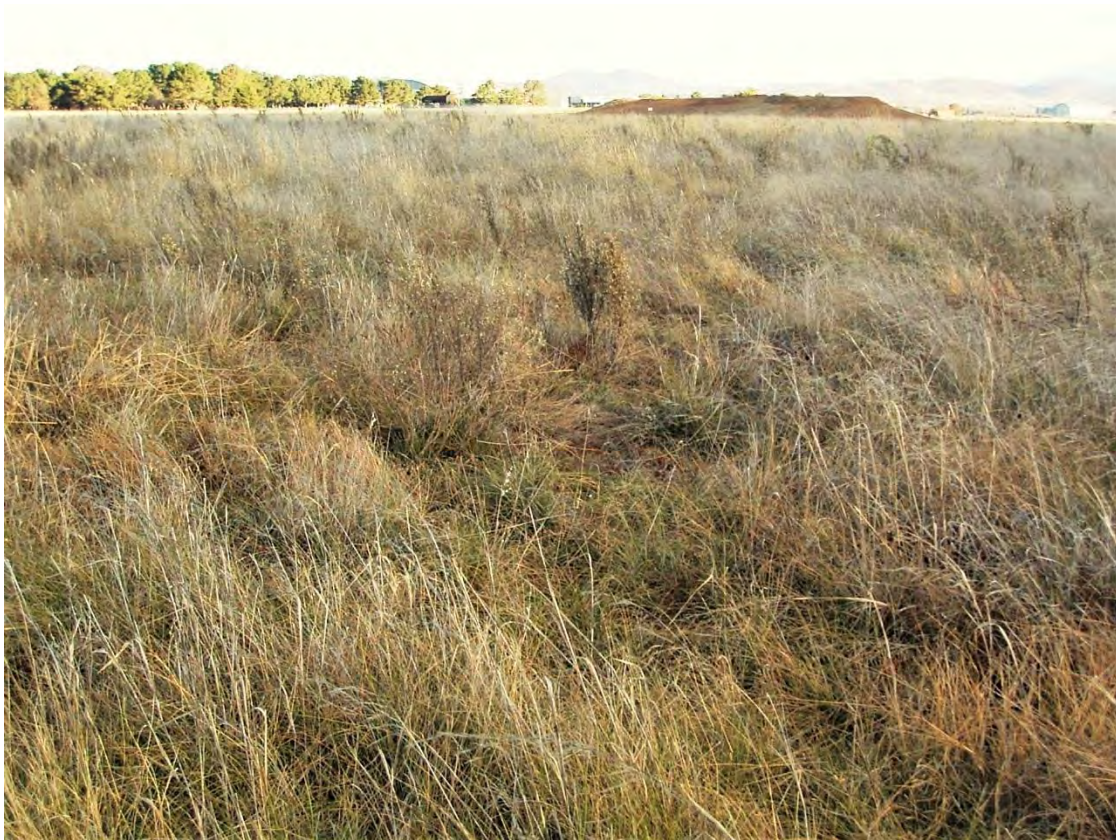
Photograph 16. Area of grassland near above site in high biomass state, May 2011.
