2022/2023 COMPLIANCE REPORT  
TAXIWAY BRAVO  
EXTENSION PROJECT

EPBC 2008/4170

## INFRASTRUCTURE UPGRADE AND CONSTRUCTION AT CANBERRA AIRPORT, ACT

## Canberra Airport: Resurvey of grassland remnants surrounding Taxiway B extension, 2023

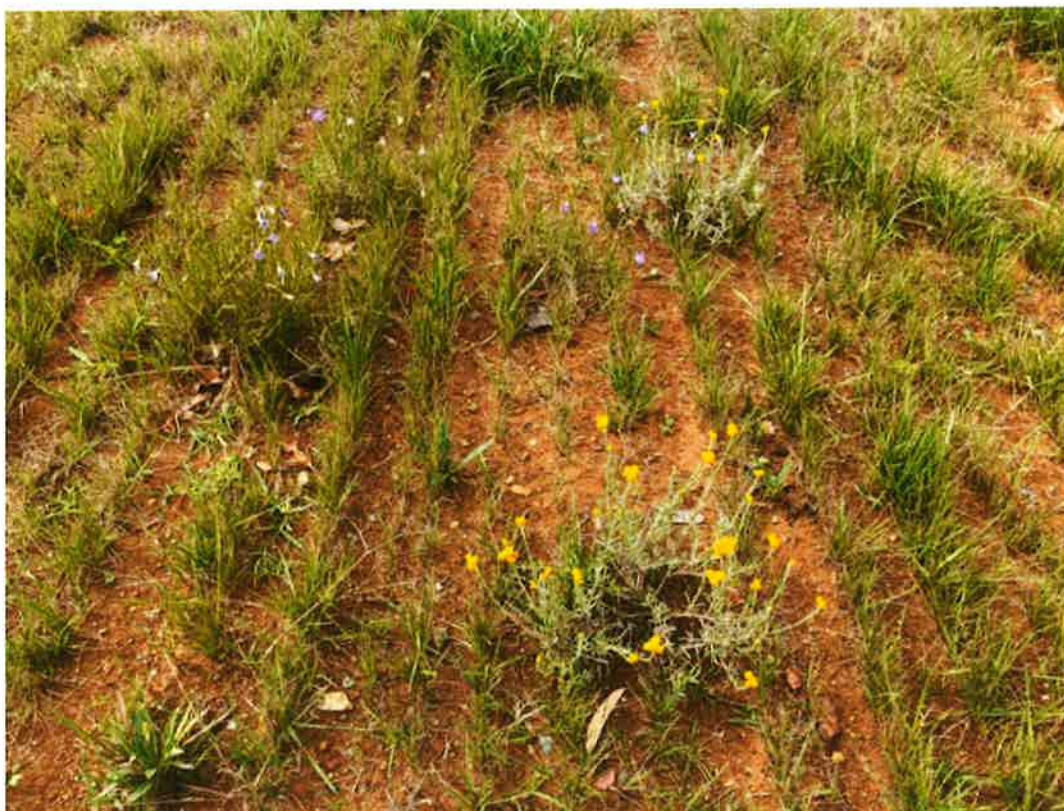
*This is similar to the effect we noted when the haul road around the Eastern Grass was left to recover, where the first species to appear on the bare and compacted soil were native forbs, probably resprouting from roots and germinating from seeds in the soil. In the Taxiway Bravo case, although the number of species and frequency of native forbs now present would allow*

*the vegetation to be classed as NTG if the surrounding grasses were native, this altered grassland would not now meet the NTG criteria. This is because the first step in determining NTG is 'The percentage cover of native vascular plants (including annual and perennial species) in the patch is greater than the percentage cover of perennial exotic species'. This is not the case here because of the higher cover of 'perennial exotic species' i.e. the sown grasses.*

***Image of Native Forbs and Exotic Grass – Taxiway Bravo SE Verge – 15 February 2021, A Rowell***

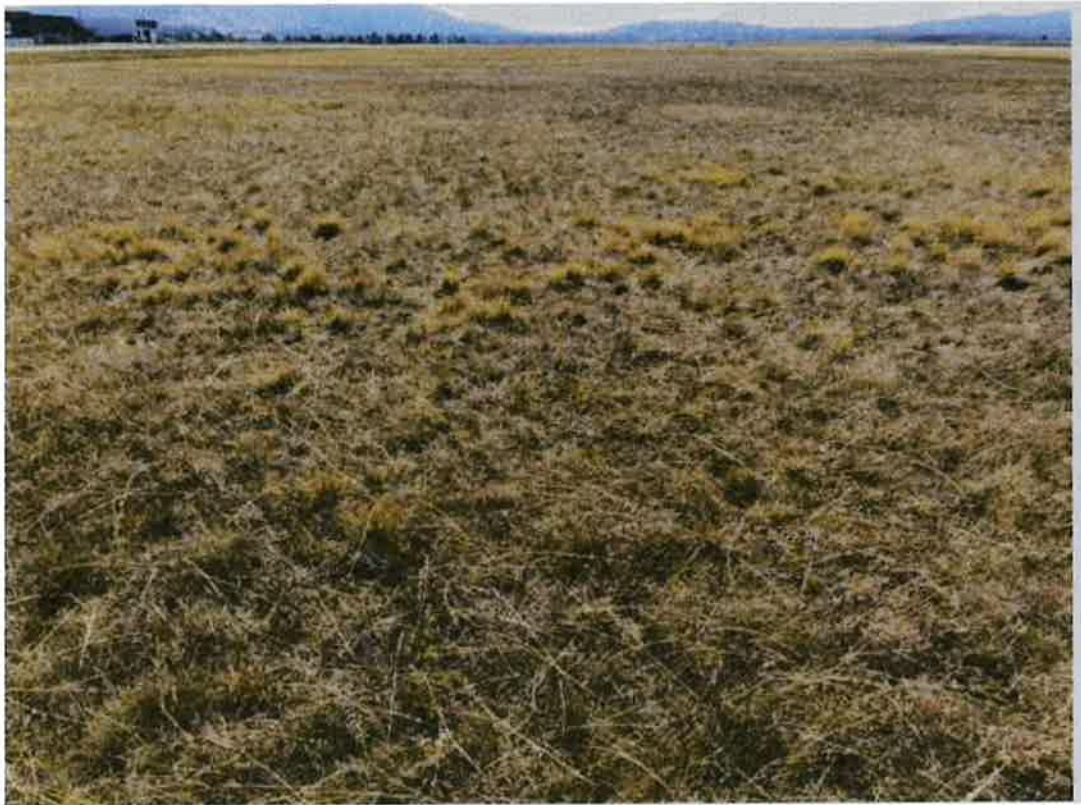
It was noted that there was some increase in scattered occurrences of Serrated Tussock *Nassella trichotoma* within and between the NTG patches (Photograph 3). Control by careful spot spraying is recommended where this species and other perennial grass weeds such as Chilean Needlegrass *Nassella neesiana*, Tall Fescue, African Lovegrass *Eragrostis curvula* and Paspalum *Paspalum dilatatum* occur within NTG patches. African Lovegrass is a more recent serious invader of grasslands in the ACT, and its spread appears to be favoured over Chilean Needlegrass in dry years.

Photograph 3. NTG patch East/D, looking north, scattered Serrated Tussock in mid-ground. July 2023.

Gradually spraying back the above weeds where they occur adjacent to NTG patches east of the taxiway and replanting the killed strip with native species appropriate to the soil conditions of the patch has the potential to increase the area occupied by NTG and to create north-south links between NTG patches.

Where the intervening exotic species are growing in deeper or wetter soil, Kangaroo Grass *Themeda triandra* would be suitable. Where the soil is shallower and compacted, Redleg Grass *Bothriochloa macra* and Wallaby Grasses *Rytidosperma* would be more appropriate. The results would need to be monitored, and after native grasses have been established and weeds controlled, native forbs could be introduced as seed supplemented with some tube stock.

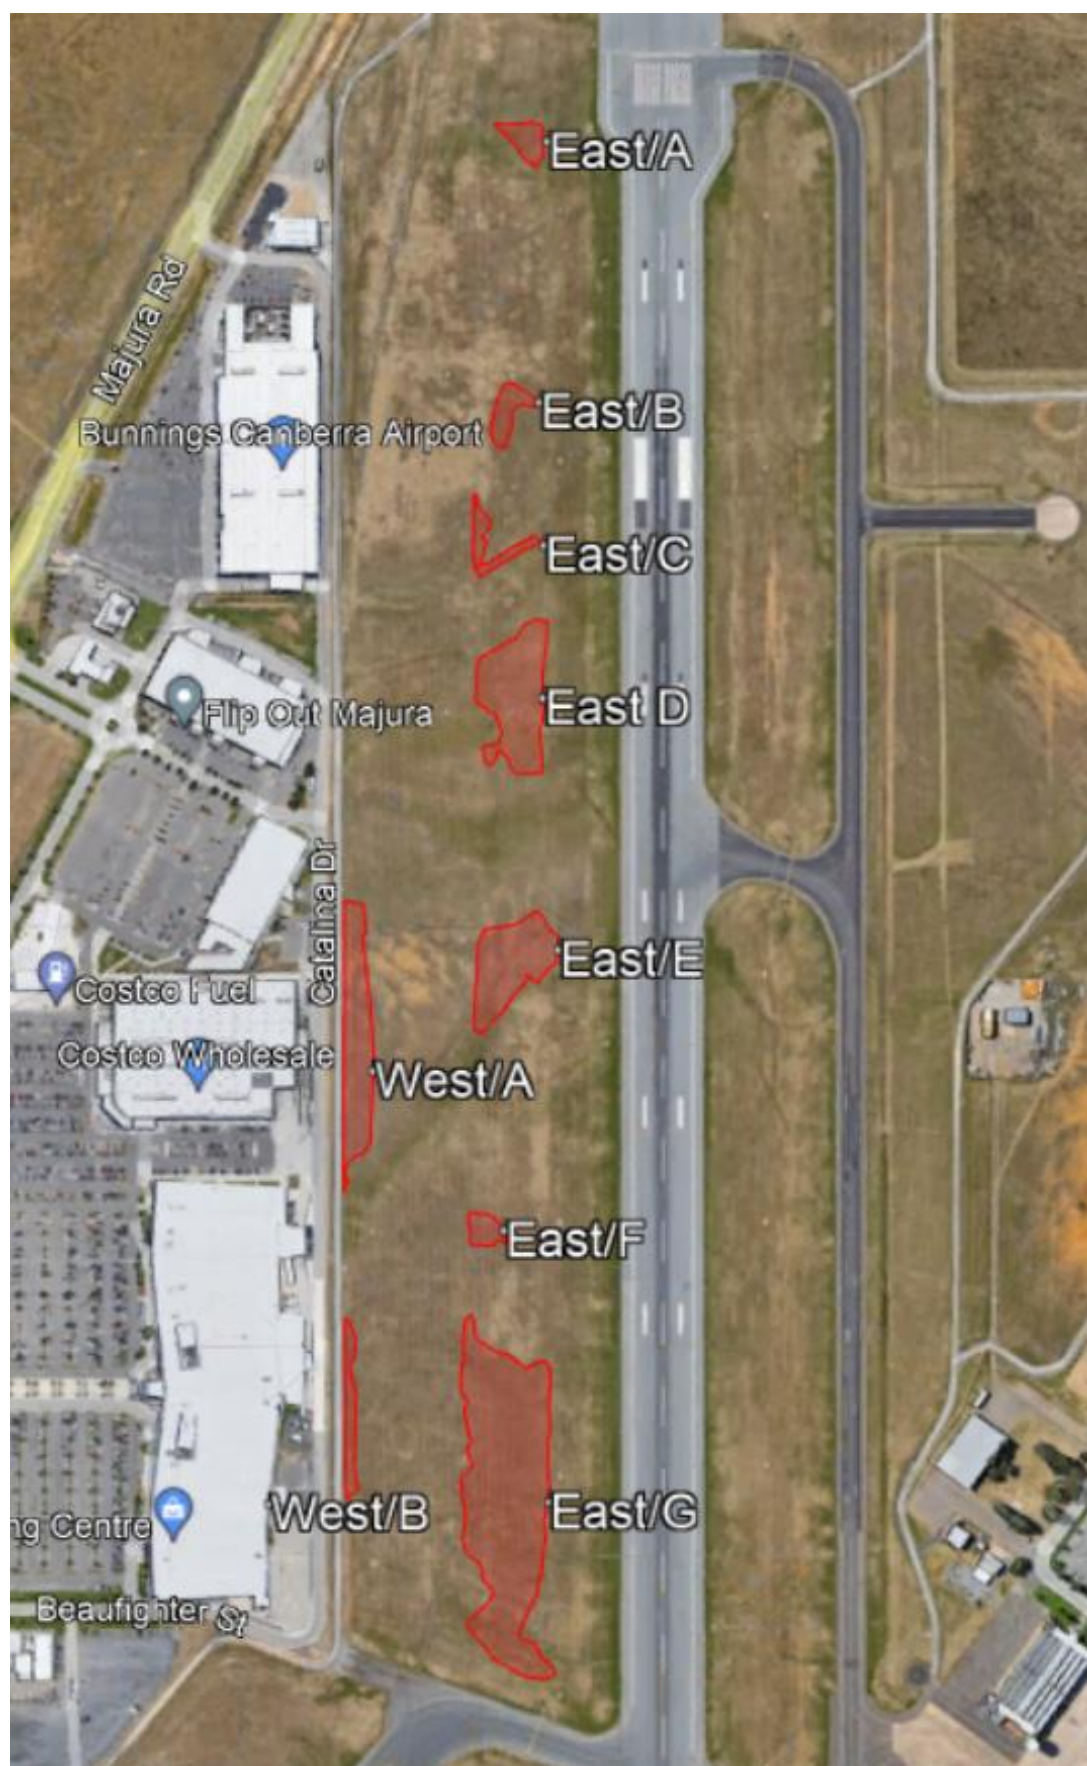
Figure 1. Patches of Natural Temperate Grassland surrounding Taxiway B.

*Resurvey of grassland remnants surrounding new Taxiway B, 2023. A Rowell 2023.*

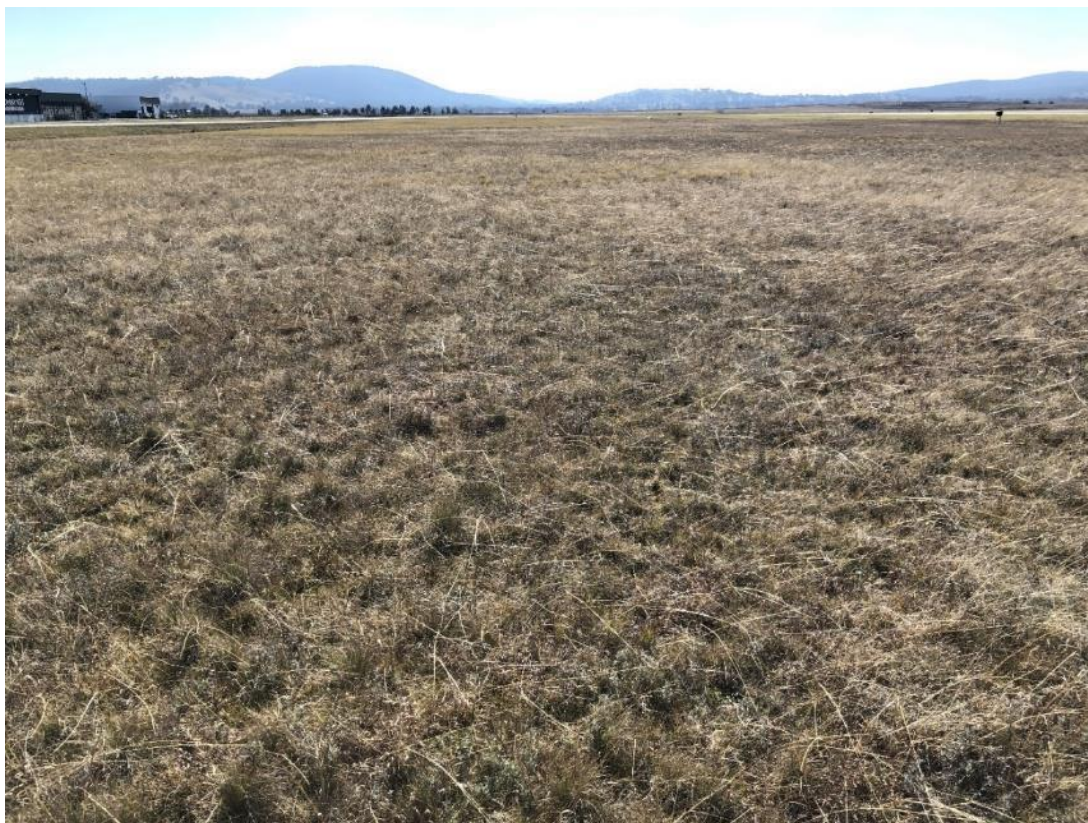
The main native species observed are shown in Table 1. These included eleven non-grass species and four Indicator species that were also recorded in 2022 (Photographs 1 and 2).

Photograph 1. NTG patch East/D looking north, with native grasses and forbs. July 2023.

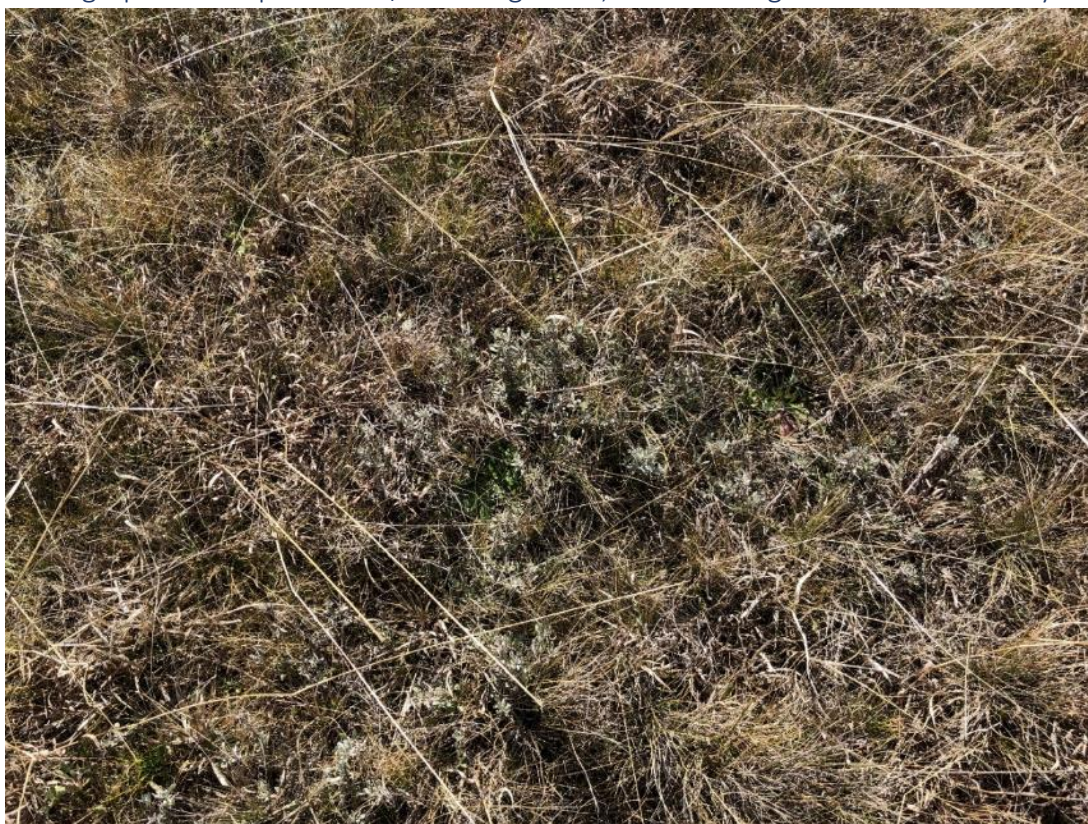
Photograph 2. NTG patch East/D detail, various native grasses and forbs. July 2023.

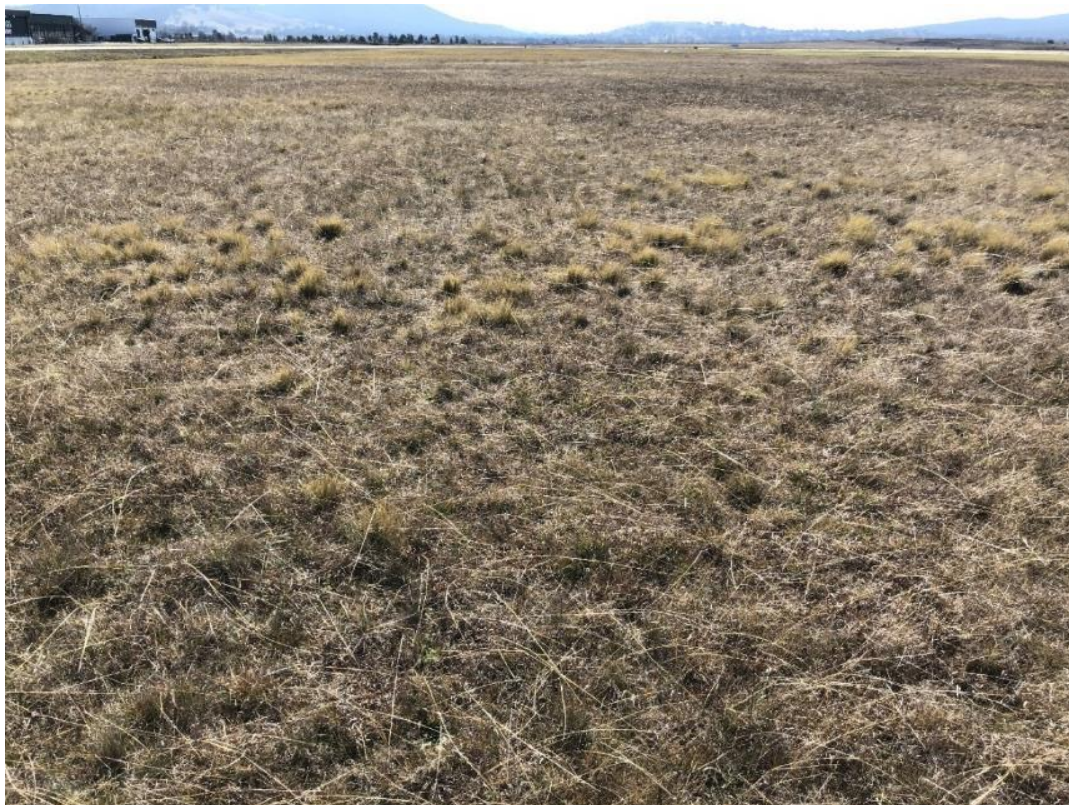
It was noted that there was some increase in scattered occurrences of Serrated Tussock *Nassella trichotoma* within and between the NTG patches (Photograph 3). Control by careful spot spraying is recommended where this species and other perennial grass weeds such as Chilean Needlegrass *Nassella neesiana*, Tall Fescue, African Lovegrass *Eragrostis curvula* and Paspalum *Paspalum dilatatum* occur within NTG patches. African Lovegrass is a more recent serious invader of grasslands in the ACT, and its spread appears to be favoured over Chilean Needlegrass in dry years.

Photograph 3. NTG patch East/D, looking north, scattered Serrated Tussock in mid-ground. July 2023.

Gradually spraying back the above weeds where they occur adjacent to NTG patches east of the taxiway and replanting the killed strip with native species appropriate to the soil conditions of the patch has the potential to increase the area occupied by NTG and to create north-south links between NTG patches.

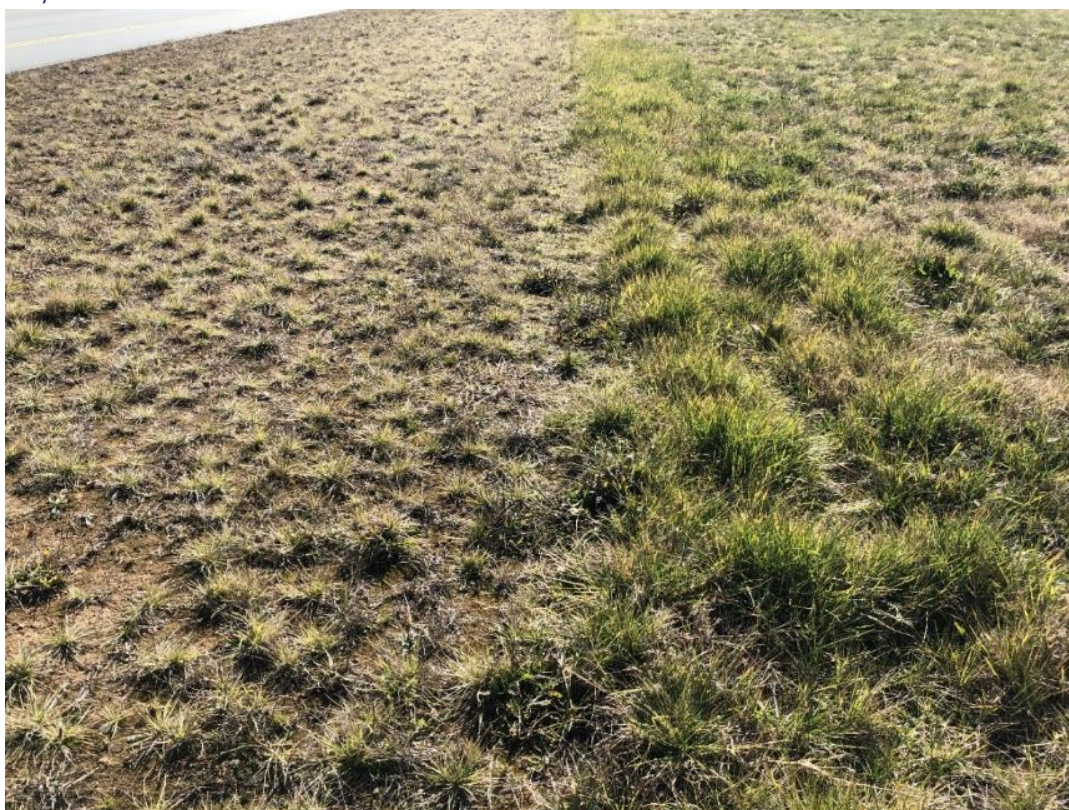
It was noted in 2022 that the Fescue had established but the verge was being invaded in parts by Chilean Needlegrass *Nassella neesiana*. This grassland weed is common on the Airport and commonly replaces planted species in Canberra as it can survive and seed under low mowing. These grasses were still present on the verges in 2023, but there were few plants of Couch or Clover and native species were rare (i.e. they had not re-established from the reused soil).

Photograph 4. Tall Fescue on eastern taxiway verge, tussocks sparse where mown short. July 2023.

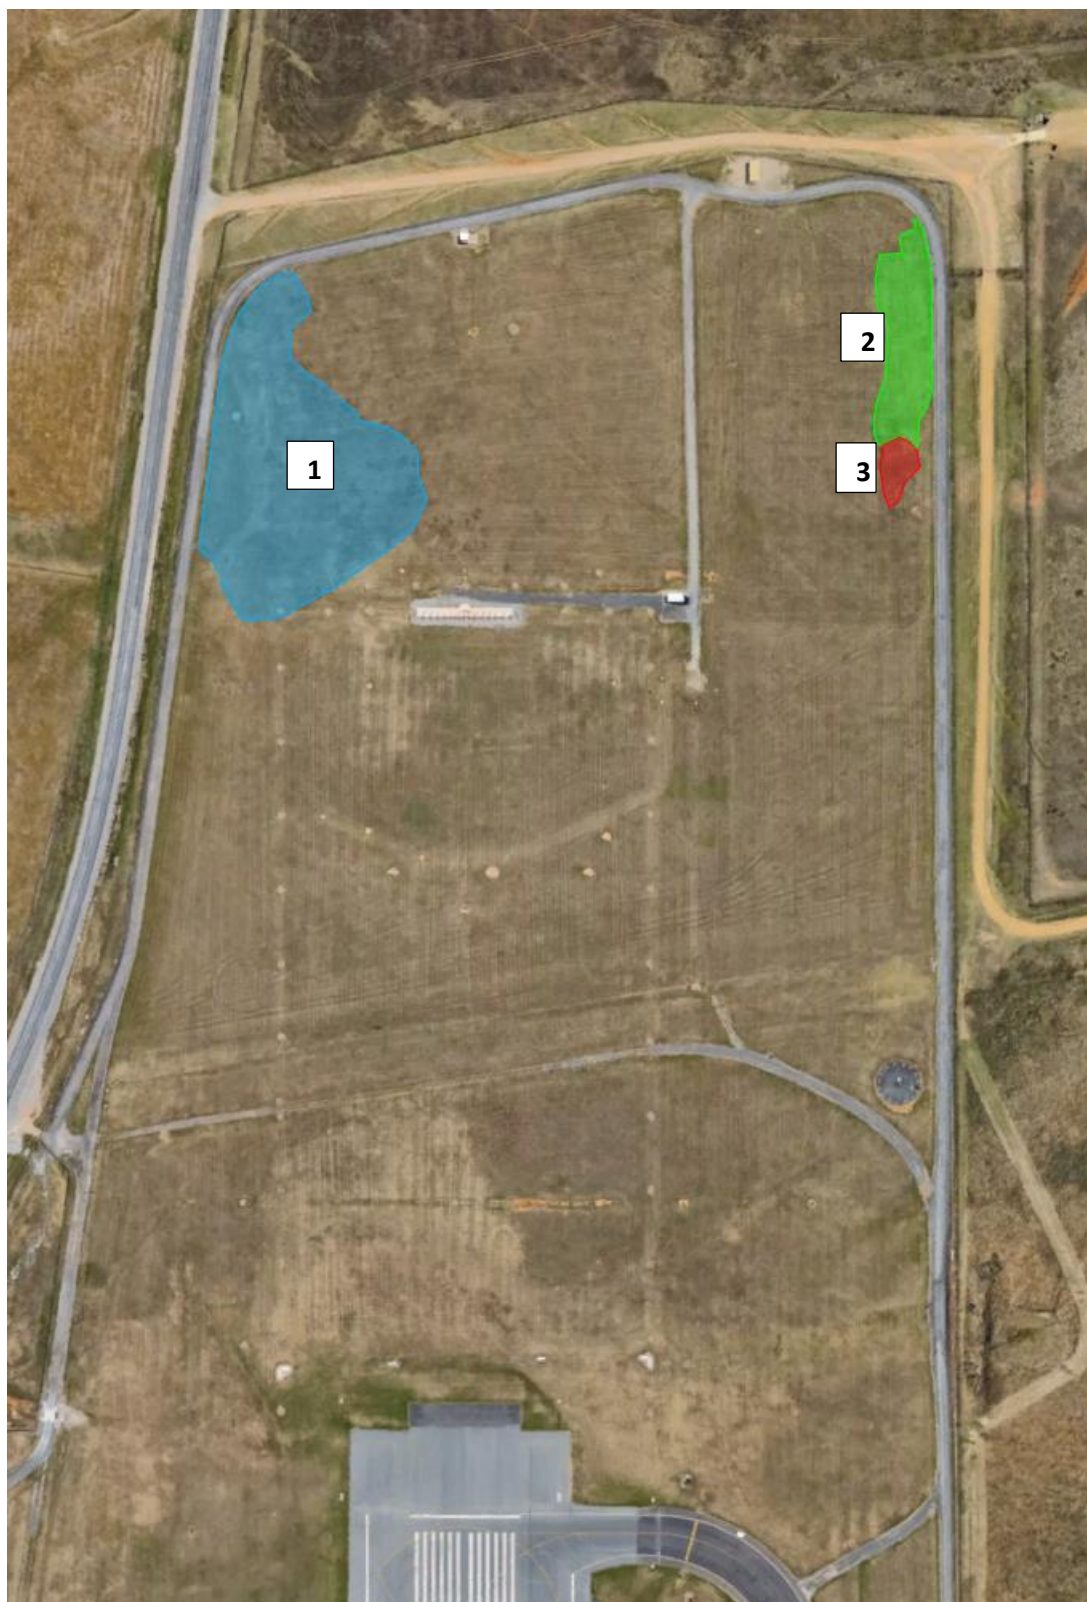
The areas mapped are shown in Figures 2 and 4 and include patches of grassland which are exotic-dominated due to historic site damage or more recent weed invasion, and others which contain a moderate level of native grasses but do not meet the criteria for NTG.

Figure 2. Areas within northern NTG which are currently exotic-dominated.

Site 1 - Paspalum

Site 2 - mixed exotics

Site 3 - African Lovegrass.

Site	Area (m <sup>2</sup> )	Current condition/management	Rehabilitation trials
1	7500	Low-lying area dominated by weeds after three wet years – mainly <i>Paspalum</i> and Chilean Needlegrass (Photograph 5).	Potential for replacement with Kangaroo Grass using commercial seed. Trial plots could be established near the boundary with NTG.
2	1500	Exotic-dominated area, possibly damaged during runway construction (ca 1960). Adjacent to large area of NTG and CGED habitat (Photograph 6).	Potential for full replacement with native grasses and forbs. Trials could include scrape/remove topsoil or use of herbicide, then resowing with commercial native seed and seed from Airport.
3	280	Small dense patch of African Lovegrass invading NTG and CGED habitat	Spray out centre of patch, spot spray plants beyond edge. Resow densely with commercial native seed and seed from Airport, follow up with spot spraying/hand-weeding until African Lovegrass is eliminated.

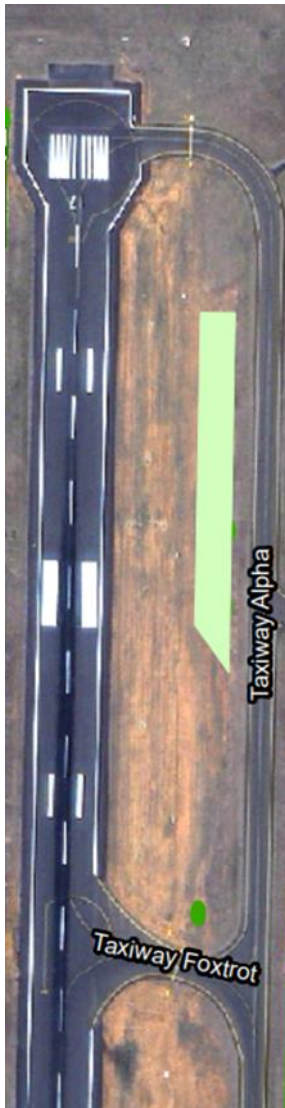
Figure 3. Strip used in soil translocation trial, 2005-2010.

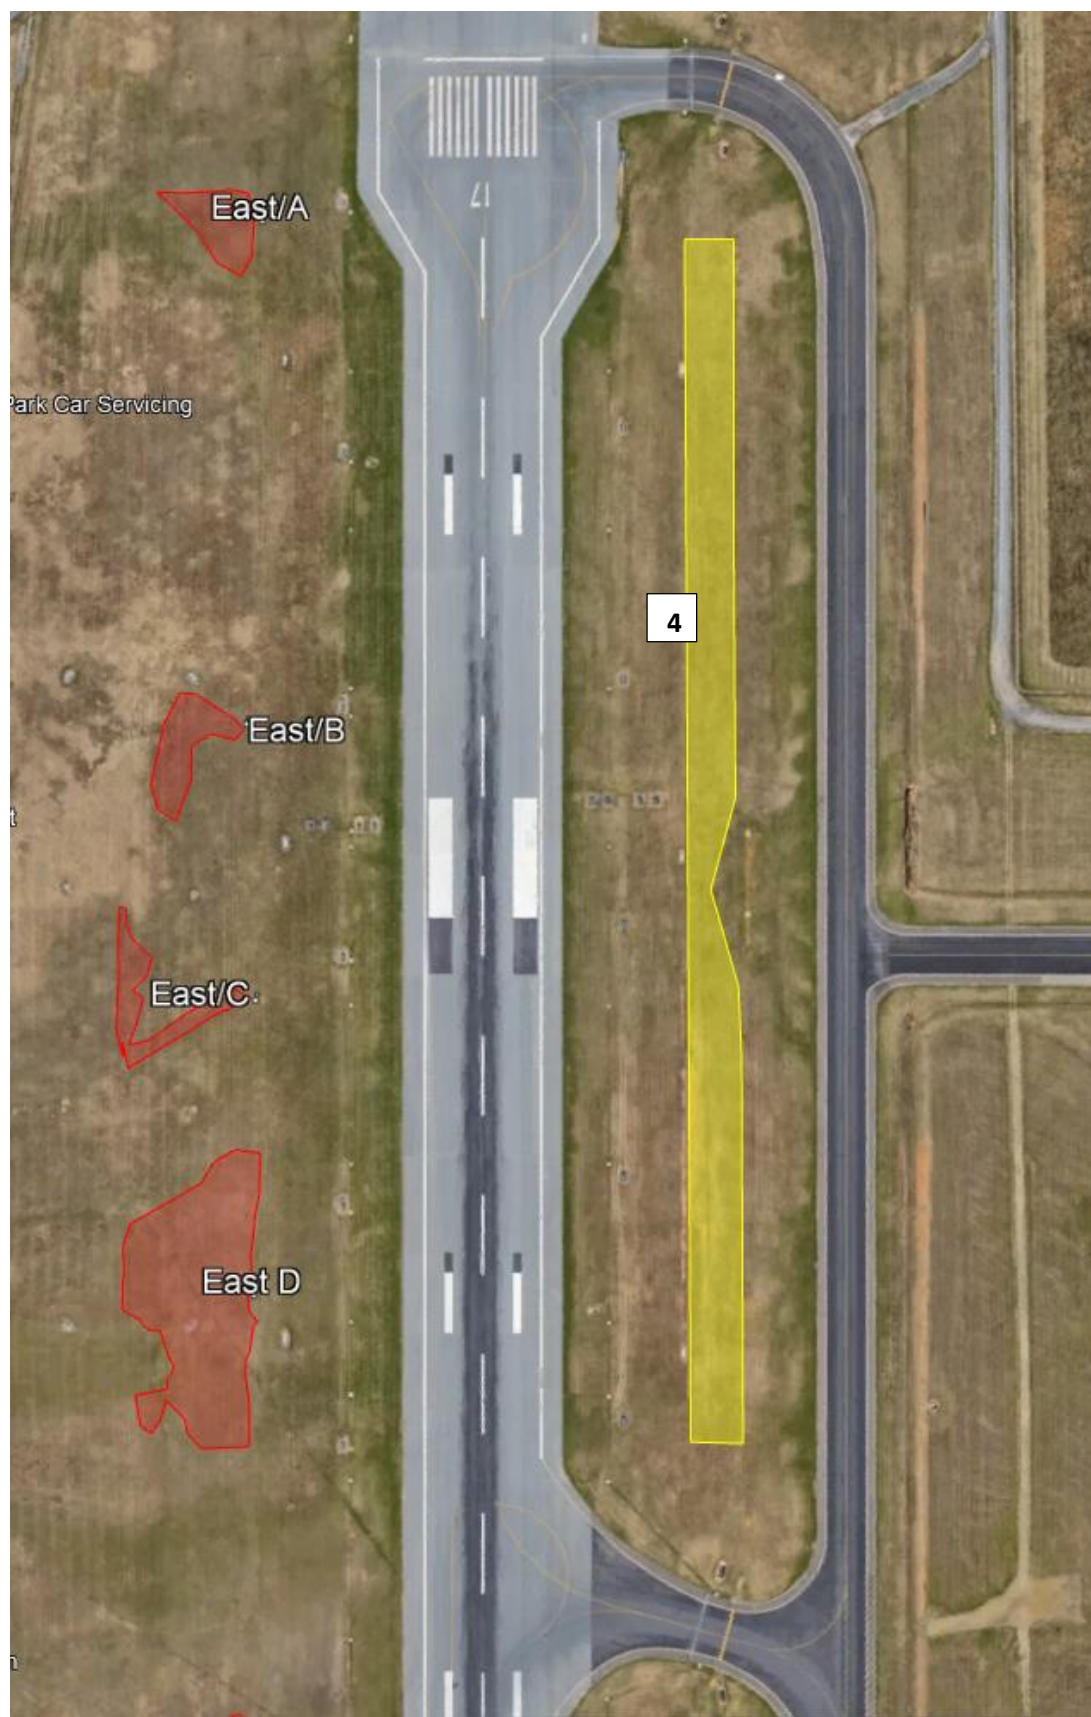
Figure 4. Strip containing mainly exotic species with some native grasses. Northern part of Site 4 was used in previous soil translocation trial.

4	8000	Strip bounded by runway and Taxiways A and F, part used in a native grassland translocation experiment in 2005-2010. Native grasses (especially Redleg Grass <i>Bothriochloa macra</i> ) among exotic species, some bare ground (Photograph 7).	Western edge contains compacted bare ground which is eroding into centre drain, eastern part has denser vegetation. Potential for trials with methods according to condition of patch. Where native grasses and bare ground are more common, spot-spray weeds then sow native seed.

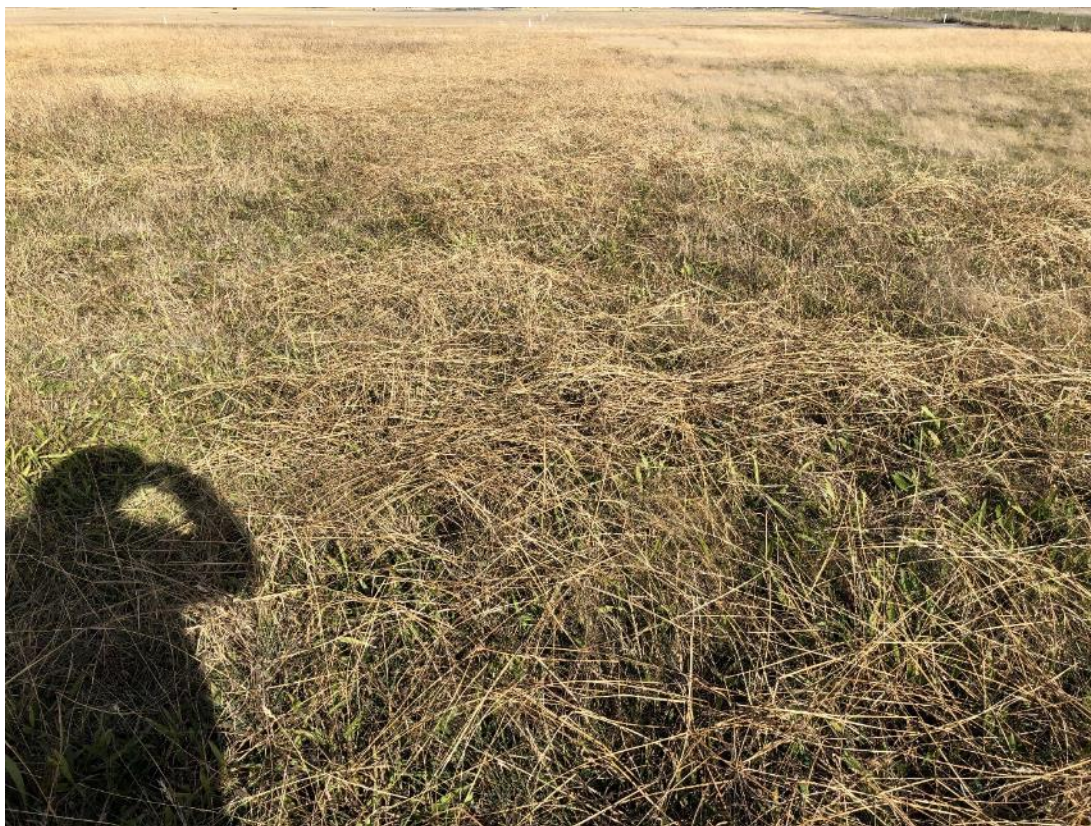
Photograph 5. Site 1, Paspalum patch that has developed after wet years.

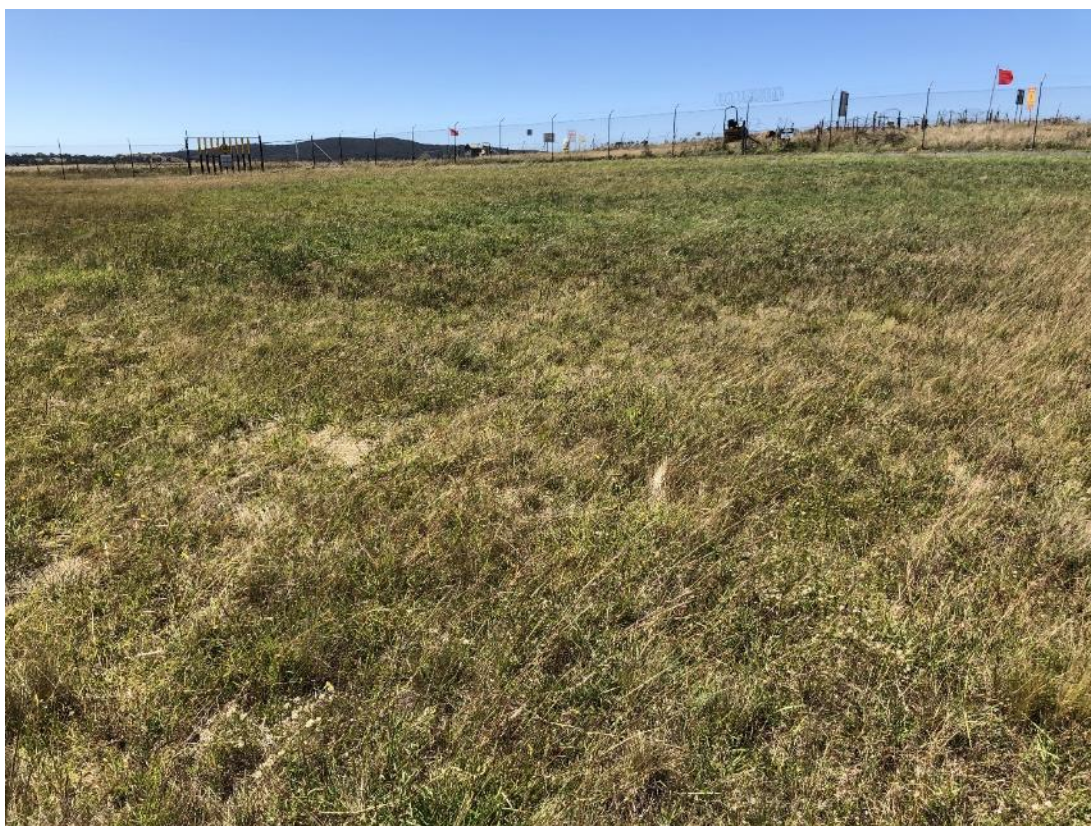
Photograph 6. Site 2 (greener patch in background). Mixed exotics on previously disturbed area.

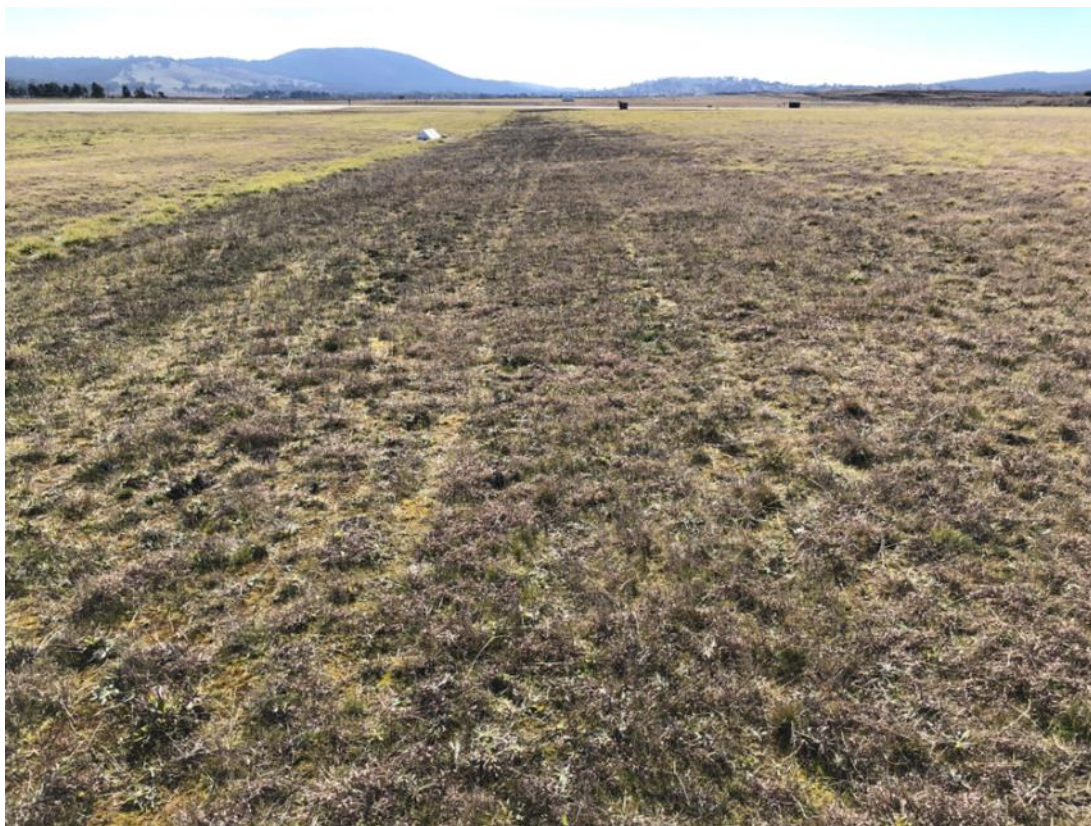
Photograph 7. Site 4, near north end, looking north. Mixed native/exotic, bare ground.

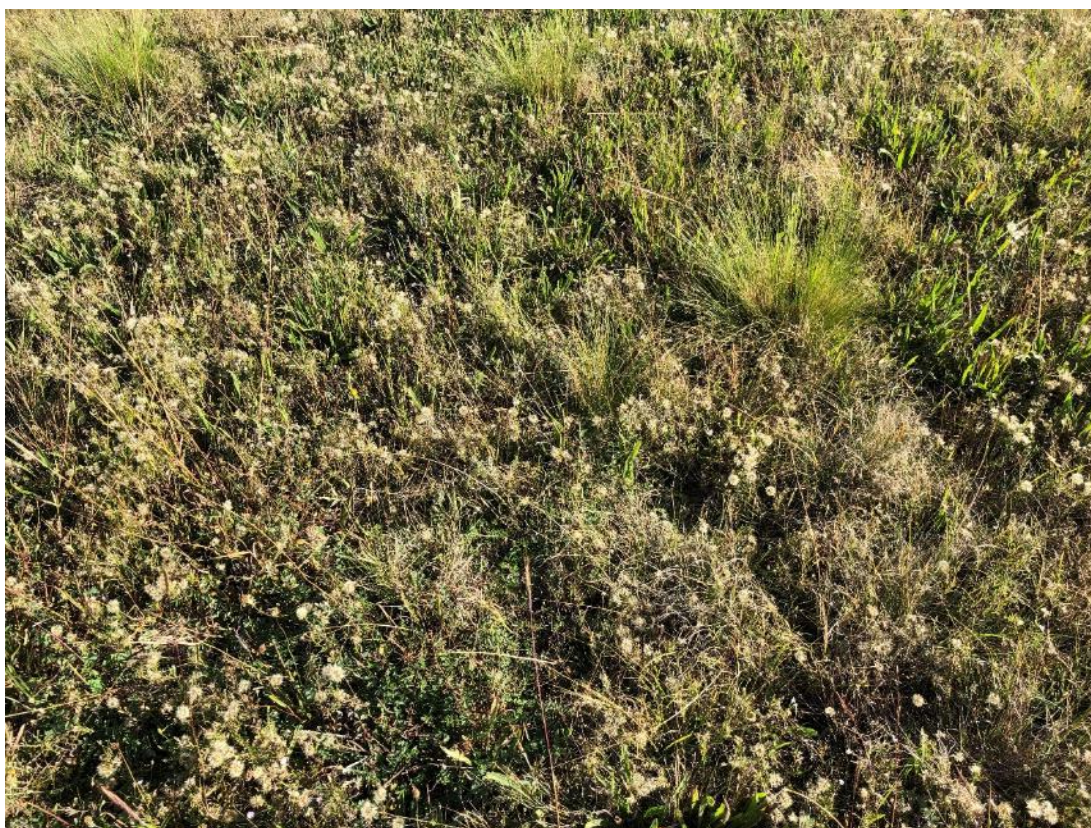
In the native-dominated grasslands north of the runway, areas where patches of Serrated Tussock had been sprayed with herbicide in the past were found to have revegetated with a mixture of exotic and some native species, and some Serrated Tussock (Photograph 8). The native species included grasses but also the New Holland Daisy *Vittadinia muelleri*, a small species that can quickly form dense patches on bare ground and persists under mowing.

Photograph 8. Mixed native and exotic plants after Serrated Tussock control.
