# Magnetic Resonance Imaging of Breast Implants

Mala Shah, MD,\* Neil Tanna, MD, MBA,† and Laurie Margolies, MD\*

(*Top Magn Reson Imaging* 2014;23: 345–353)

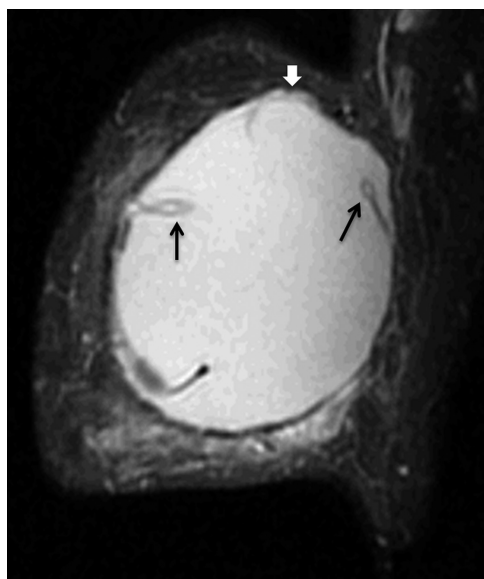
**FIGURE 6.** Sagittal T2-weighted water-suppressed sequence. Noose signs in a single-lumen silicone breast implant (arrows). Silicone signal is seen both within and outside the radial folds, distinguishing this from normal radial folds. Note the bulge in contour at the cephalad margin of the implant (solid arrow). This can be a sign of extracapsular rupture; however, here, the surrounding capsule is intact.

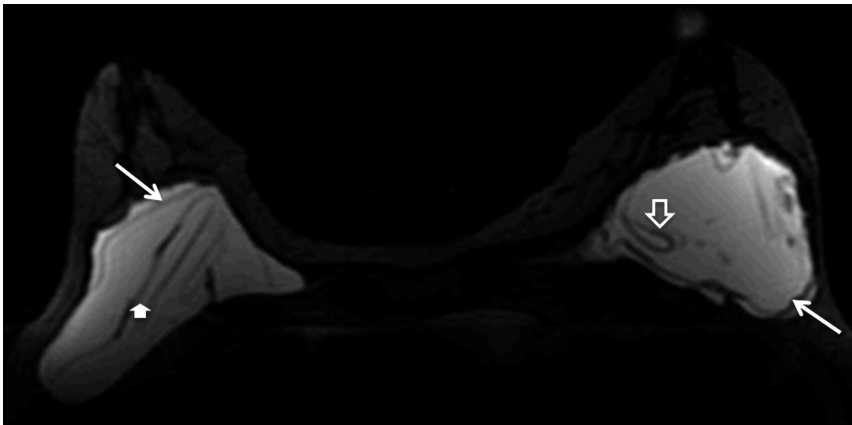
**FIGURE 9.** Axial silicone-sensitive sequence of a silicone breast implant. Summary of the signs of intracapsular rupture. Seen here are *noose/keyhole* (open arrow), *subcapsular line* (arrows), and *linguine* (solid arrow) signs.

On MRI, this creates the *subcapsular line* sign, which is a dark wavy line following the implant contour (Figs. 7 and 9). The implant envelope has ruptured, but the fibrous capsule that was formed by the body's reaction to the implant remains intact. The fibrous capsule keeps the silicone from touching the breast or other tissue. The implant's envelope collapses into the space maintained intact by the fibrous capsule. Silicone is able to leak between the envelope and the capsule creating the subcapsular line.

Progression to gross collapse is seen as the *linguine* sign (the MRI correlate of the *stepladder* sign on ultrasound). This appearance, marked by multiple low-signal curvilinear lines, represents the multiple layers of collapsed elastomer shell floating within the silicone gel (Figs. 8 and 9).<sup>19,33</sup>
