ATV Middle Passenger – RED ALERT

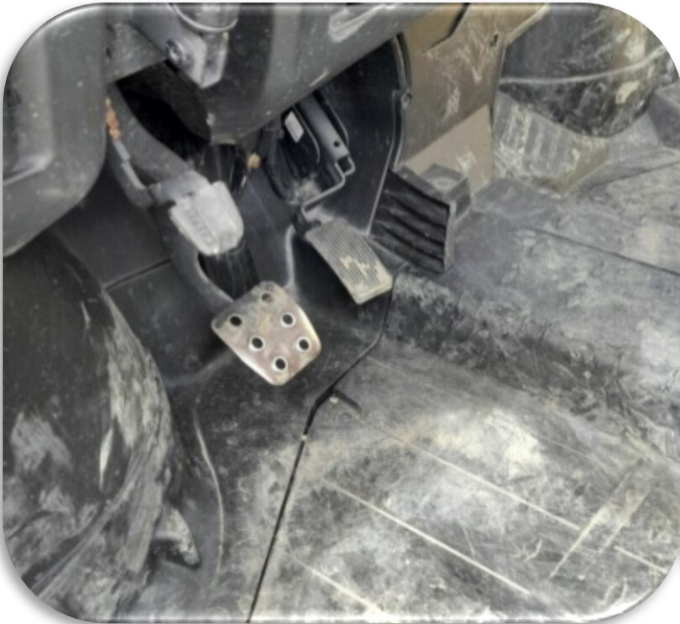
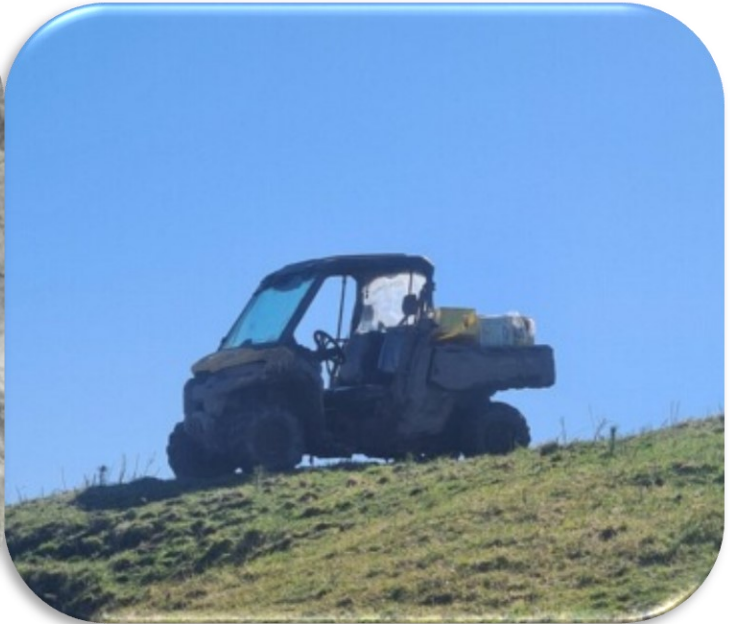
A can-am side by side was slowly descending a steep track, the driver had taken his foot off the accelerator and was braking when the buggy gained speed, failed to take a corner at the foot of the slope, cleared a small creek and hit the far side bank. Apart from a few bumps and bruises no one was seriously hurt although there was the potential for this to be a very serious incident.

- Left hand drive ATV's.
- Unknowingly, the middle passenger's left foot had slipped across to the left and managed to apply pressure on the accelerator causing the vehicle to speed up and the operator to lose control.

- **ATV operators need to be aware that when carrying a third passenger there is the potential for the middle passenger's foot to interfere with pedals. *They need to make sure the middle passenger is also aware of this possibility.***
- When carrying unsecured loads in the front, there is also the potential for the load to move across and cause an issue with either the accelerator or brake pedals.

- Avoid carrying a middle passenger if possible. Secure loads carried in the front so they cannot interfere with the pedals, e.g. smoko bags, rifles etc.
- Addition of a more robust guard to the right of the accelerator pedal.
- Warning stickers to be placed inside ATV to alert users of hazard.
