Safety Alert

Stem entering processor cab

30th May 2019

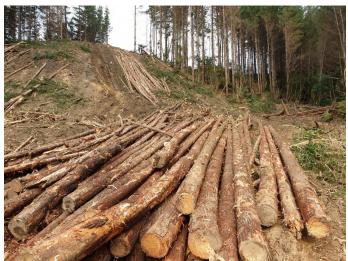
- A hauler crew was shovelling wood away from the hauler, downhill towards a landing where the processor was positioned.
- They were running two stockpiles, one where the processor was and another stockpile on the hill, midway between the hauler and the processor.
- To mitigate the risk of a runaway stem, they rigged up the winch-assisted felling machine to shovel the wood away from the hauler and down the hill, instead of "throwing" the wood down the hill towards the processor.
- The two stockpiles were situated at different angles to combat the possibility of a runaway stem heading towards the processor.

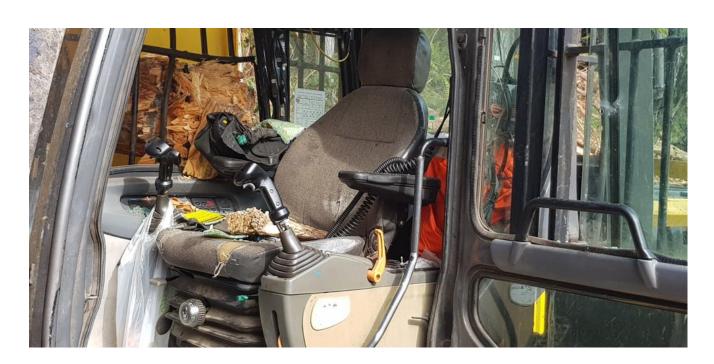
- The processor operator was cutting up wood, when a stem dislodged itself from the first stockpile, the stem hit some of the heads in the stockpile that the processor was working on, this managed to turn the stem and it went in the direction of the processor.

- The stem went in-between the lift rams, past the boom and had enough force to destroy the operator protective structure and partially entered the cab. It struck the operator on the right arm, thankfully the velocity was reduced, and the operator only suffered bruising.

- The stem hit with such force that it bent both lifting rams.

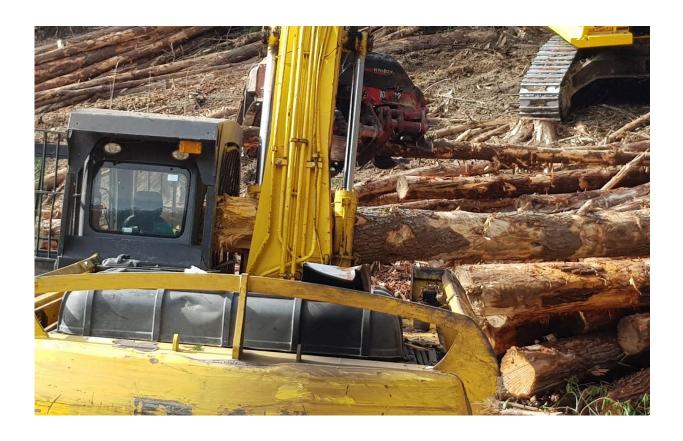
- The operator protective structure performed as it should have and saved the operator from significant harm.
- Although this machine has current and valid OPS, FOPS and ROPS protection, the escape hatch is unprotected and was exposed to the hazard every time the processor turned away from the stockpile to place wood in his cut-pile.

- Retrofit a guard on the escape hatch that can be opened from inside the cab and from outside the cab. All machines performing a task where there is a potential for a log the enter the escape hatch, should have adequate protection fitted.
- Avoid working under stockpiles.
- Always move machines to safe areas to perform maintenance.
- Don't presume that stems are stable, and they won't move.
- Install higher lift ram guards:
