ENGINEERING SAFETY SOLUTIONS

Reducing the risk of falling from a Madill 124 swing yarder

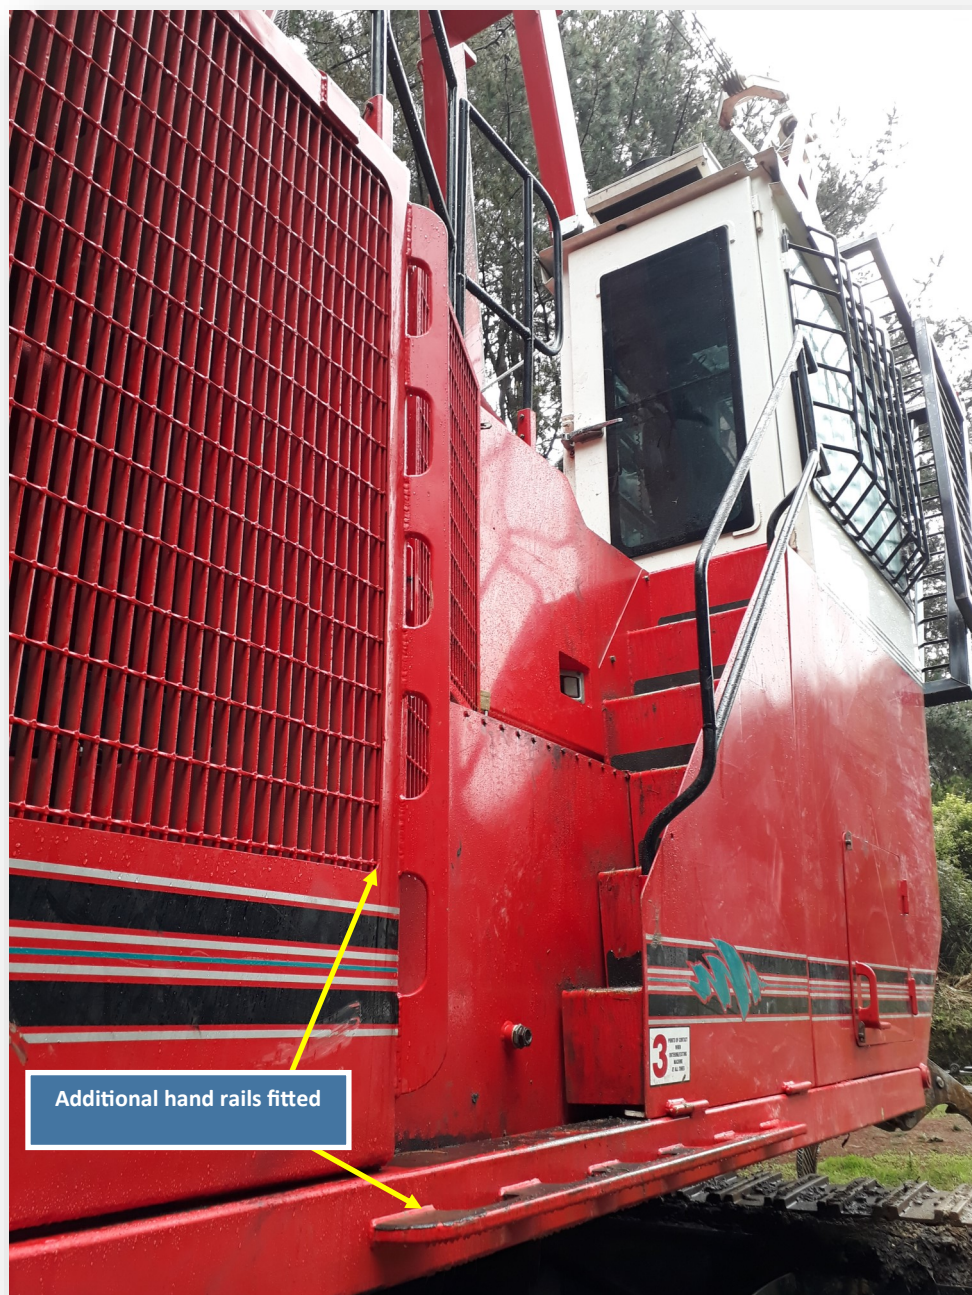
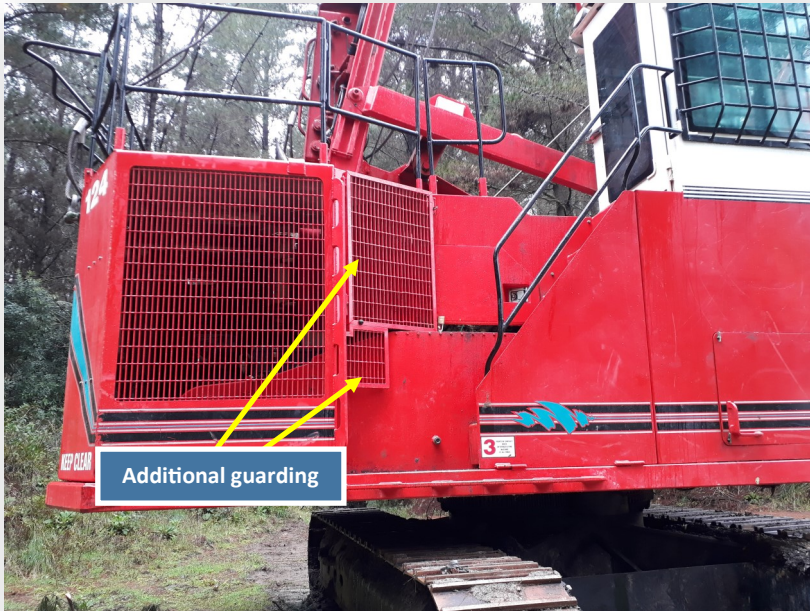
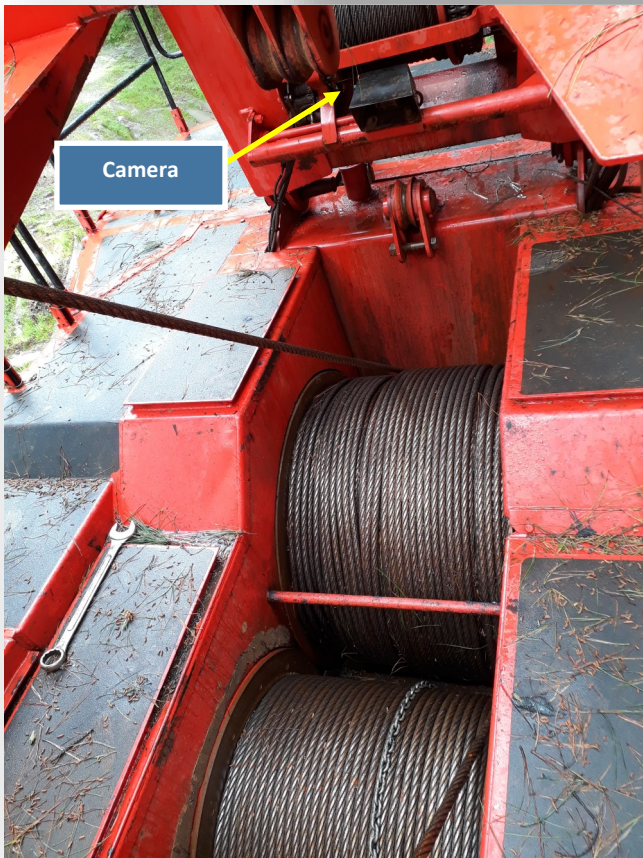
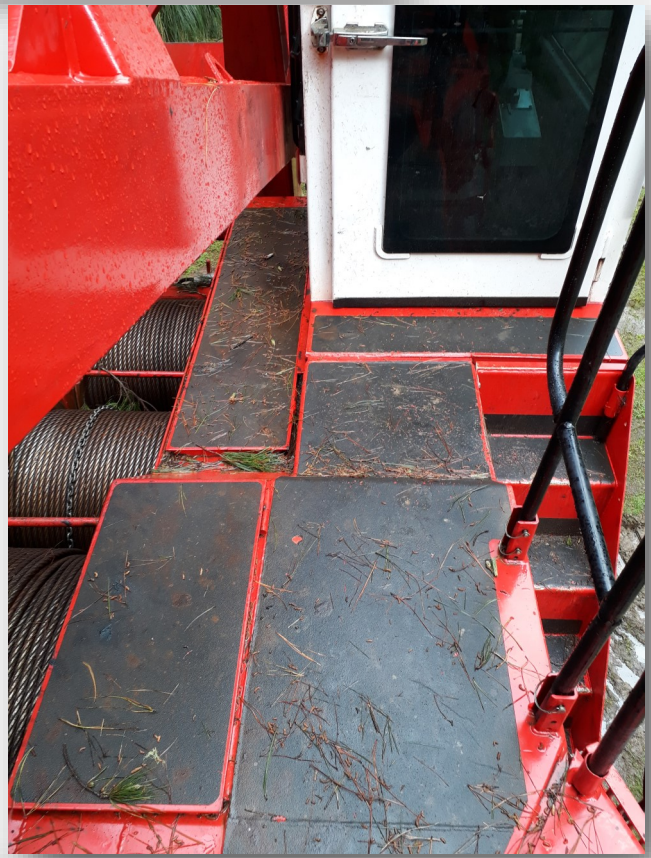
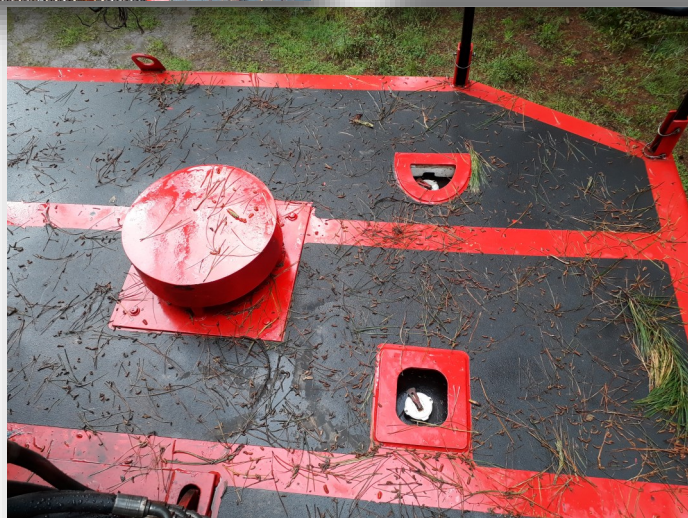
Access / Egress Modifications

The modifications made to improve access and egress, includes:

- New handrails fabricated and fitted at the base of the hauler, this allows a person to maintain 3 points of contact when accessing the hauler from the ground.
- All areas of foot traffic had anti-slip adhesive applied to reduce the risk of slipping in wet and muddy conditions, or oil spills.
- Secure railings fitted, all around the machine .
- They installed a camera that allows the operator to monitor the drums from inside the cab.

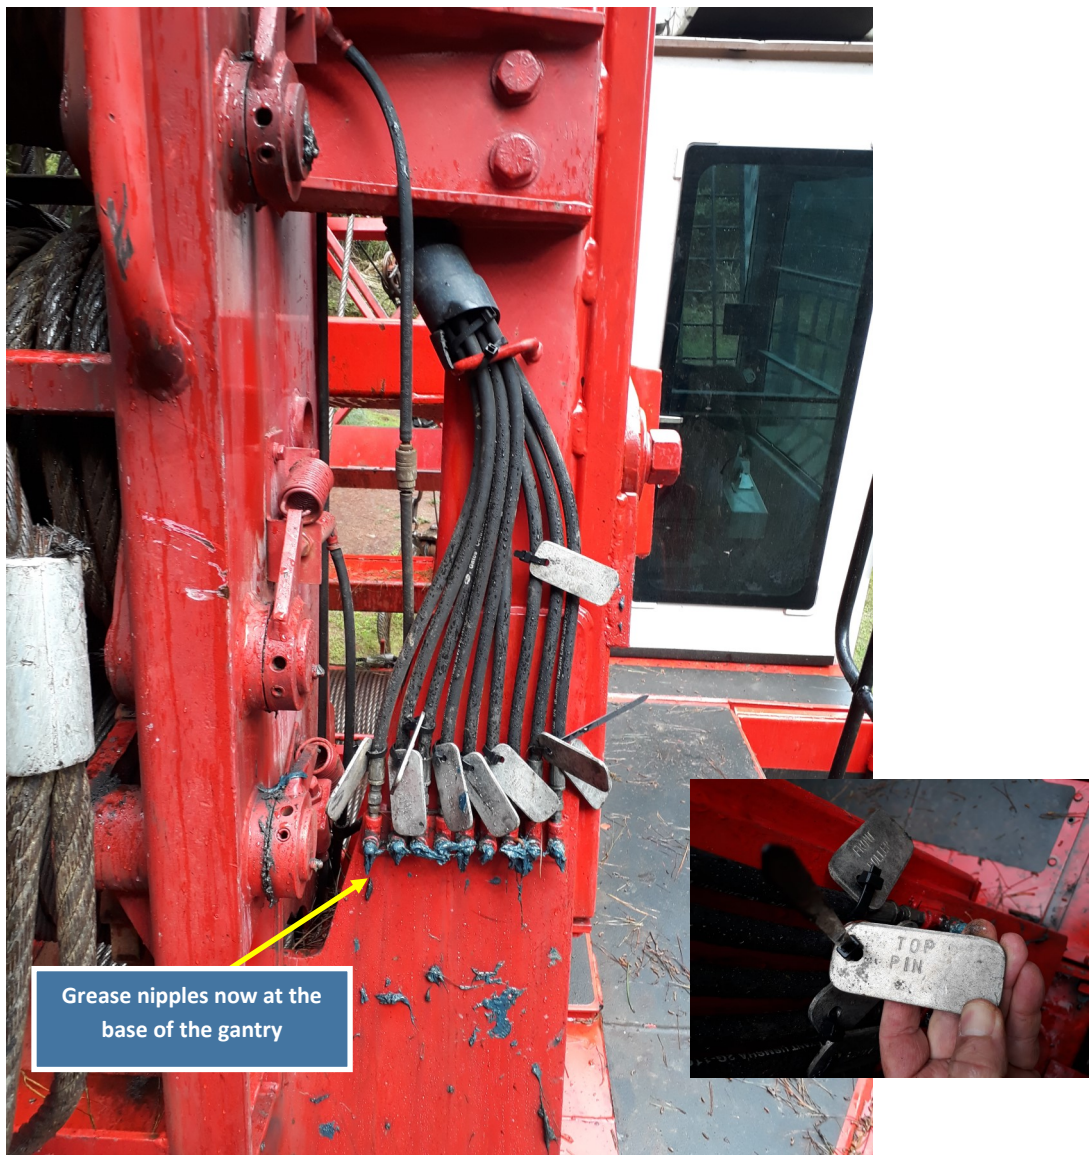
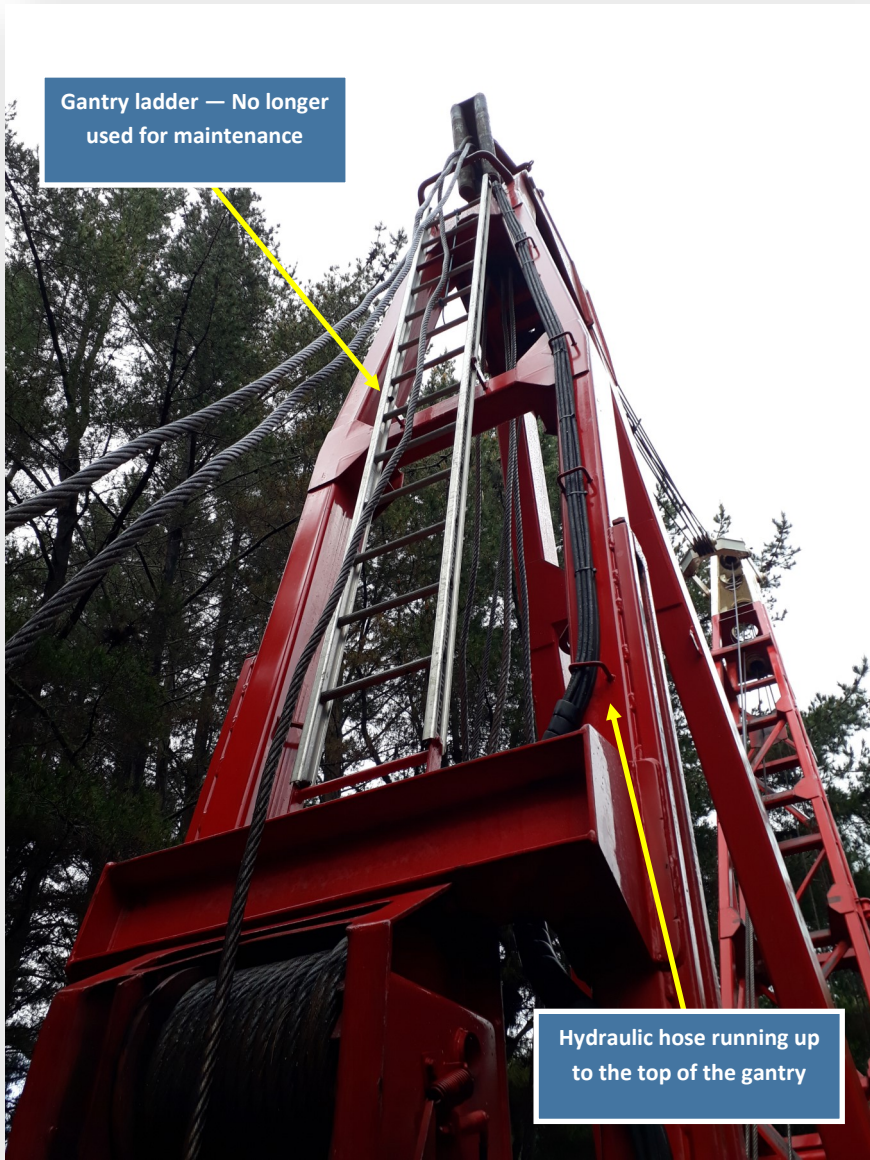
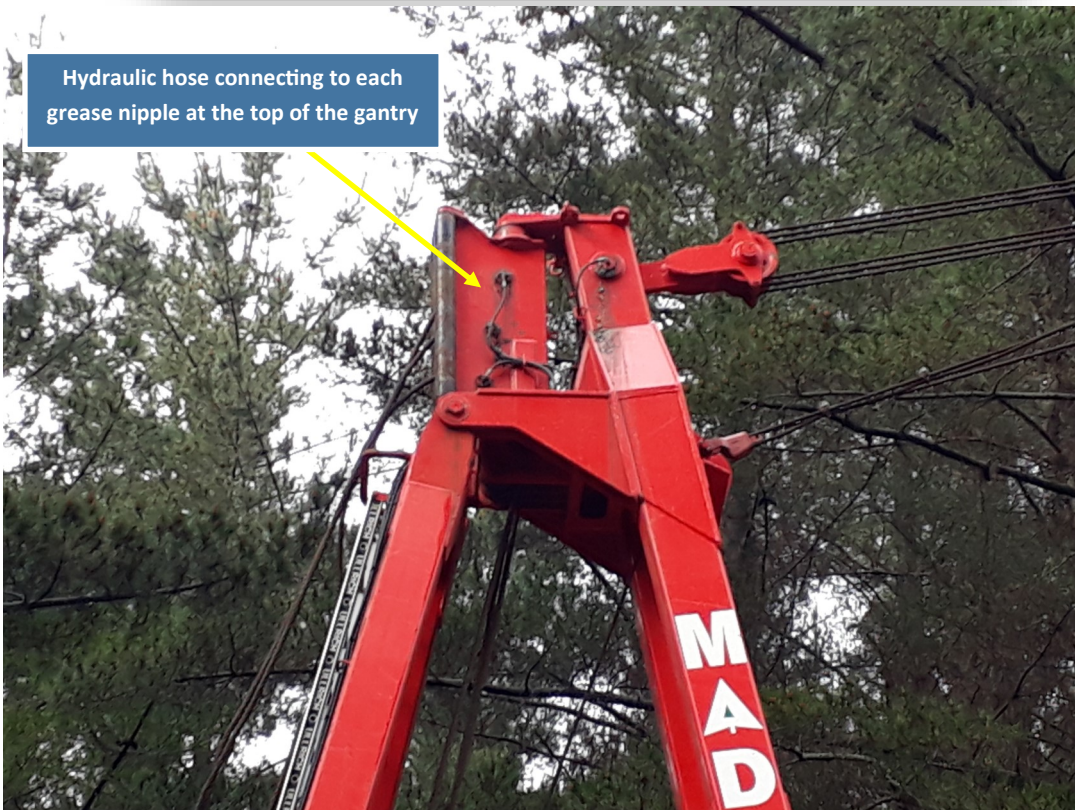
Eliminating the use of the gantry ladder

In the past, common practice was to use the gantry ladder to get to the top fairlead to grease the components. Danny and Steve modified this, to allow for greasing to take place from the base of the hauler. It is no longer necessary to expose people to the risk of climbing up the ladder and performing maintenance at the top of the gantry.

They achieved this by;

- Installing a hydraulic hose from each component, at the top, leading down to the base. The grease nipples at the bottom are marked to correspond with each component at the top. Using a simple hand grease gun is sufficient once the system is primed.
- A person can now stand with their feet firmly placed on the hauler deck and grease the components at the top of the gantry. There is no need for a harness and the potential to fall from height has been removed.

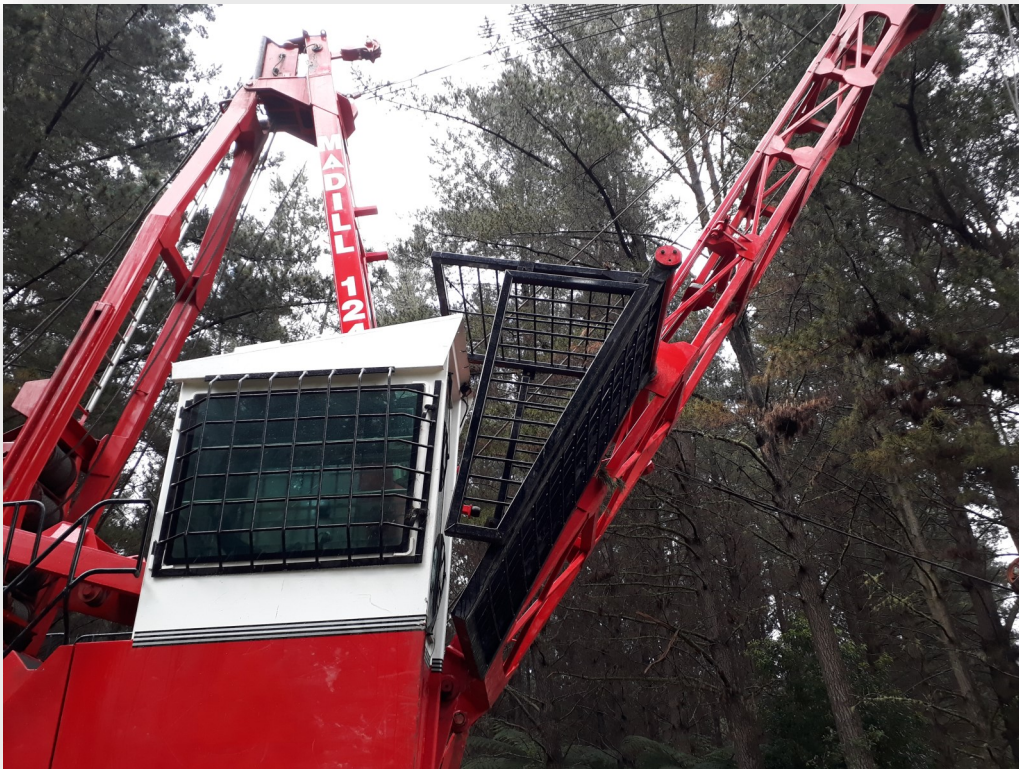
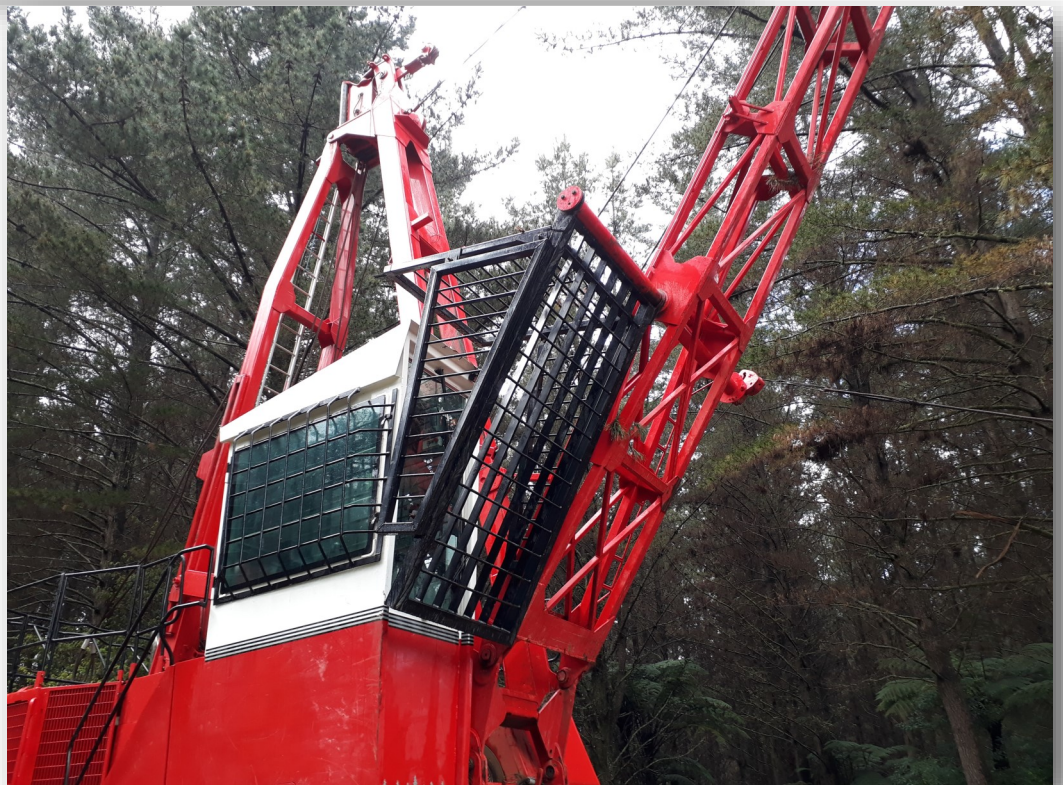
Cab protection improvements

A few years ago, a head snapped off and a large piece of wood fell in between the original cab guard and the front window. It smashed the window and had the potential to cause serious harm to the operator.

Danny and Steve modified the original cab guard design, to now include 180° protection for the operator.
