Safety Alert: Chainsaw Kickback

Date: 17/01/2024	Focus Group: All Forestry Contractors
Topic: Chainsaw kickback	Issued by: Travis Terry

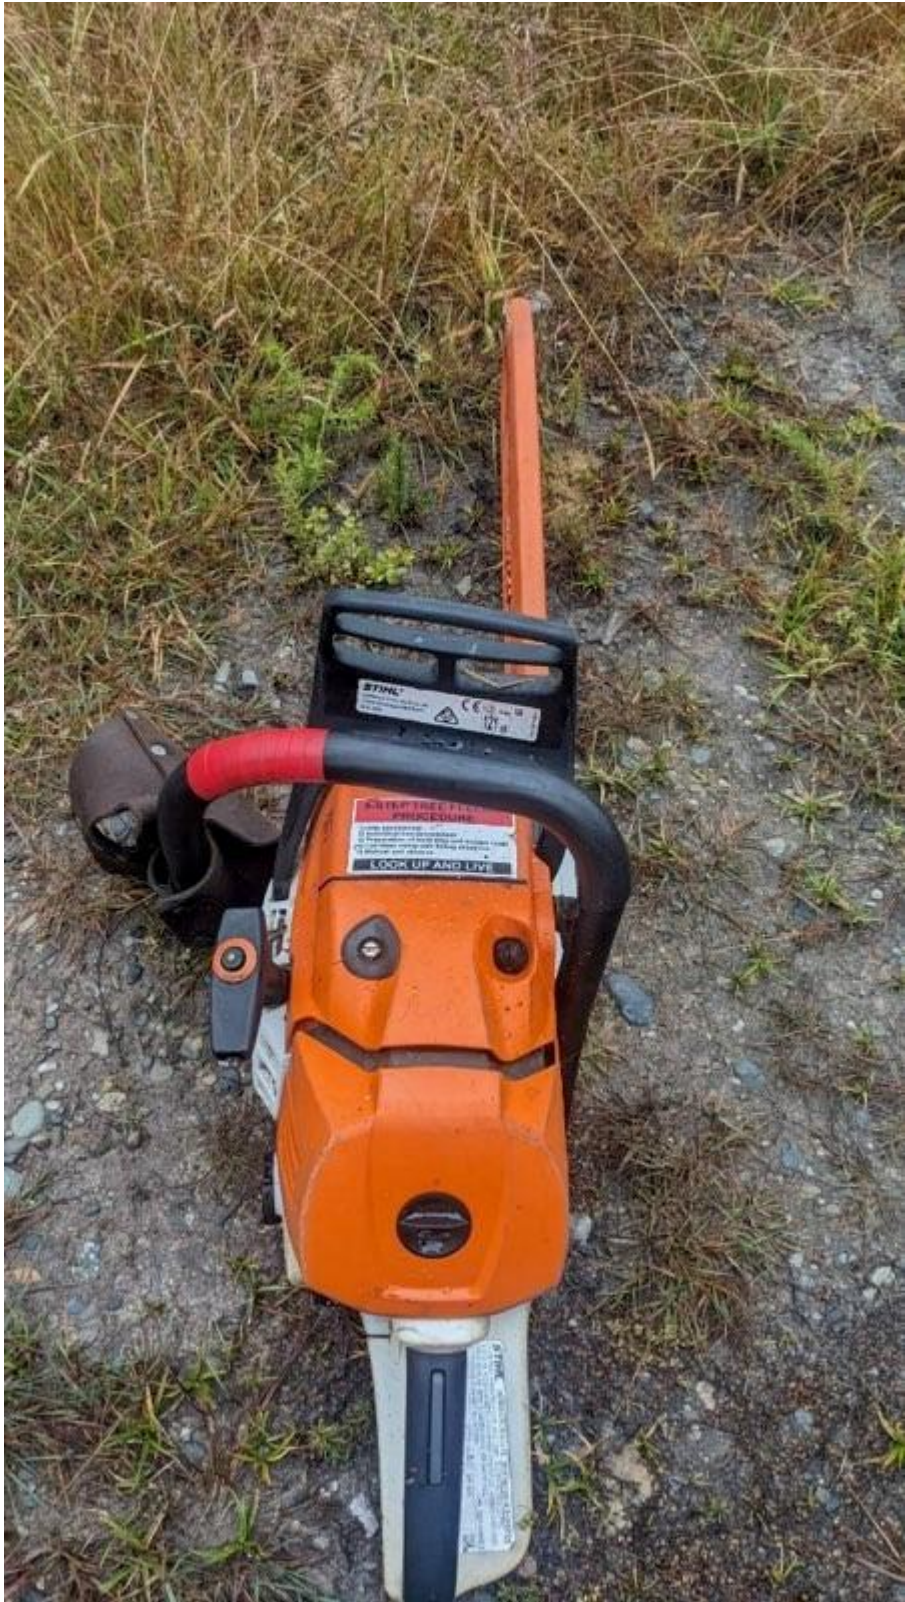
While there were recommendations relating to changes in the technique applied in this particular situation to prevent this reoccurring. The investigation identified that, when the chainsaw was held in a particular position along the wrap around handle, the safety chain brake may not activate as expected in the event of kickback.

- When using a chainsaw be prepared for the possibility of kickback.
- The contractor has implemented a coloured band on the roll over handle (see photo) to serve as a visual reminder to operators of the position of their hand and the heightened risk of the chain brake not activating if required while their hand is in this position.
