REPUBLIC OF SERBIA  
CENTER FOR INVESTIGATION OF ACCIDENTS IN TRANSPORT  
SECTOR FOR INVESTIGATION OF ACCIDENTS IN RAILWAY TRAFFIC  
Nemanjina 11, 11000 Belgrade

## FINAL REPORT ON SERIOUS ACCIDENT INVESTIGATION

Serious accident type: Train derailment

Place: City of Pirot, outskirts of the village of Sopot, open track  
between the Staničenje crossing point and the Pirot station

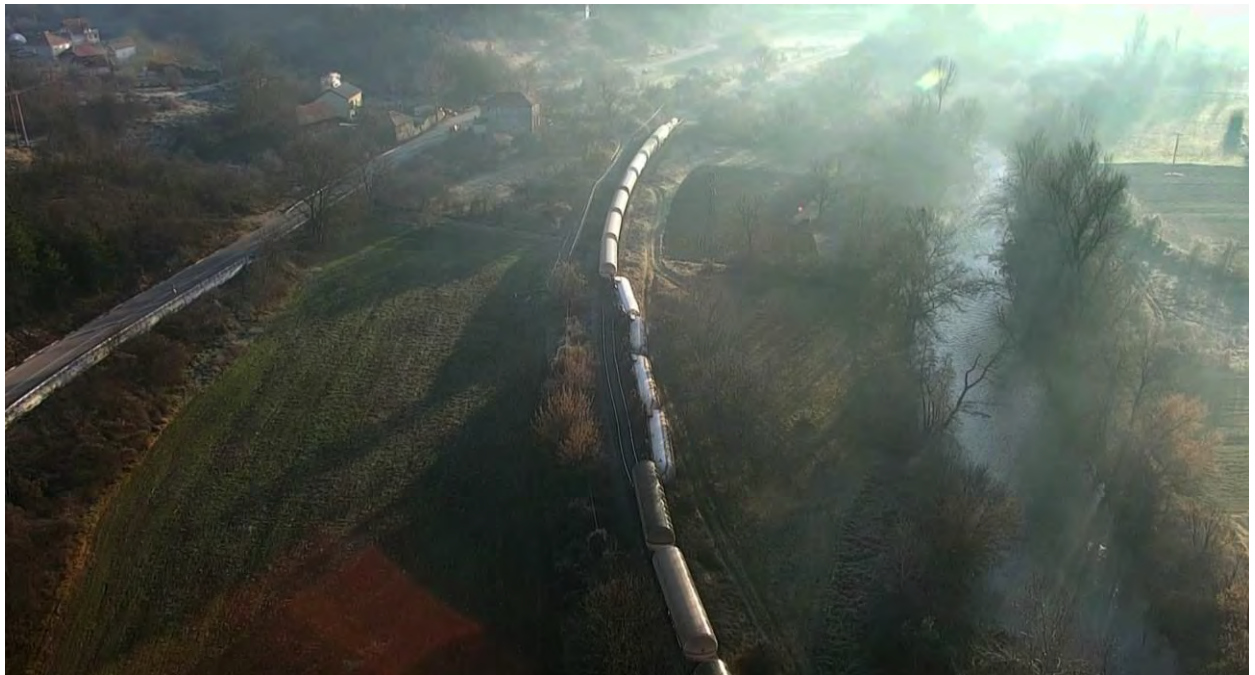
**Figure 2.1.2.1:** The appearance of the serious accident site (source: MUP, Sector for Emergency Situations)

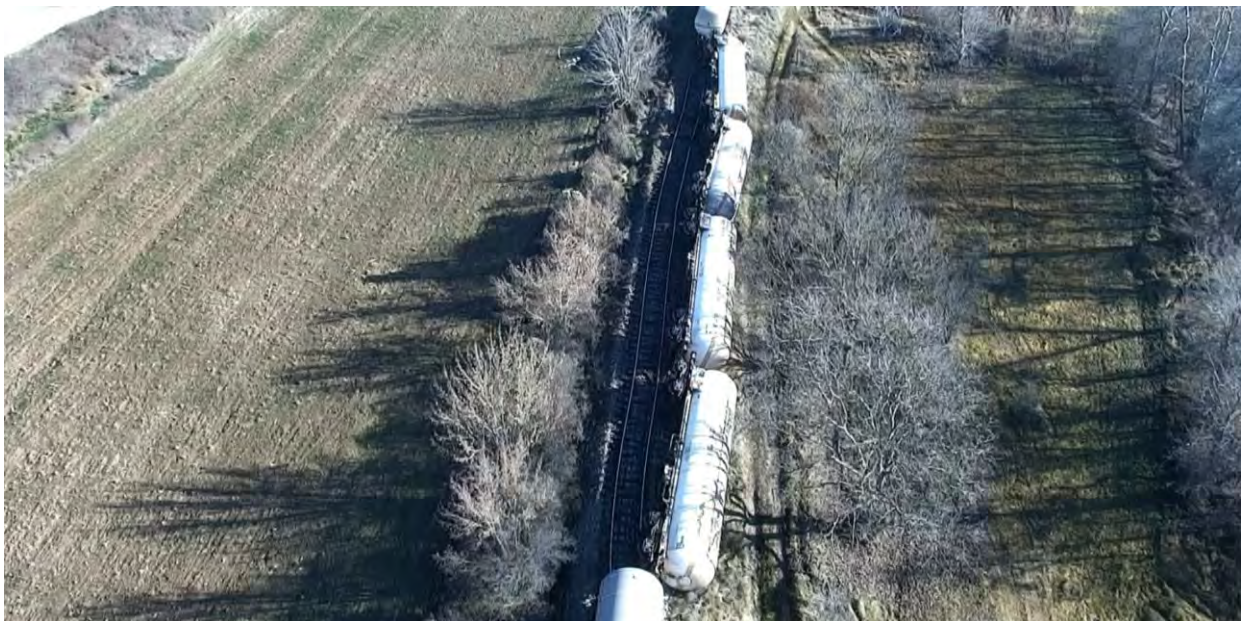
**Figure 2.1.2.2:** The appearance of the point of overturning of the wagon-tanks  
(source: MUP, Sector for Emergency Situations)

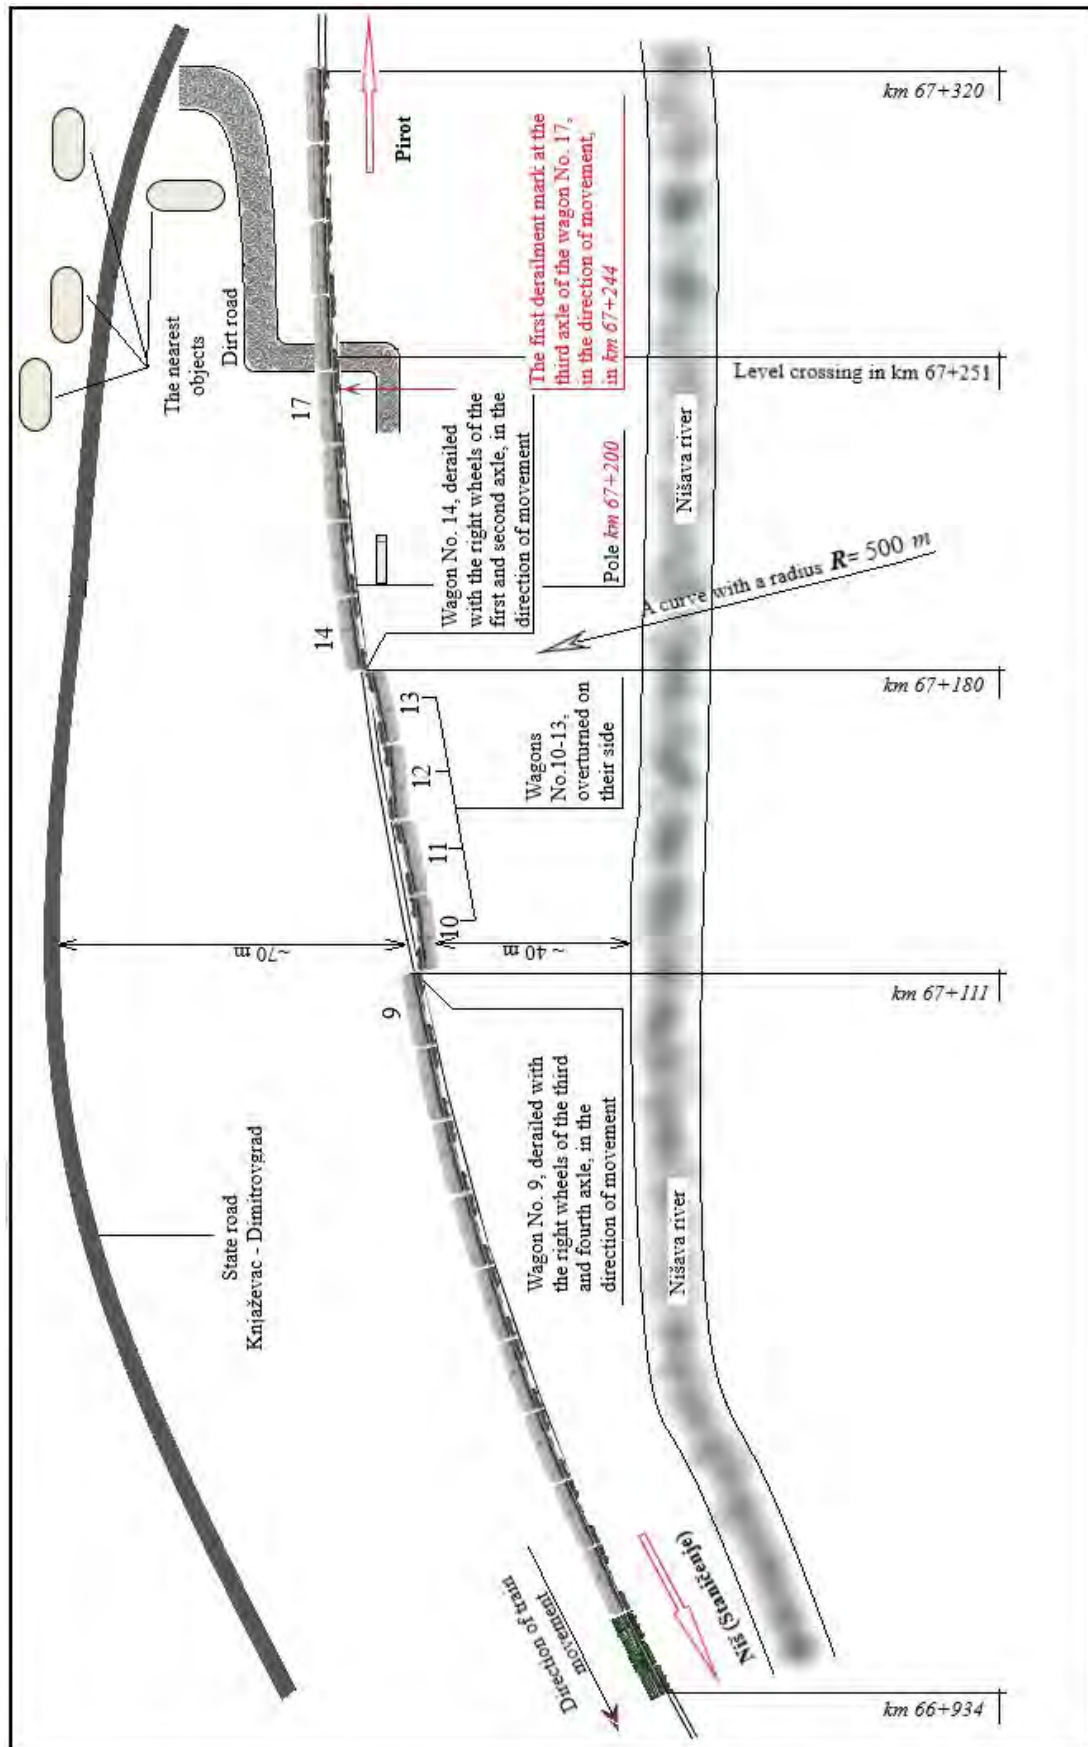
In Figure 2.1.2.3. a schematic view of the mutual position of the wagon-tanks in the train, after the serious accident, is shown.

Figure 2.1.2.3: The scheme of the serious accident site (CINS)

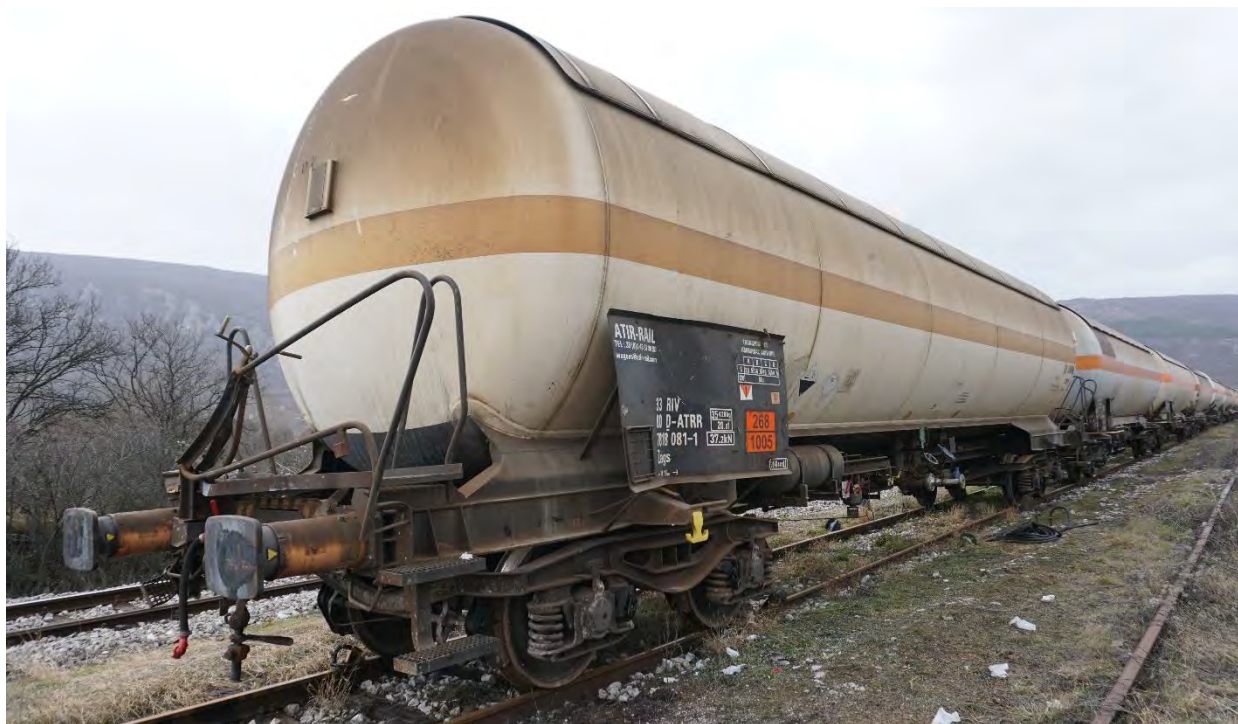
A total of 6 (six) Z series wagon-tanks derailed from the train composition.

Figure 2.2.2.1: Appearance of Z-series derailed wagons

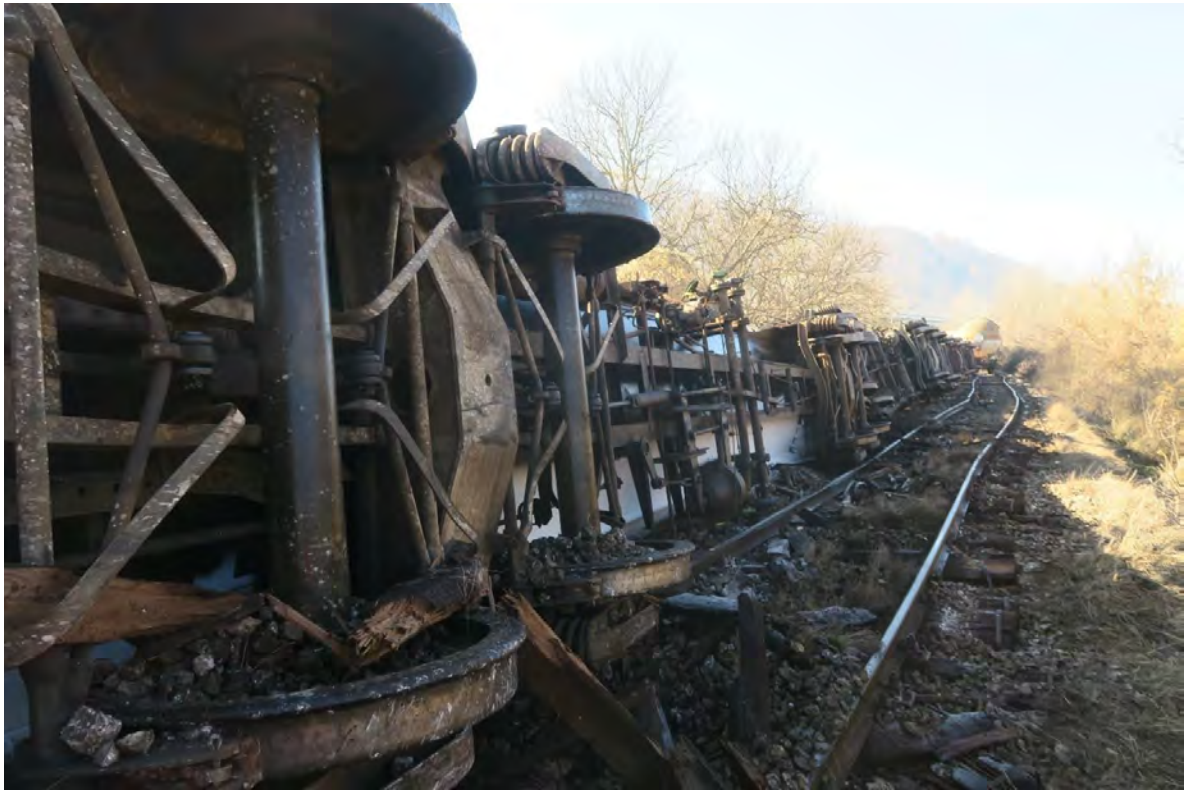
**Figure 3.4.4.1:** Appearance of the derailed wagons

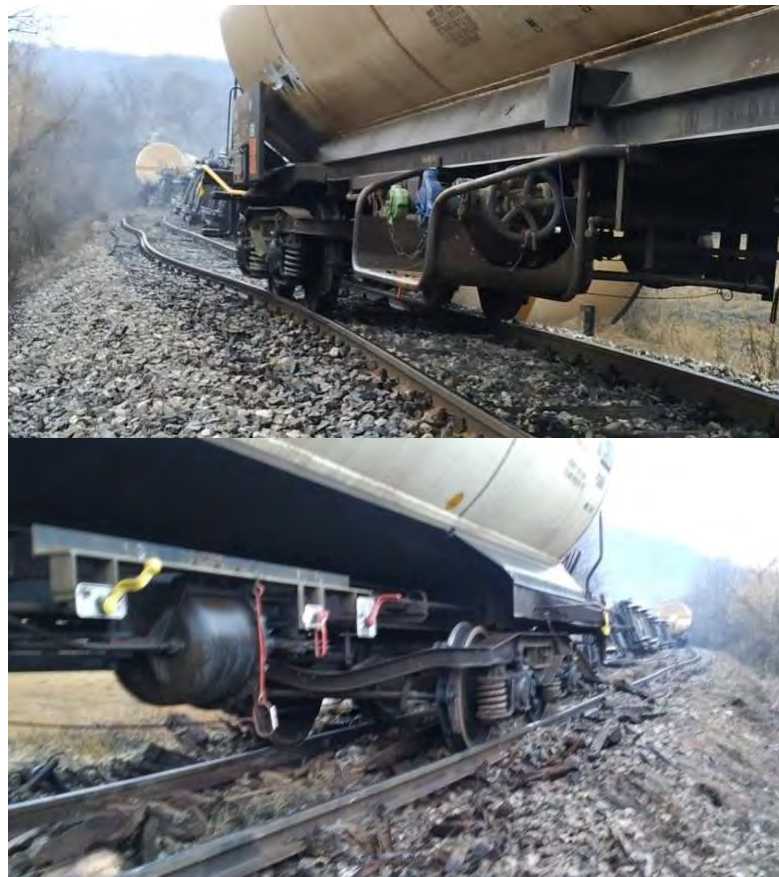
**Figure 3.4.4.2:** Appearance of the derailed ninth (up) and fourteenth wagon (down) (source: “IŽS” a.d.)

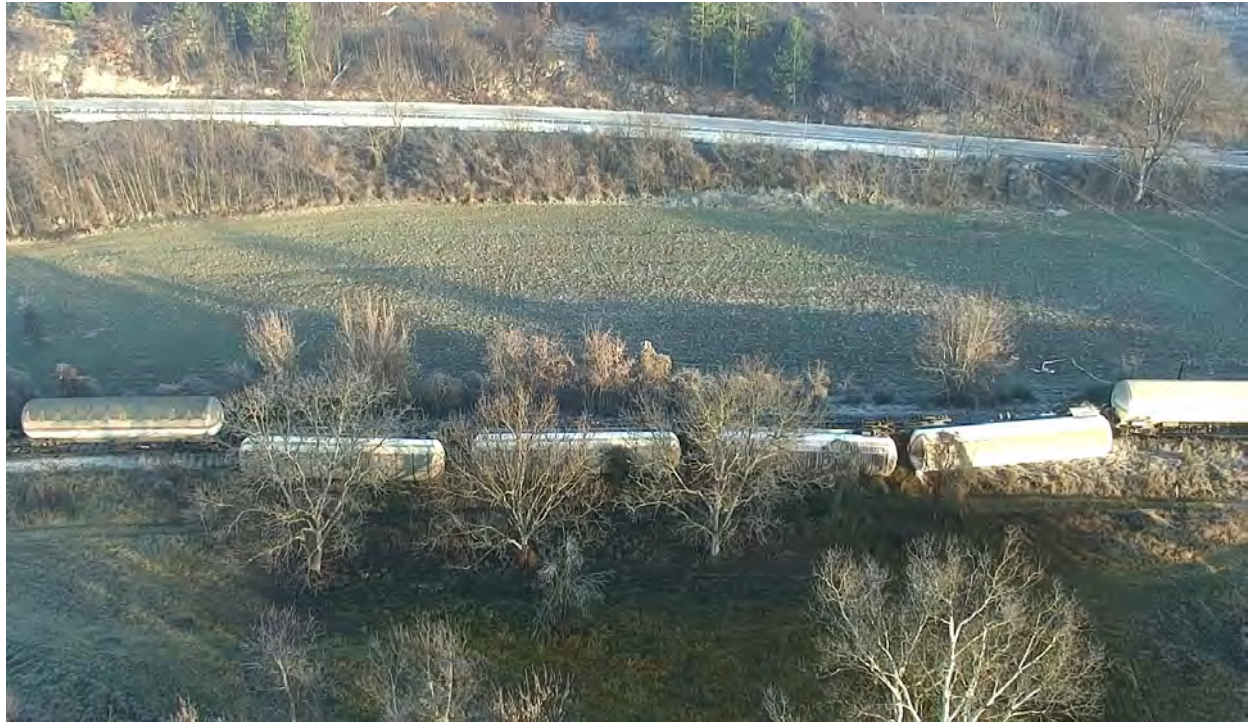
**Figure 4.2.1.1:** Overview of the derailed wagons (source: MUP, Sector for Emergency Situations)

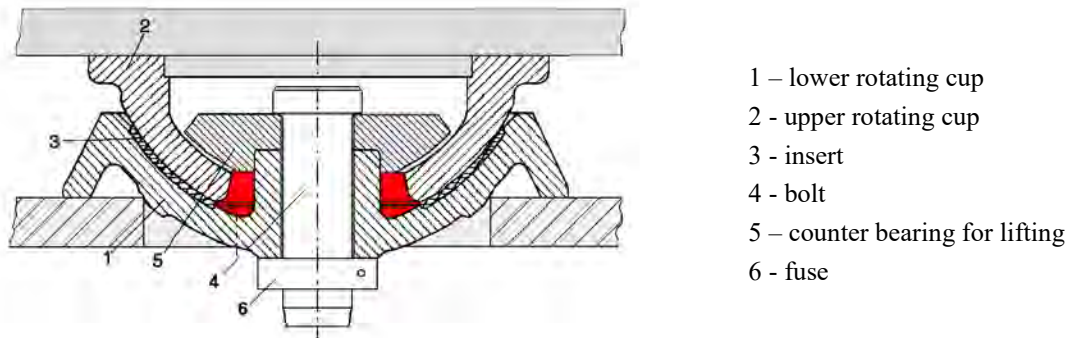
Figure 4.2.2.1. does not show the initial condition before the removal of the deposits. Judging by everything, the dirt was packed in the gap between the upper and lower center bowl, as illustrated in red on Fig.4.2.2.2. It is unclear how such a quantity of material could have entered the center bowl through the small gap between the brackets and the opening in the lower center bowl.

**Figure 4.2.2.2:** Cross-section through the center bowl assembly

The presence of soil in the center bowl, regardless of other factors, could have increased friction within the center bowl and the swivel torque of the bogie. In Figure 4.2.2.3, firstly the effect of the swivel torque on the lateral force on the leading wheels of the front and rear bogie is shown. The direction of the swivel torque on the rear bogie (as was the case with the tenth wagon in the serious accident) is such that it reduces the guiding force and, consequently, the rail spread, while on the front bogie, it increases it.

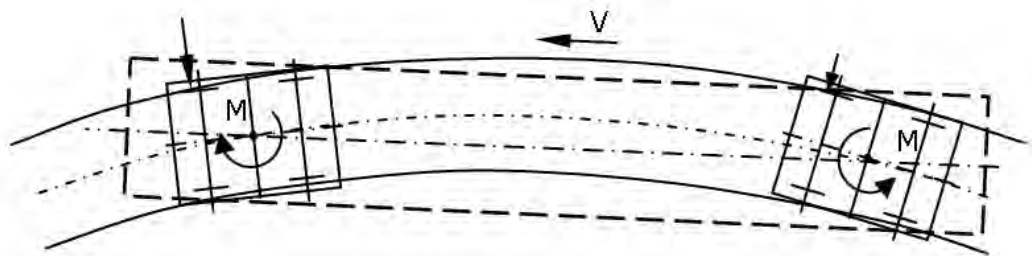
In this sense, the increased swivel torque on the rear bogie does not have a significant impact on the specific case of the non-guiding (inner in relation to the curve) wheel entering the rail.

**Figure 4.2.2.3:** The action of the swivel torque on the guiding force of the front and rear bogie

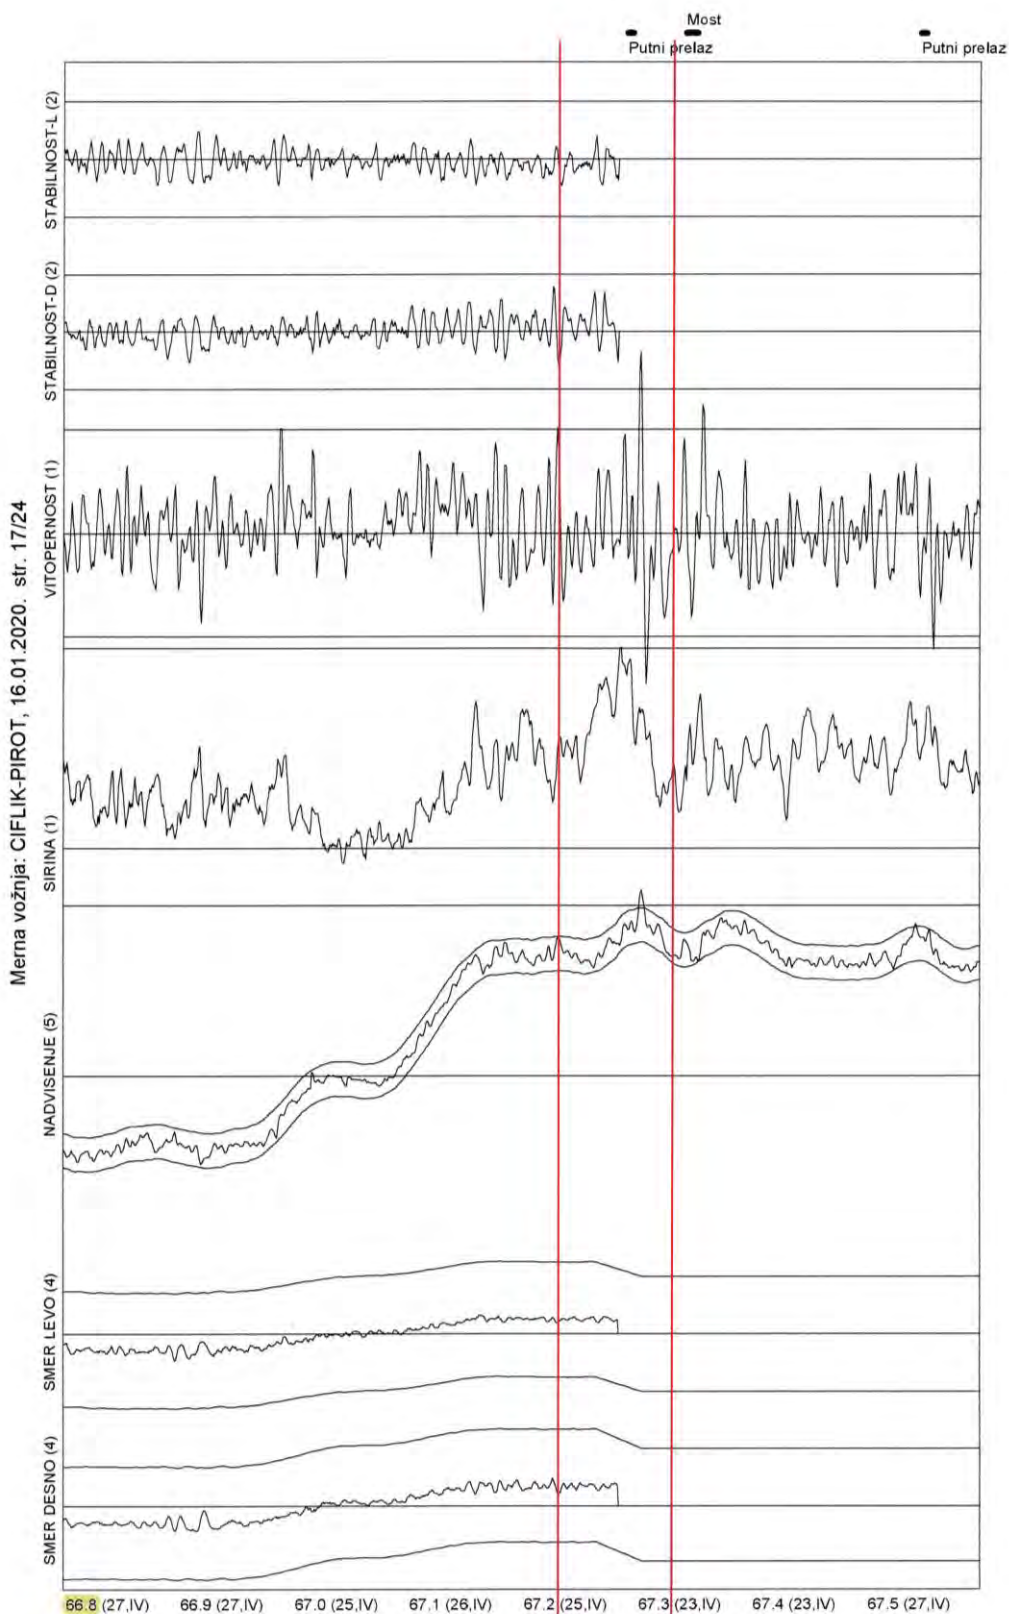
Serial No.	<i>km</i> position		Error type	Size	Deadline for removal
	From <i>km</i>	To <i>km</i>			
92	66+720	6+725	CROSS LEVEL	-21 <i>mm</i>	20.02.2020.
93	66+957	66+959	TWIST 3.5 <i>m</i>	18 <i>mm</i>	Immediately
94	67+271	67+274	TWIST 3.5 <i>m</i>	31 <i>mm</i>	Immediately
95	67+271	67+276	CROSS LEVEL	30 <i>mm</i>	20.02.2020.
96	67+271	67+276	CROSS LEVEL > 150 <i>mm</i>	163 <i>mm</i>	Immediately
97	67+276	67+279	TWIST 3.5 <i>m</i>	-26 <i>mm</i>	Immediately
98	67+326	67+328	TWIST 3.5 <i>m</i>	22 <i>mm</i>	Immediately
99	67+511	67+514	CROSS LEVEL	17 <i>mm</i>	20.02.2020.

**Figure 4.2.7.1:** Track inspection coach graphic representation excerpt from 16.01.2020.

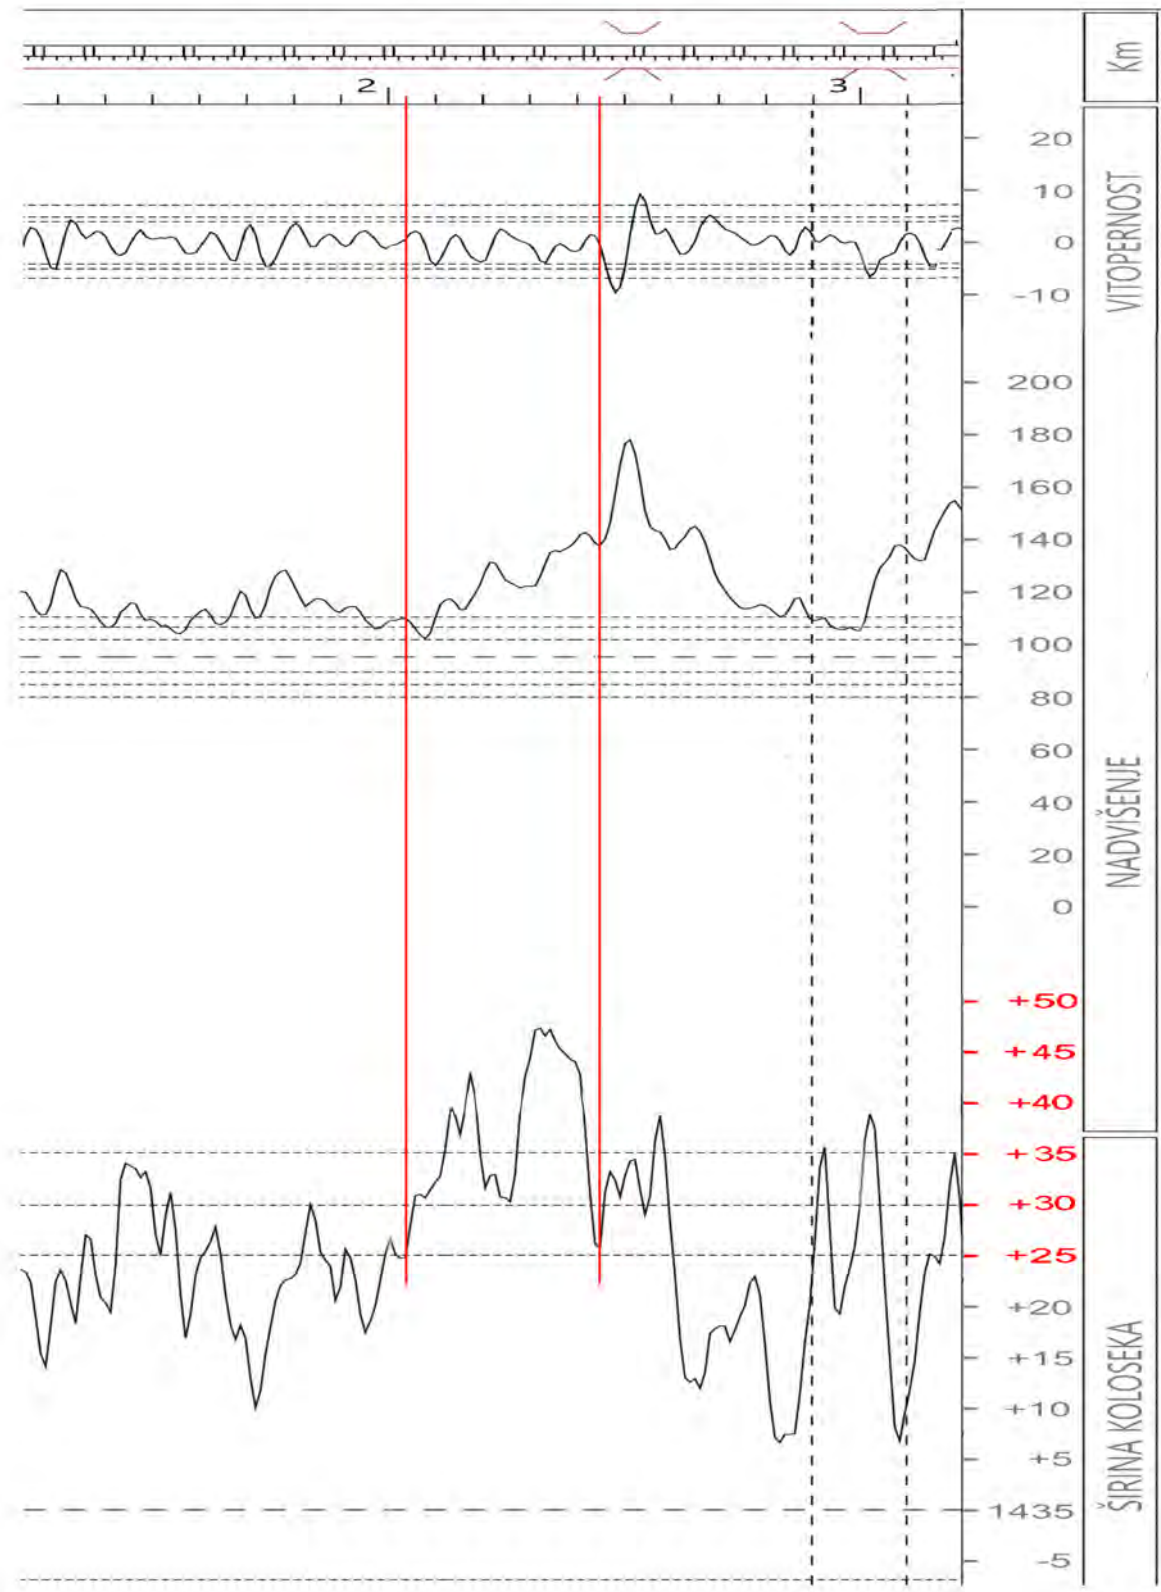
**Figure 4.2.7.2:** Excerpt from the graphical record of measuring devices from 20.10.2022.

Based on the provided analytical presentation and graphic records from the last measurement of the track condition No. 106: Niš - Dimitrovgrad - state border - (Dragoman) with track inspection coach Sever 1435, on 20.10.2022 (approximately 2 months before the serious accident occurred), it can be concluded that in the zone of train No.45010 derailment, from km 66+700 to km 67+700, according to defined parameters in the Instructions on Uniform Criteria for the Inspection of Track Condition on the JŽ Railways Network, Instruction 339 (“Official Gazette of ZJŽ”, No. 2/2001, 4/2004, and “Official Gazette of ŽS”, No. 14/22), the condition of the observed kilometer of the track was unsatisfactory. **The length of “C” type errors exceeded 20 times the maximum prescribed length of “C” type errors, which is 25 m for a satisfactory condition.** Furthermore, out of the total number of “C” type errors, **more than 76% were errors related to excess rail cross level**, where on some parts of the track, the values of outer rail cross level in curves exceeded 150 mm, resulting from the poor condition of both the super and sub track

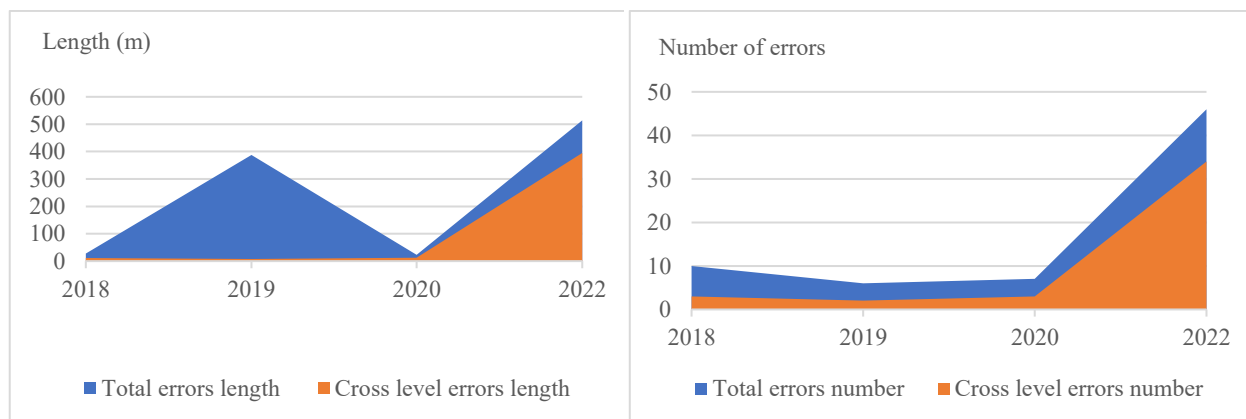
Track inspection Serial No.	Track inspection date	Errors type “C”	
		Total errors length/ errors length at cross level [m]	Total errors length/ errors length at cross level
1	09.05.2018.	28/11	10/3
2	24.04.2019.	388/8	6/2
3	16.01.2020.	23/13	7/3
4	20.10.2022.	514/395	46/34

**Graph 4.2.7.1:** Overview of the length and number of “C” type errors from km 66+700 to km 67+700

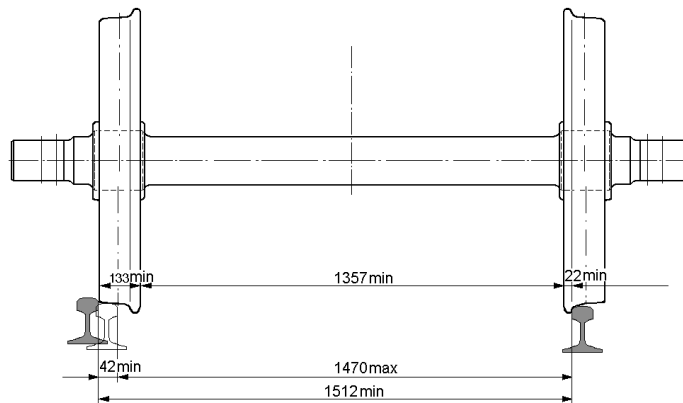
**Figure 4.2.9.1:** Conditions for wheel derailment

Figure 4.2.9.1 illustrates the necessary relationship between the dimensions of the track and the wheelset to cause a wheel to derail from the track when the relevant dimensions are within the allowed limits. It can be observed that the rails need to spread apart by at least 42 mm beyond the permitted limit of  $1435+35$  mm, due to loose or missing track fasteners or rottenness of sleepers. Considering that the measurements from the track inspection coaches (point 4.2.7.) show that in several places, the track expansion exceeds the operational limit of +35 mm, it is possible for a wheel to derail in such locations even with a smaller additional rail spacing.

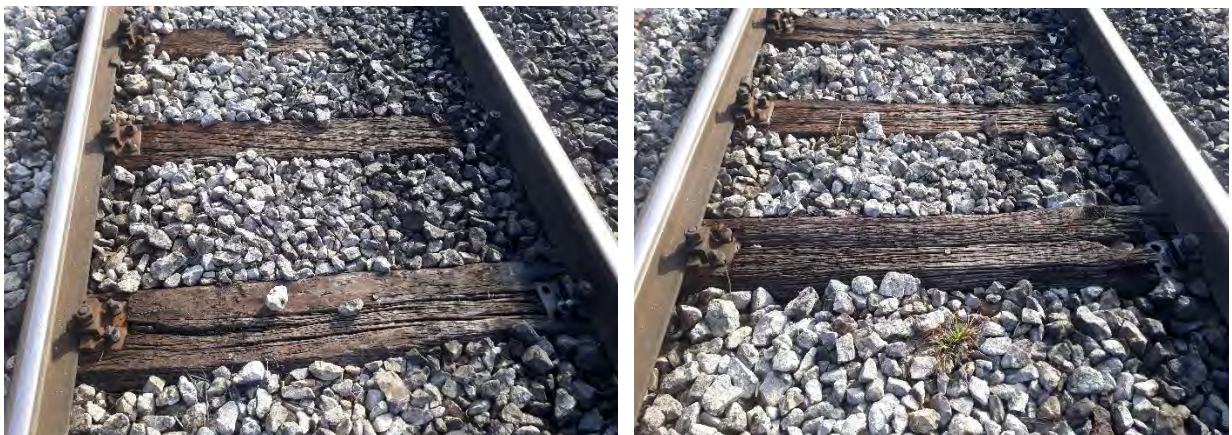
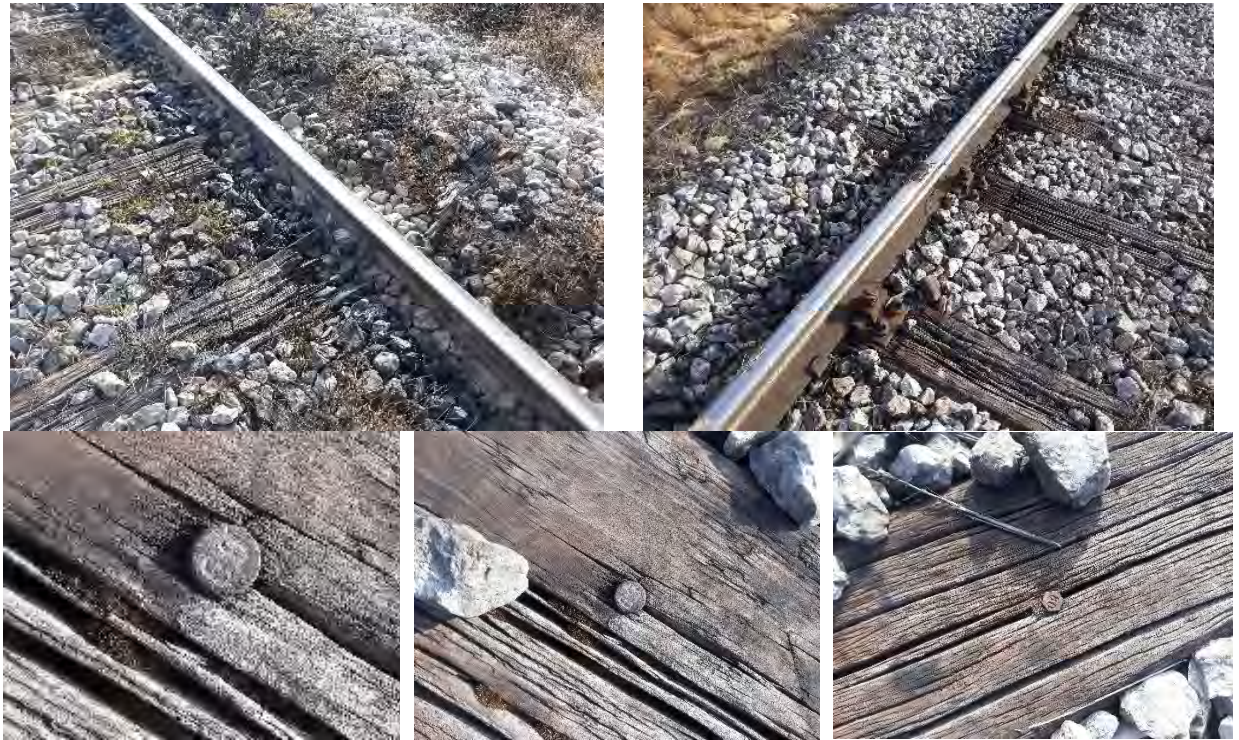
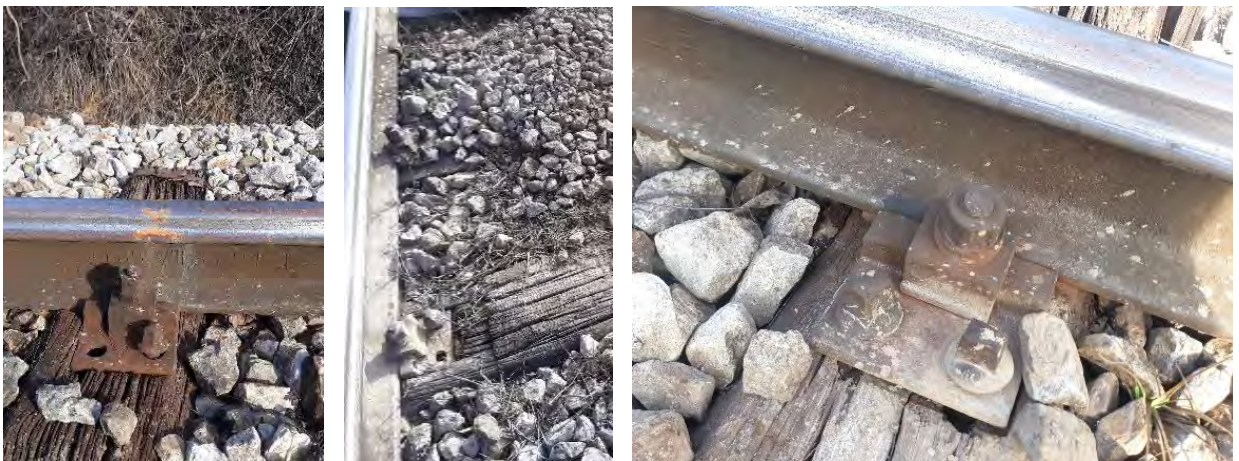
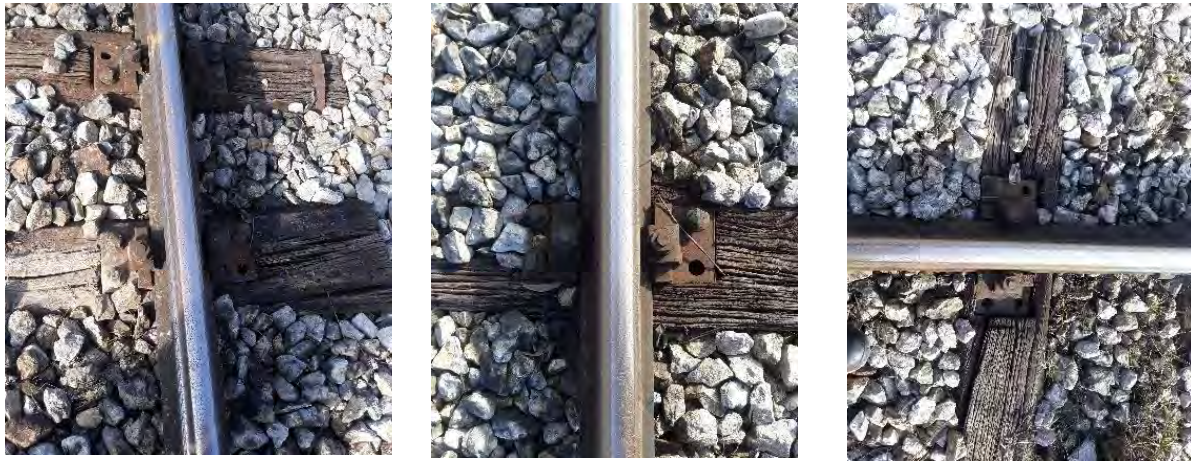
Upon inspecting the condition of the sleepers and fastening equipment, it was found that in the broader area around the wheel derailment site, the track was in a faulty condition due to loose or missing fastening equipment, shifted fastening plates, or rotten and cracked sleepers. It should be noted that the railway was put into operation on 01.08.1888, with the last repair carried out in 1985. On-site inspection revealed that some rails were over 40 years old, and some sleepers were over 50 years old in the wider area of the wheel derailment site.

**Figure 4.2.9.2:** Overview of the track

**Figure 4.2.9.3:** Overview of the sleepers

**Figure 4.2.9.4:** Overview of the rail- sleeper link with a supporting plate

**Figure 4.2.9.5:** Overview of the rail- sleeper link with a supporting plate
