## **QL-A REPORT: SUBSURFACE UTILITY ENGINEERING (SUE)**

230 The Donway W, North York, ON M3B 2V8

Rev No.	Date	Description	Prepared By	Reviewed by
01	Feb 28, 2023	Issued for Client Review	Manjotdeep	Youssef CHOULLI, P.Eng.

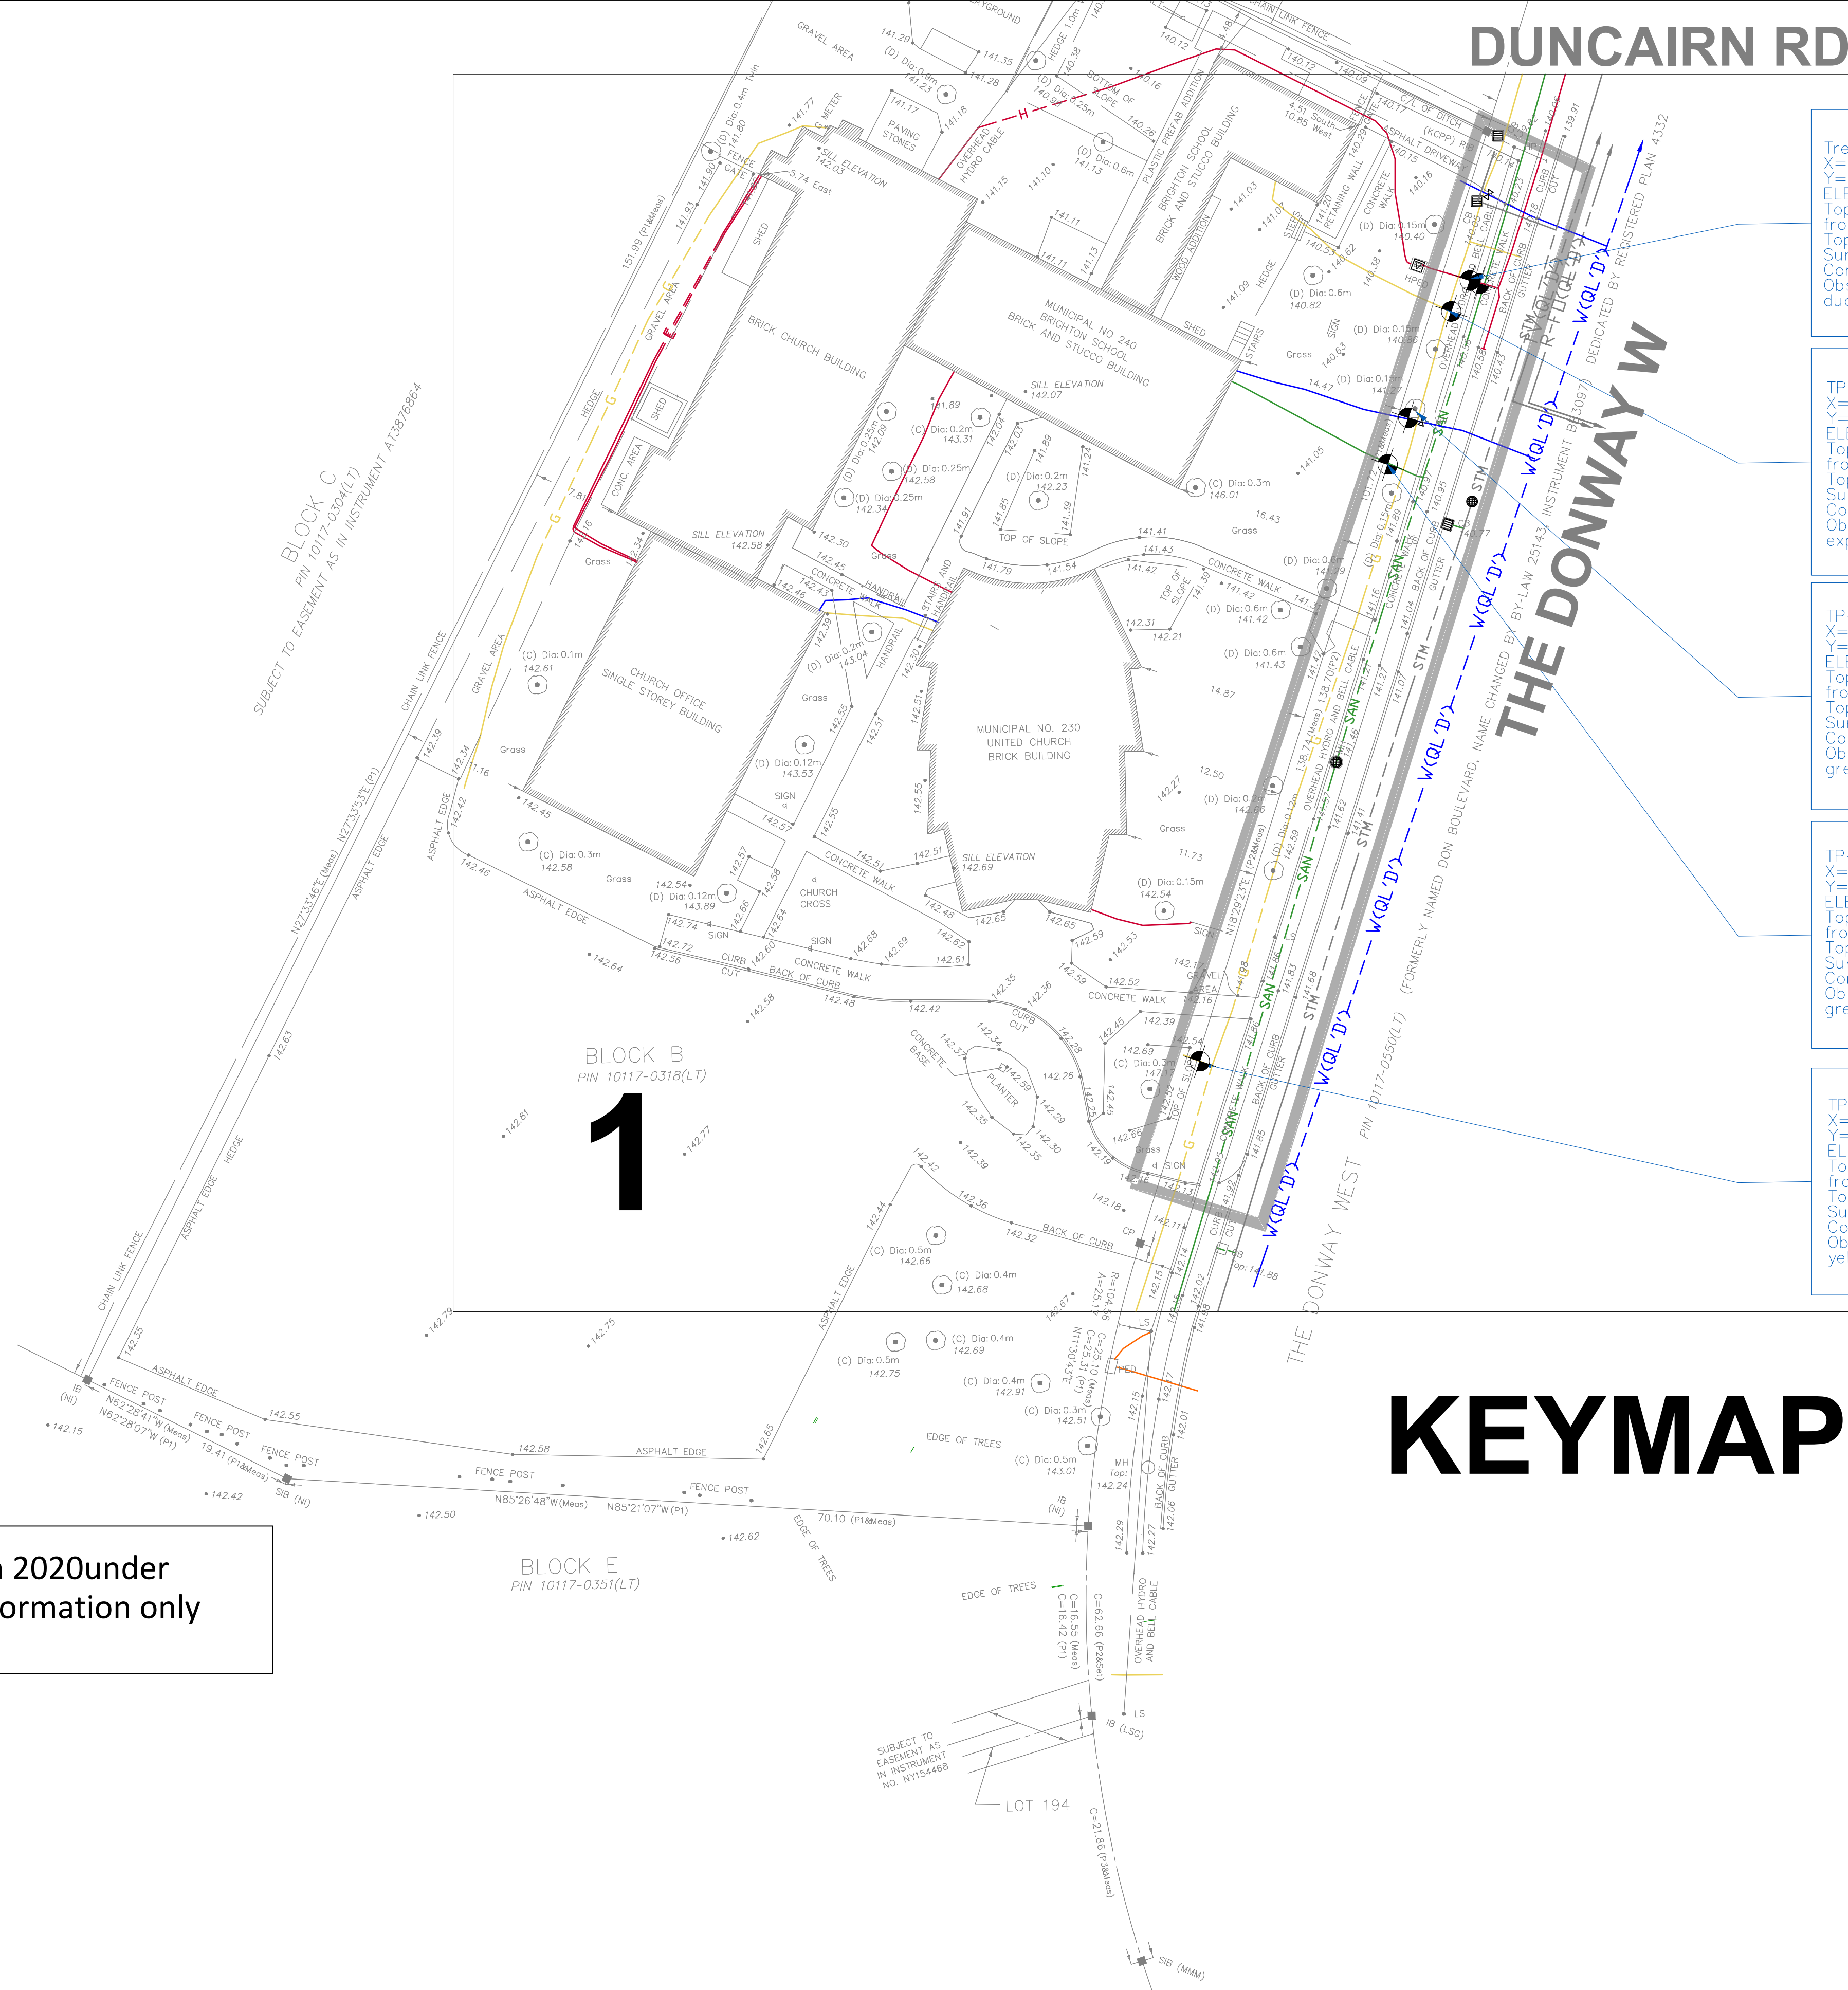
TP-5/Hydro  
 X=633116.760  
 Y=4844235.383  
 ELEV=140.248m  
 Top depth to utility from surface=0.80m  
 Top of utility elevation=139.448m  
 Surface Material:Grass  
 Composition:Concrete  
 Observations:Found a duct running E/W

TP-3/Water Service  
 X=633112.416  
 Y=4844223.489  
 ELEV=140.650m  
 Top depth to utility from surface=1.55m  
 Top of utility elevation=139.10m  
 Surface Material:Grass  
 Composition:Unable to identify  
 Observations:Found a grey pipe running E/W

TP-2/SAN Service  
 X=633110.616  
 Y=4844219.414  
 ELEV=140.931m  
 Top depth to utility from surface=3.70m  
 Top of utility elevation=137.23m  
 Surface Material:Grass  
 Composition:Unable to identify  
 Observations:Found a grey pipe running E/W

TP-1/Gas Service  
 X=633094.193  
 Y=4844167.334  
 ELEV=142.200  
 Top depth to utility from surface=1.17m  
 Top of utility elevation=141.03m  
 Surface Material:Grass  
 Composition:Unable to identify  
 Observations:Found a yellow pipe running E/W

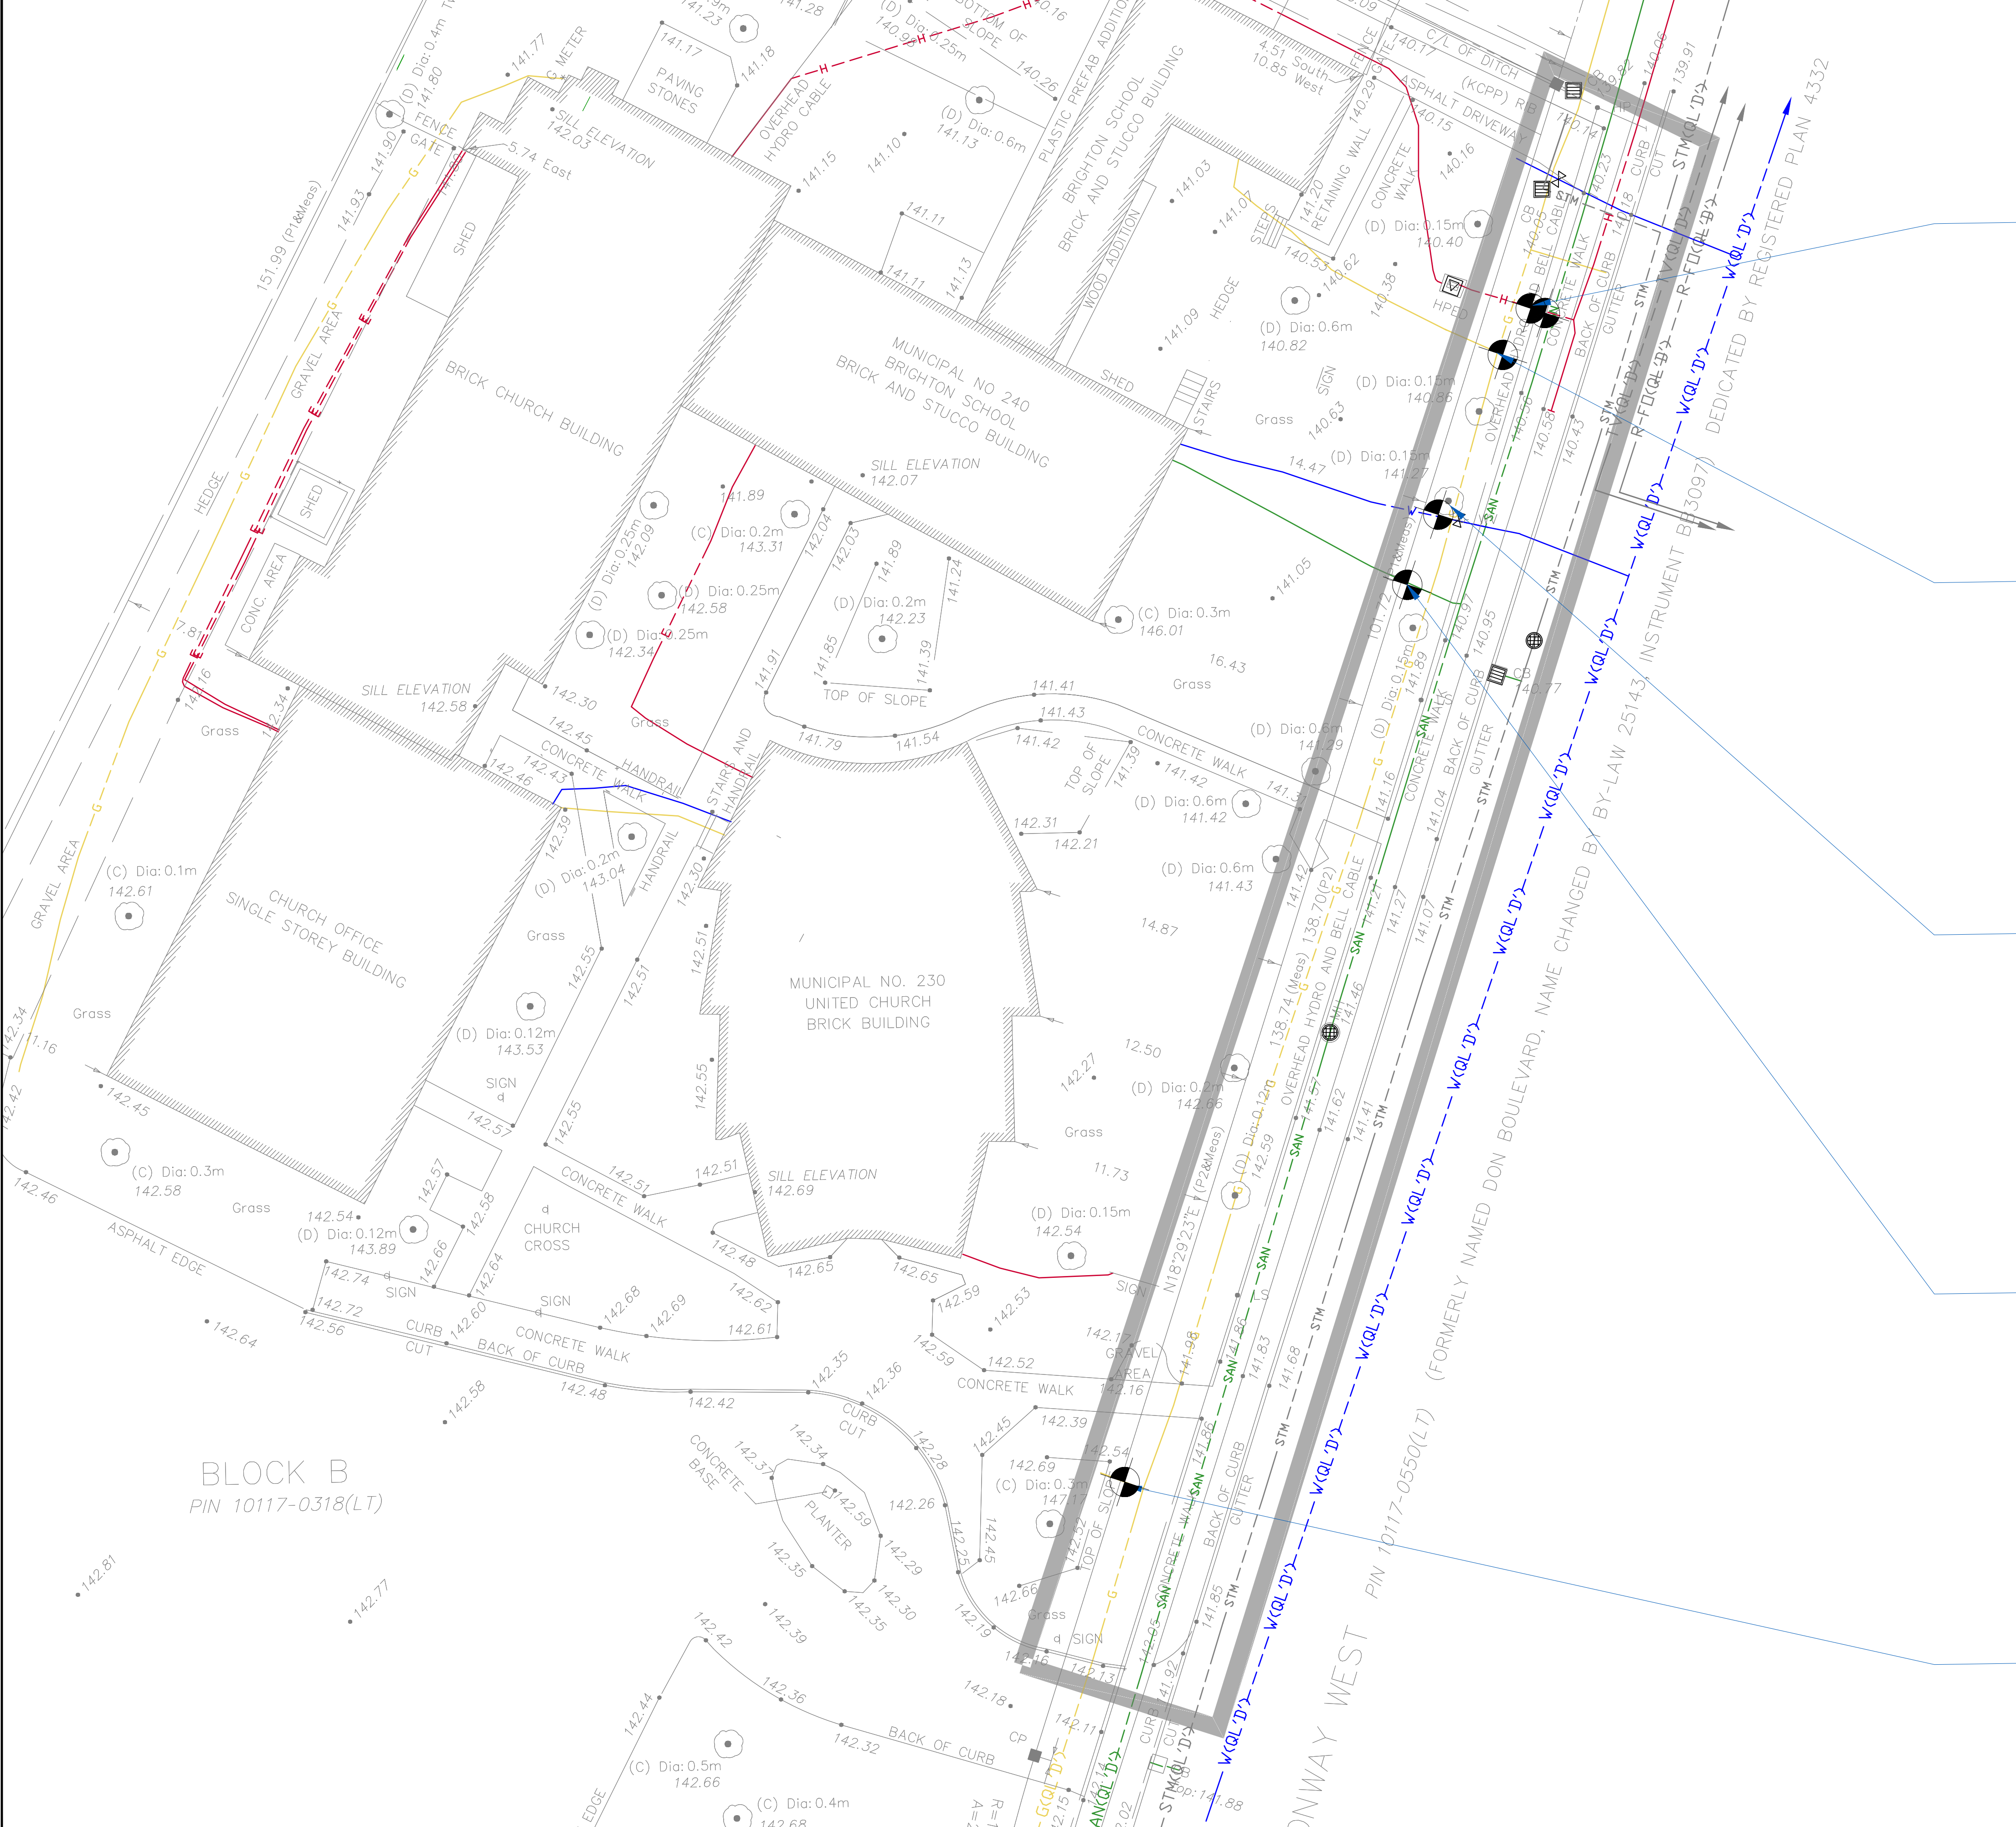
Trench-5/Hydro  
 X=633117.760  
 Y=4844235.383  
 ELEV=140.248m  
 Top depth to utility from surface=0.80m  
 Top of utility elevation=139.448m  
 Surface Material: Grass  
 Composition: Concrete  
 Observations: Found a duct running E/W

TP-3/Water Service  
 X=633112.416  
 Y=4844223.489  
 ELEV=140.650m  
 Top depth to utility from surface=1.55m  
 Top of utility elevation=139.10m  
 Surface Material: Grass  
 Composition: Unable to identify  
 Observations: Found a grey pipe running E/W

TP-2/SAN Service  
 X=633110.616  
 Y=4844219.414  
 ELEV=140.931  
 Top depth to utility from surface=3.70m  
 Top of utility elevation=137.23m  
 Surface Material: Grass  
 Composition: Unable to identify  
 Observations: Found a grey pipe running E/W

TP-1/Gas Service  
 X=633094.193  
 Y=4844167.334  
 ELEV=142.200  
 Top depth to utility from surface=1.17m  
 Top of utility elevation=141.03m  
 Surface Material: Grass  
 Composition: Unable to identify  
 Observations: Found a yellow pipe running E/W
