BANKSY

Valentine's Day Mascara, Margate

Date: 1 August 2023

1.0 Summary

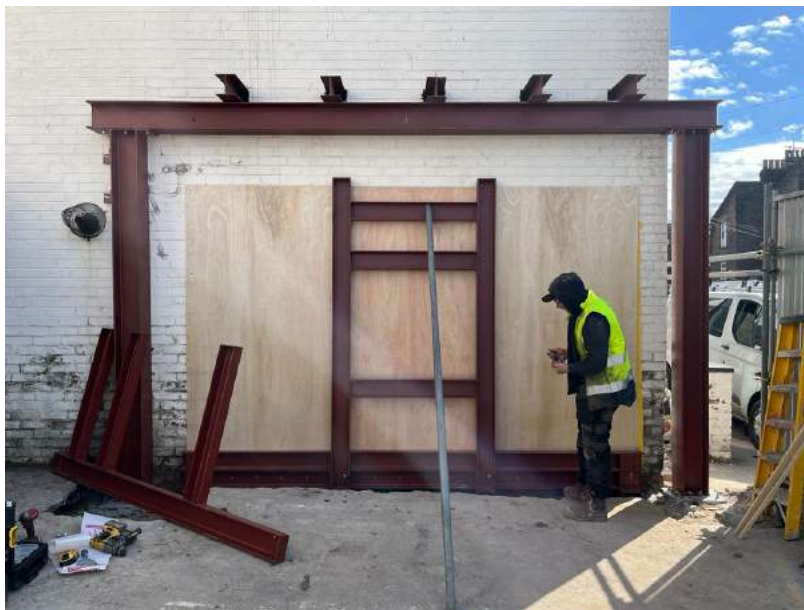
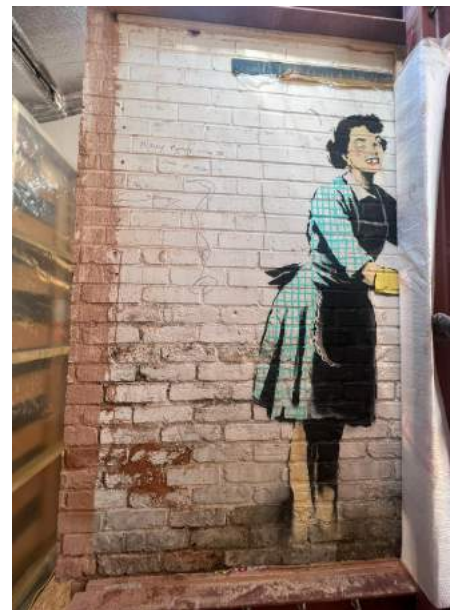
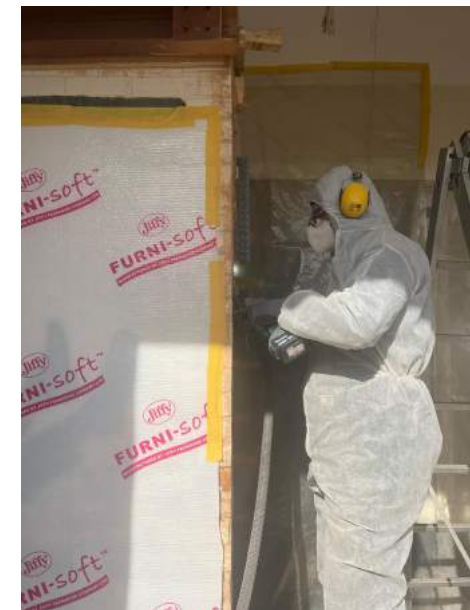
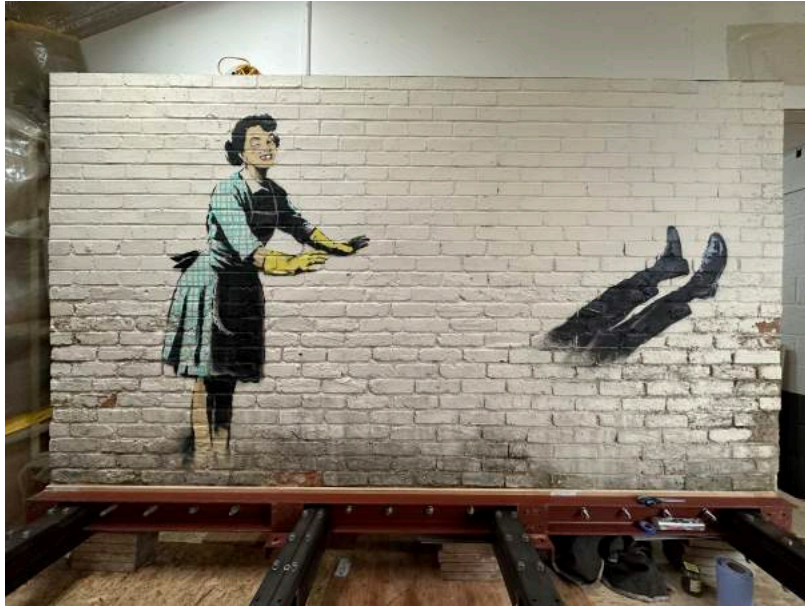
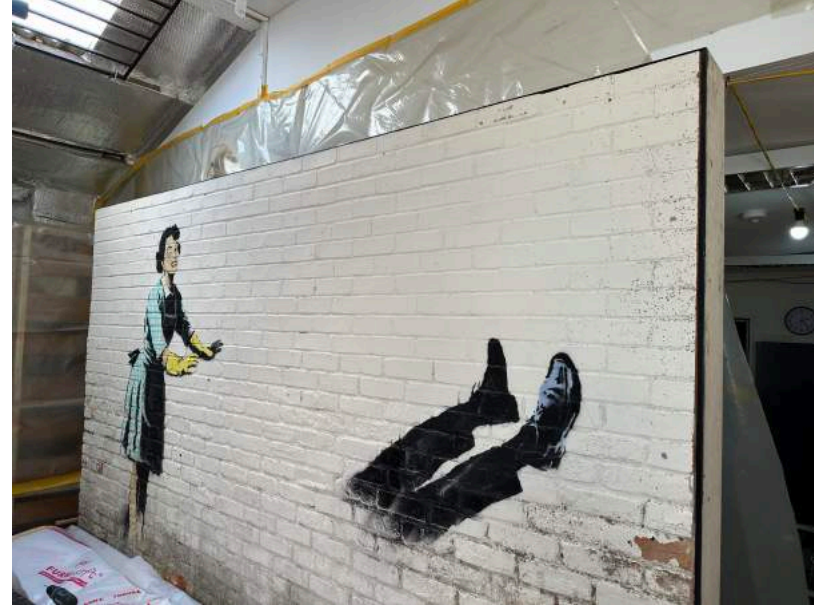
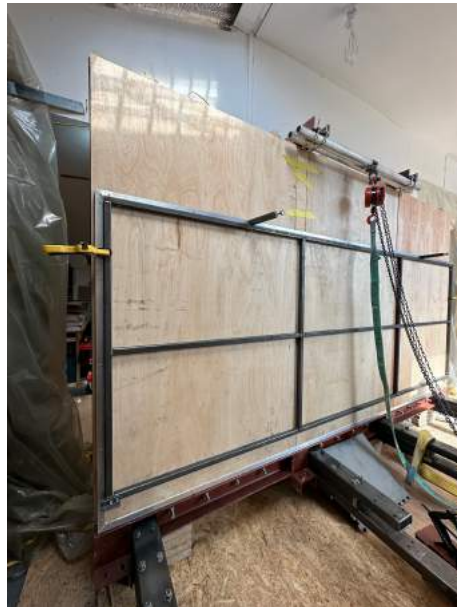
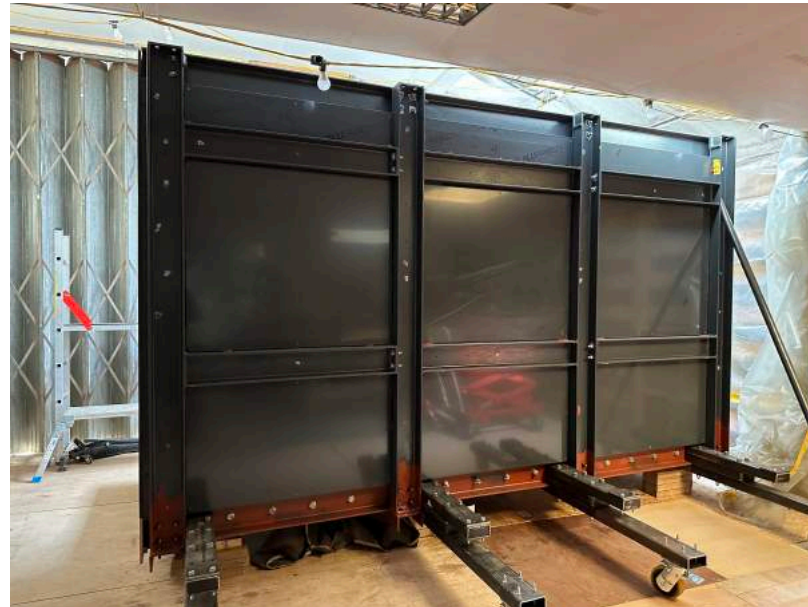
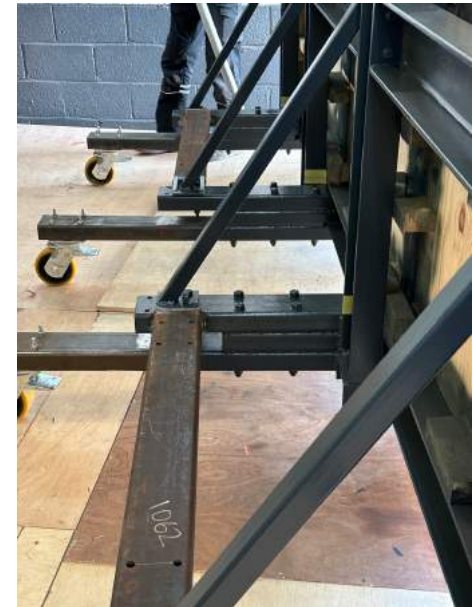
The existing off-white masonry paint appeared to be in relatively good condition prior to the application of Banksy's spray paint. However, there were areas of damage and loss along the lower parts of the wall and flaking associated with microbiological growth on the right side in particular. The lower part of the wall was obscured by grass and other weeds and the freezer originally stood on a tarmacked surface. A broken three legged plastic garden chair was part of the original ensemble of abandoned freezer and other detritus which made up the scene.

3.11 Apply lightweight, dimensionally stable 26.4mm aluminium honeycomb board or ply sheets and resin fix to reverse of the sections. This will ensure that the bricks are individually supported.

3.12 Design, manufacture and apply new frame. The outer edges of the aluminium support board may extend out beyond the painted plaster finish to allow secure fixing to an outer frame. Fill gap between frame and plaster with neutrally toned black finish to provide visual spacer between the mural and its frame. The ground in front of the wall to be reconstructed on a steel supported plate covered with resin-bonded gravel to imitate the original surface on which the chest freezer originally stood and on which it will then be mounted. A dark-grey, powder-coated aluminium frame was chosen.
