Richard Crookes Constructions
Remedial Action Plan - Addendum 1
Sydney Modern Development
Art Gallery Road, Sydney NSW

Remedial Action Plan - Addendum 1

Prepared for
Richard Crookes Constructions

SYDGE234348-EH

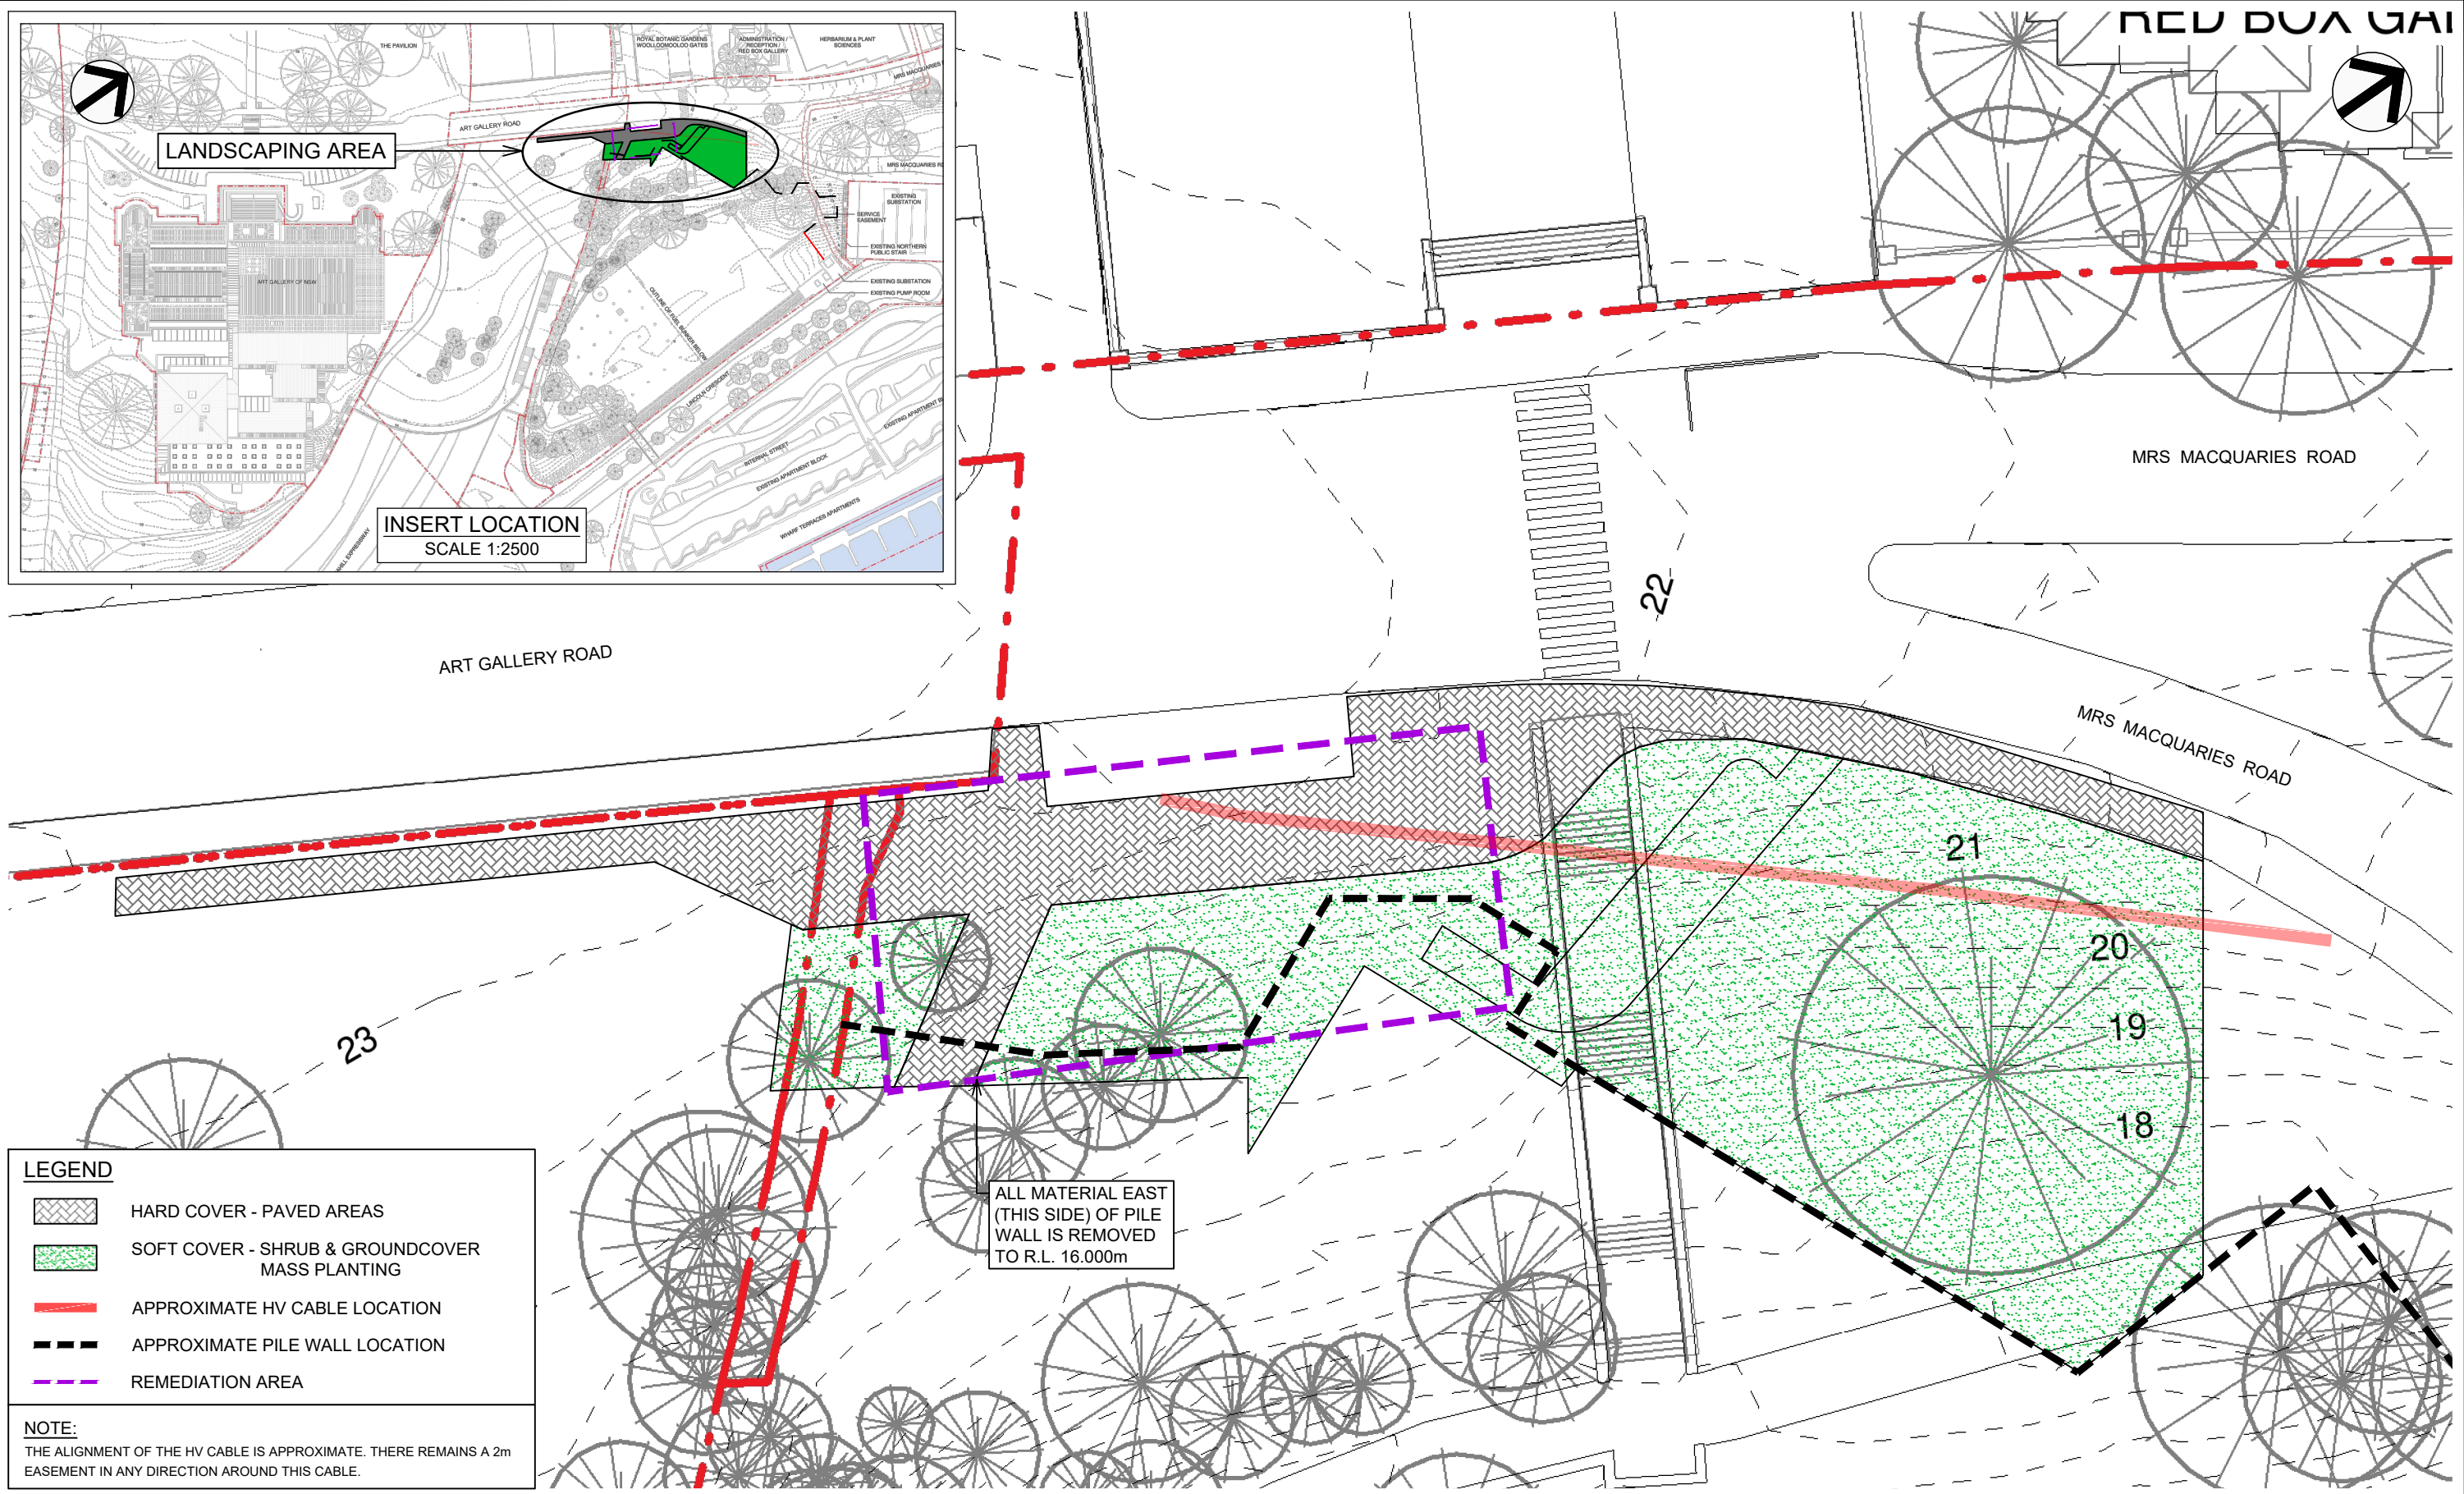
| project no: | 754-SYDGE234348-EH | figure no: | FIGURE 2 |

Figure 2 – Cover Layer: Western Wedge Area

| Site Area | Preferred Remedial Strategy |
|---|---|
| Remediation Area: Fill material around BH2 and BH4 (Western Wedge) | <ul style="list-style-type: none"> • Excavate and remove impacted fill materials within the Remediation Area east of the contiguous pile wall and dispose offsite as waste. • Fill material within the Remediation Area that is west of the contiguous pile wall will be retained within the site beneath an appropriate Cover Layer that will be managed over the long term. Some excavation and off-site disposal of soil from this area may be required to achieve design levels to establish landscaping and pavements. • The extent of the Cover Layer for the Remediation Area is shown on Figure 2. |

Based on the concept landscape design plans, the Remediation Area will be covered by a combination of hard pavement and soft landscaped materials and shown in Figure 2. This area is designed for movement of pedestrians and not as a location where users would occupy for long periods (a few hours). The Cover Layers shall be formed as follows:
