Richard Crookes Constructions – Jesse Moss

Unexpected Finds Procedure

Sydney Modern Gallery
Art Gallery Road, Sydney, NSW

SYDGE234348-EB_UFP

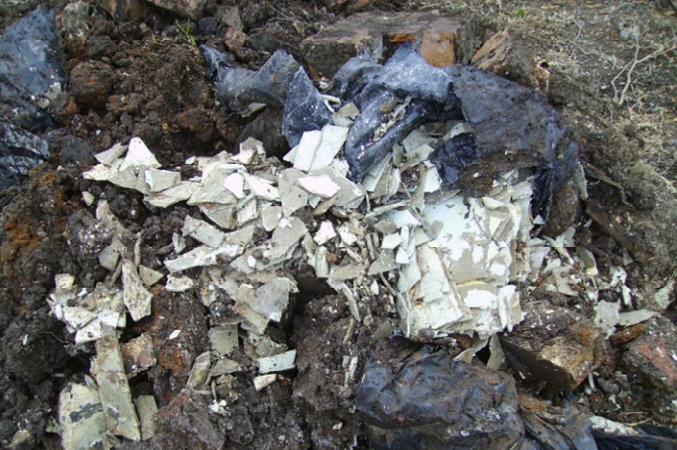
Potential Unexpected Find	Observed Characteristic	Typical Key Contaminant of Concern	Example of an unexpected find where applicable
Asbestos containing materials and/or buried asbestos pipes	<p>It is often very difficult to identify the presence of asbestos by sight. The only way to be certain is to have a sample of the material analysed by a laboratory. Cement bound asbestos (fibro cement sheet) may be present in building materials such as wall sheeting, pipes and roofing, backing of electrical switch boards, linoleum floor tiles etc and may be found as fragments of broken building materials (often found close to the building) and building wastes.</p> <p>Friable forms of asbestos including lagging and insulation may occur as fibrous material which flakes and powders easily. Textured coatings used to improve fire-resistance may also contain asbestos.</p>	Asbestos

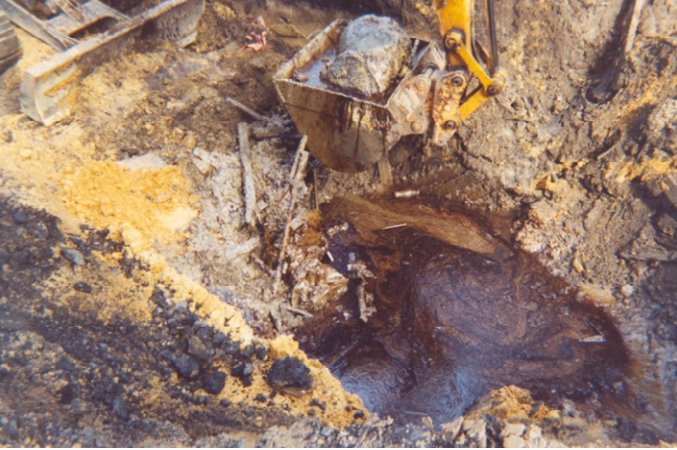
Buried waste materials	<p>May include a variety of waste materials, inclusive of waste oil drums, wood, plastic, metal fragments, building rubble (e.g. concrete, brick, asphalt, asbestos containing materials), lead paint. We do not consider that a trivial piece or fragment of foreign material constitutes as an unexpected find (e.g. a single brick).</p>	<p>Total Recoverable Hydrocarbons (TRH) Benzene, toluene, ethylbenzene, xylenes and naphthalene (BTEXN) Polycyclic Aromatic Hydrocarbons (PAHs)</p> <p>Volatile Halogenated Compounds (VHCs) Asbestos Heavy metals – usually arsenic, cadmium, chromium, copper lead, mercury, nickel and zinc</p>

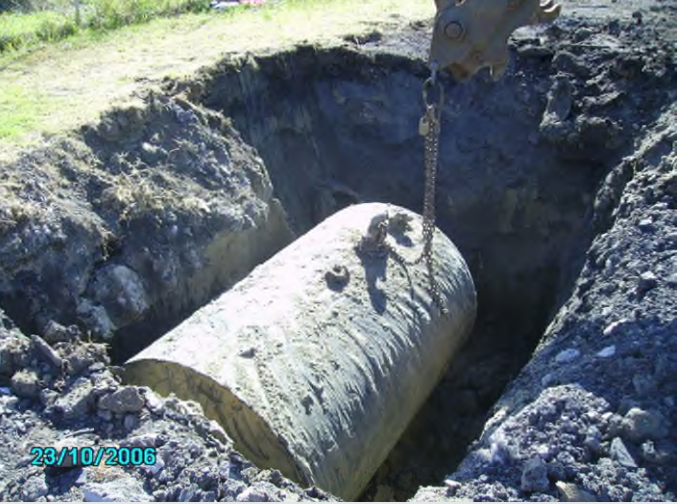
Underground storage tanks (USTs)	<p>Though unlikely but can be identified as follows:</p> <ul style="list-style-type: none"> • A buried steel underground tank; • Deeper sand fill is sometimes observed and / or hydrocarbon odours or staining. • Encountering relatively small concrete footings or steel pipelines, sometimes with observed hydrocarbon odours or staining. 	TRH, BTEXN, PAHs, VHCs, phenols, lead

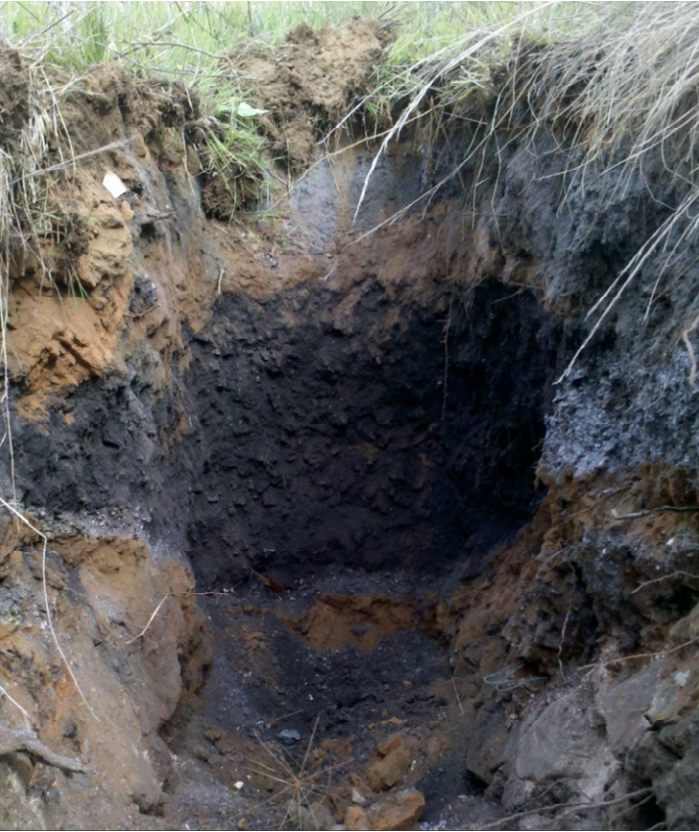
Potential Unexpected Find	Observed Characteristic	Typical Key Contaminant of Concern	Example of an unexpected find where applicable
Ash or slag deposits	<p>Ash materials typically light weight, grey and white gravel and sand sized (1mm to 10mm) particles (see photograph example).</p> <p>Slag materials can be varied in consistency and colour. Typically slags from steelmaking are pale grey to grey, however can be blue/green/grey, loose or cemented. Slag gravels can be very angular and appear to have a vesicular (i.e. 'honeycomb') shape.</p>	PAHs, heavy metals

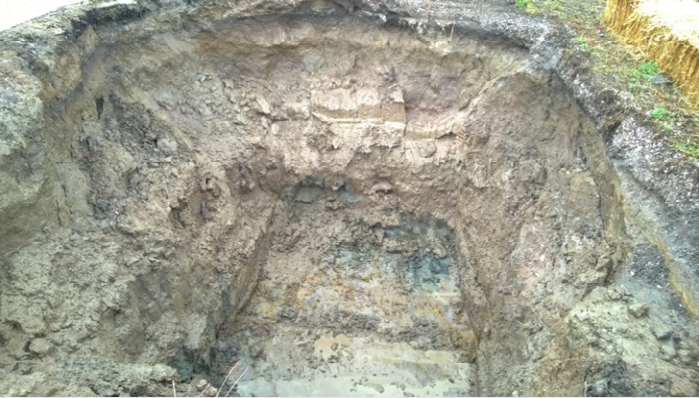
Hydrocarbon Compounds	<p>May be identified by a hydrocarbon (e.g. petrol, diesel or oil) odour which may vary in strength from possible (just detectable) to very strong (easily detectable at a distance from the source).</p> <p>The odour may or may not be accompanied by specific areas of dark staining (black-grey) or larger scale discolouration of strata from a previously identified 'natural colour' e.g. staining of orange and brown clay to dark grey and green.</p>	TRH, BTEXN, PAHs, lead

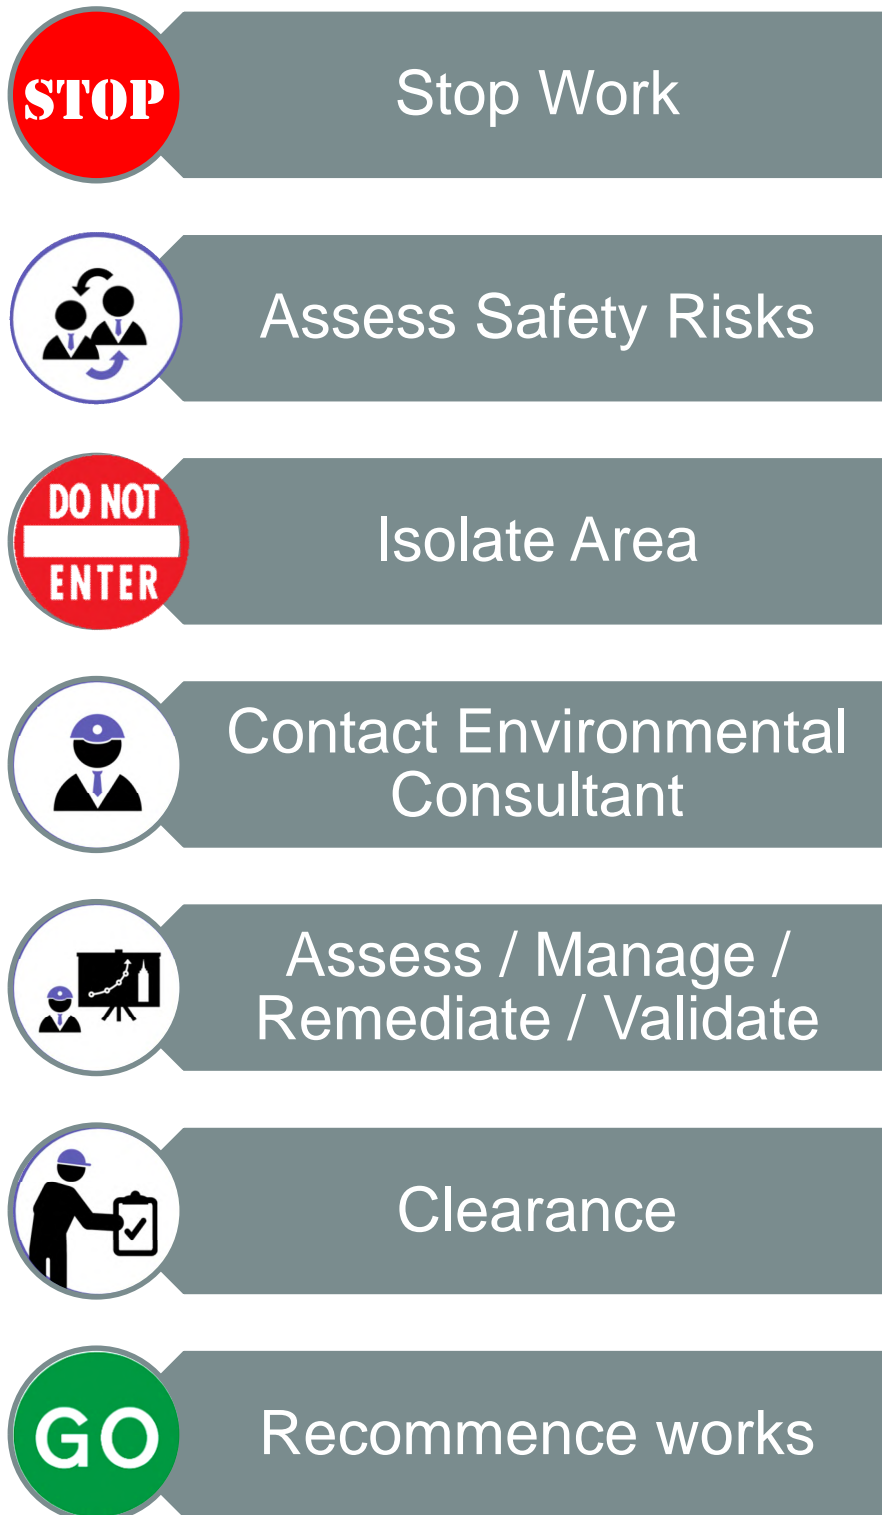
A simple one-page summary of the sequence of actions recommended in the UFP.

Below is a summary version of the **Unexpected Finds Procedure** and can be used as a handout:
