Site Classification Summary Report

Client	Indesco Consulting Engineers Pty Ltd	Project No.	46231.94
Project	Site Classification	Date	23 Jan 2018
Address	Block 1 Section 59, Denman Prospect	Doc No.	R.S59B1.Rev0

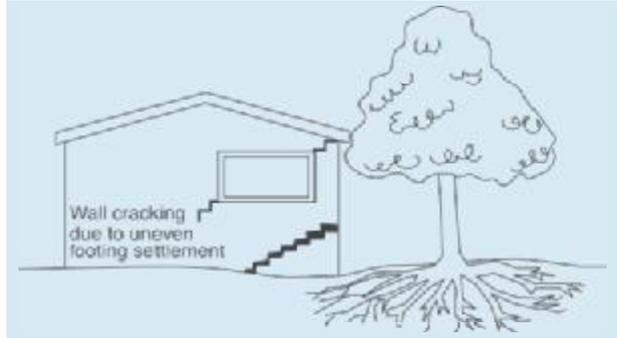
Trees can cause shrinkage and damage

As the weather pattern changes and the soil begins to dry out, the external footings will be first affected, beginning with the locations where the sun's effect is strongest. This has the effect of lowering the external footings. The doming is accentuated and cracking reduces or disappears where it occurred because of dishing, but other cracks open up. The roof lines may become convex.
