## Site Classification Summary Report

<b>Client</b>	Indesco Consulting Engineers Pty Ltd	<b>Project No.</b>	46231.94
<b>Project</b>	Site Classification	<b>Date</b>	23 May 2018
<b>Address</b>	Block 1 Section 70, Denman Prospect	<b>Doc No.</b>	R.001.Rev0

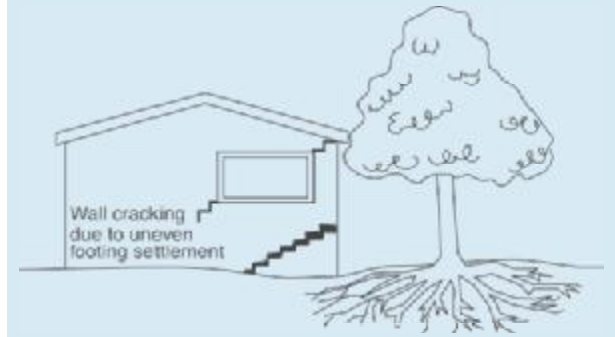
### Trees can cause shrinkage and damage

As the weather pattern changes and the soil begins to dry out, the external footings will be first affected, beginning with the locations where the sun's effect is strongest. This has the effect of lowering the external footings. The doming is accentuated and cracking reduces or disappears where it occurred because of dishing, but other cracks open up. The roof lines may become convex.
