SITE CLASSIFICATION REPORT SUMMARY

BLOCK: 1 **SECTION:** 56 **SUBURB:** Denman Prospect
JOB No: 46231.94 **DATE:** May 2018
CLIENT: Indesco Consulting Engineers Pty Ltd

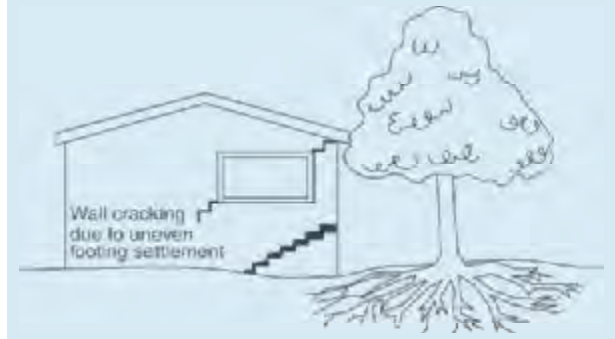
Trees can cause shrinkage and damage

As the moisture absorption process completes its journey to the innermost areas of the building, the internal footings will rise. If the spread of moisture is roughly even, it may be that the symptoms will temporarily disappear, but it is more likely that swelling will be uneven, creating a difference rather than a disappearance in symptoms. In buildings with timber flooring supported by bearers and joists, the isolated piers will rise more easily than the strip footings or piers under walls, creating noticeable doming of flooring.

As the weather pattern changes and the soil begins to dry out, the external footings will be first affected, beginning with the locations where the sun's effect is strongest. This has the effect of lowering the external footings. The doming is accentuated and cracking reduces or disappears where it occurred because of dishing, but other cracks open up. The roof lines may become convex.
