SITE CLASSIFICATION REPORT SUMMARY

BLOCK:	1	SECTION:	61	SUBURB:	Denman Prospect
JOB No:	46231.94			DATE:	May 2018
CLIENT:	Indesco Consulting Engineers Pty Ltd

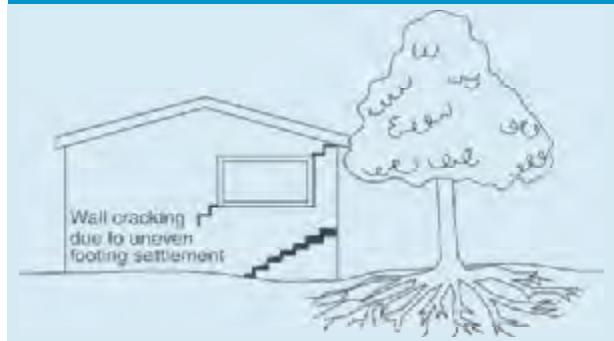
Trees can cause shrinkage and damage

As the weather pattern changes and the soil begins to dry out, the external footings will be first affected, beginning with the locations where the sun's effect is strongest. This has the effect of lowering the external footings. The doming is accentuated and cracking reduces or disappears where it occurred because of dishing, but other cracks open up. The roof lines may become convex.
