SITE CLASSIFICATION REPORT SUMMARY

BLOCK: 1 **SECTION:** 47 **SUBURB:** Denman Prospect
JOB No: 46231.94 **DATE:** May 2018
CLIENT: Indesco Consulting Engineers Pty Ltd

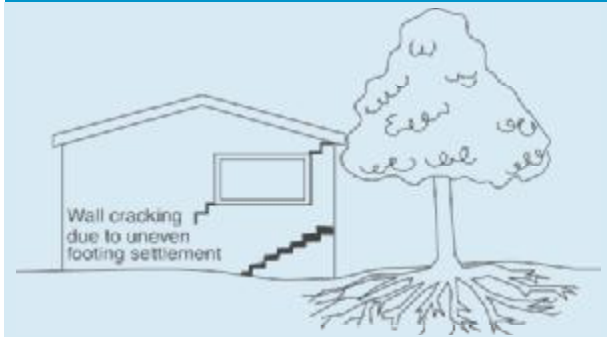
Trees can cause shrinkage and damage

Movement caused by tree roots

Uphoal caused by growth of tree roots under footings is not a simple vertical shear stress. There is a tendency for the root to also exert lateral forces that attempt to separate sections of brickwork after initial cracking has occurred.
