SITE CLASSIFICATION REPORT SUMMARY

BLOCK:	2	SECTION:	58	SUBURB:	Denman Prospect
JOB No:	46231.94			DATE:	May 2018
CLIENT:	Indesco Consulting Engineers Pty Ltd

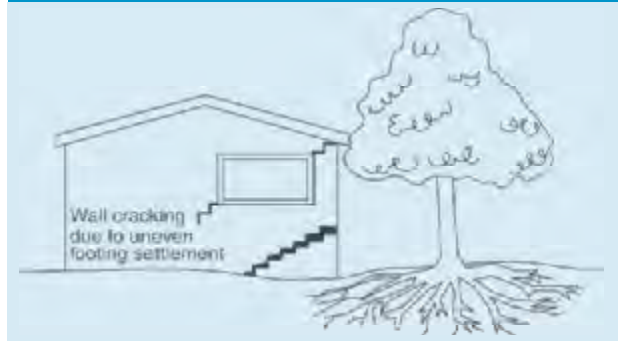
Trees can cause shrinkage and damage

As the moisture absorption process completes its journey to the innermost areas of the building, the internal footings will rise. If the spread of moisture is roughly even, it may be that the symptoms will temporarily disappear, but it is more likely that swelling will be uneven, creating a difference rather than a disappearance in symptoms. In buildings with timber flooring supported by bearers and joists, the isolated piers will rise more easily than the strip footings or piers under walls, creating noticeable doming of flooring.

As the weather pattern changes and the soil begins to dry out, the external footings will be first affected, beginning with the locations where the sun's effect is strongest. This has the effect of lowering the external footings. The doming is accentuated and cracking reduces or disappears where it occurred because of dishing, but other cracks open up. The roof lines may become convex.

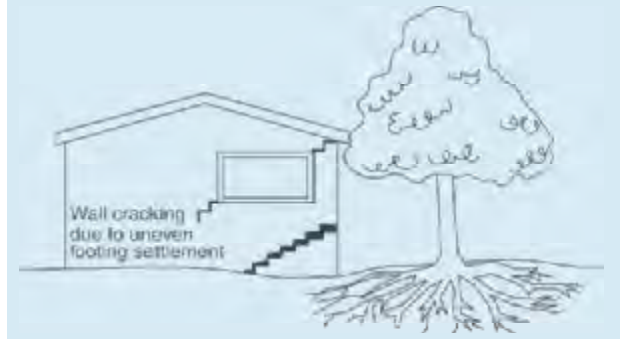
Trees can cause shrinkage and damage

As the moisture absorption process completes its journey to the innermost areas of the building, the internal footings will rise. If the spread of moisture is roughly even, it may be that the symptoms will temporarily disappear, but it is more likely that swelling will be uneven, creating a difference rather than a disappearance in symptoms. In buildings with timber flooring supported by bearers and joists, the isolated piers will rise more easily than the strip footings or piers under walls, creating noticeable doming of flooring.

As the weather pattern changes and the soil begins to dry out, the external footings will be first affected, beginning with the locations where the sun's effect is strongest. This has the effect of lowering the external footings. The doming is accentuated and cracking reduces or disappears where it occurred because of dishing, but other cracks open up. The roof lines may become convex.

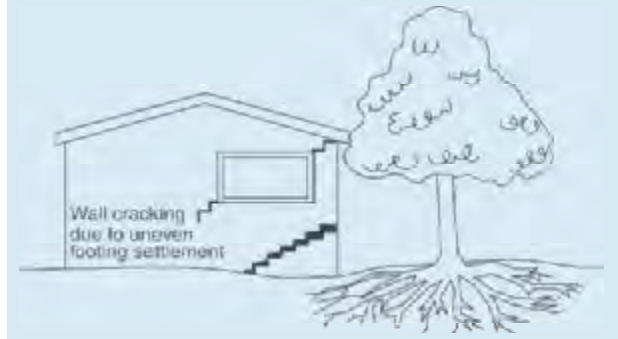
Trees can cause shrinkage and damage

As the moisture absorption process completes its journey to the innermost areas of the building, the internal footings will rise. If the spread of moisture is roughly even, it may be that the symptoms will temporarily disappear, but it is more likely that swelling will be uneven, creating a difference rather than a disappearance in symptoms. In buildings with timber flooring supported by bearers and joists, the isolated piers will rise more easily than the strip footings or piers under walls, creating noticeable doming of flooring.

As the weather pattern changes and the soil begins to dry out, the external footings will be first affected, beginning with the locations where the sun's effect is strongest. This has the effect of lowering the external footings. The doming is accentuated and cracking reduces or disappears where it occurred because of dishing, but other cracks open up. The roof lines may become convex.

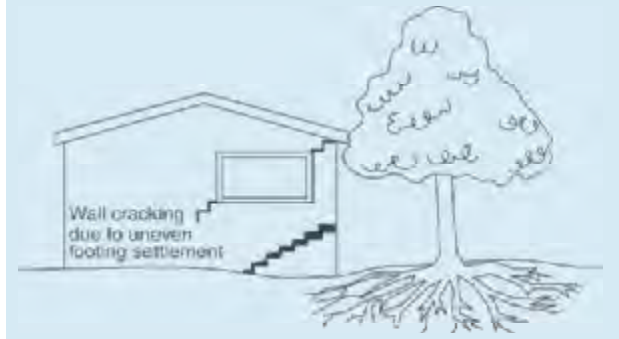
Trees can cause shrinkage and damage

As the moisture absorption process completes its journey to the innermost areas of the building, the internal footings will rise. If the spread of moisture is roughly even, it may be that the symptoms will temporarily disappear, but it is more likely that swelling will be uneven, creating a difference rather than a disappearance in symptoms. In buildings with timber flooring supported by bearers and joists, the isolated piers will rise more easily than the strip footings or piers under walls, creating noticeable doming of flooring.

As the weather pattern changes and the soil begins to dry out, the external footings will be first affected, beginning with the locations where the sun's effect is strongest. This has the effect of lowering the external footings. The doming is accentuated and cracking reduces or disappears where it occurred because of dishing, but other cracks open up. The roof lines may become convex.
