SITE CLASSIFICATION REPORT SUMMARY

BLOCK: 1 **SECTION:** 60 **SUBURB:** Denman Prospect
JOB No: 46231.94 **DATE:** May 2018
CLIENT: Indesco Consulting Engineers Pty Ltd

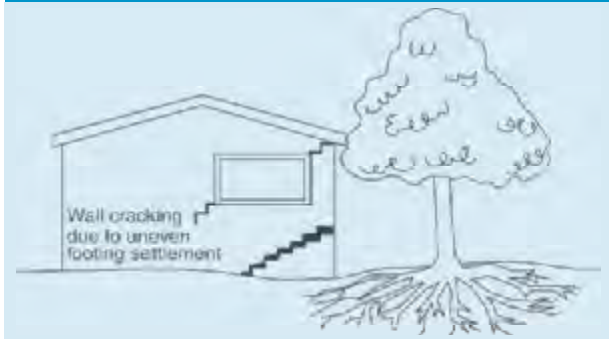
Trees can cause shrinkage and damage

As the moisture absorption process completes its journey to the innermost areas of the building, the internal footings will rise. If the spread of moisture is roughly even, it may be that the symptoms will temporarily disappear, but it is more likely that swelling will be uneven, creating a difference rather than a disappearance in symptoms. In buildings with timber flooring supported by bearers and joists, the isolated piers will rise more easily than the strip footings or piers under walls, creating noticeable doming of flooring.

As the weather pattern changes and the soil begins to dry out, the external footings will be first affected, beginning with the locations where the sun's effect is strongest. This has the effect of lowering the external footings. The doming is accentuated and cracking reduces or disappears where it occurred because of dishing, but other cracks open up. The roof lines may become convex.

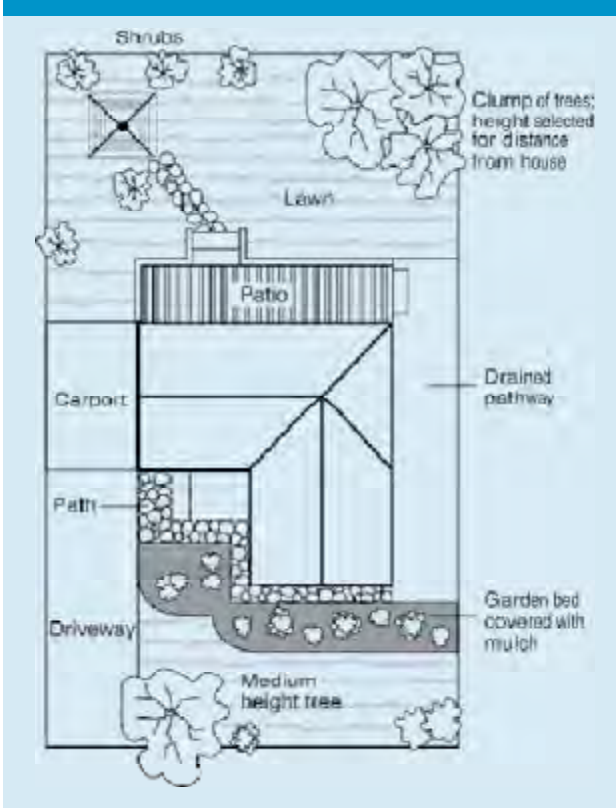
Gardens for a reactive site

For this reason, particularly where problems exist or are likely to occur, it is recommended that an apron of paving be installed around as much of the building perimeter as necessary. This paving

should extend outwards a minimum of 900 mm (more in highly reactive soil) and should have a minimum fall away from the building of 1:60. The finished paving should be no less than 100 mm below brick vent bases.

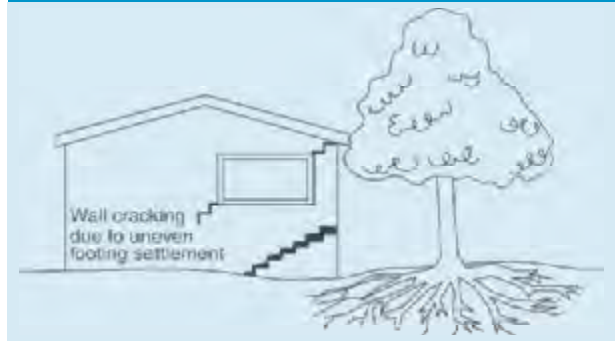
Trees can cause shrinkage and damage

As the moisture absorption process completes its journey to the innermost areas of the building, the internal footings will rise. If the spread of moisture is roughly even, it may be that the symptoms will temporarily disappear, but it is more likely that swelling will be uneven, creating a difference rather than a disappearance in symptoms. In buildings with timber flooring supported by bearers and joists, the isolated piers will rise more easily than the strip footings or piers under walls, creating noticeable doming of flooring.

As the weather pattern changes and the soil begins to dry out, the external footings will be first affected, beginning with the locations where the sun's effect is strongest. This has the effect of lowering the external footings. The doming is accentuated and cracking reduces or disappears where it occurred because of dishing, but other cracks open up. The roof lines may become convex.

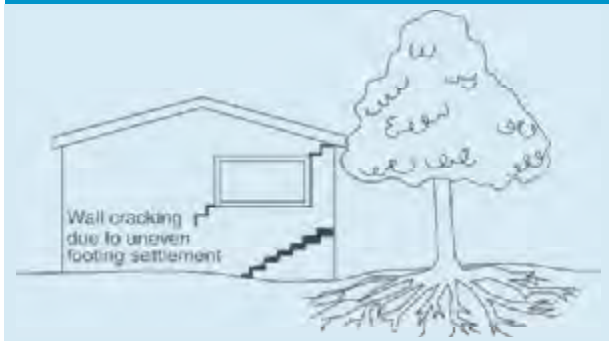
Trees can cause shrinkage and damage

As the moisture absorption process completes its journey to the innermost areas of the building, the internal footings will rise. If the spread of moisture is roughly even, it may be that the symptoms will temporarily disappear, but it is more likely that swelling will be uneven, creating a difference rather than a disappearance in symptoms. In buildings with timber flooring supported by bearers and joists, the isolated piers will rise more easily than the strip footings or piers under walls, creating noticeable doming of flooring.

As the weather pattern changes and the soil begins to dry out, the external footings will be first affected, beginning with the locations where the sun's effect is strongest. This has the effect of lowering the external footings. The doming is accentuated and cracking reduces or disappears where it occurred because of dishing, but other cracks open up. The roof lines may become convex.

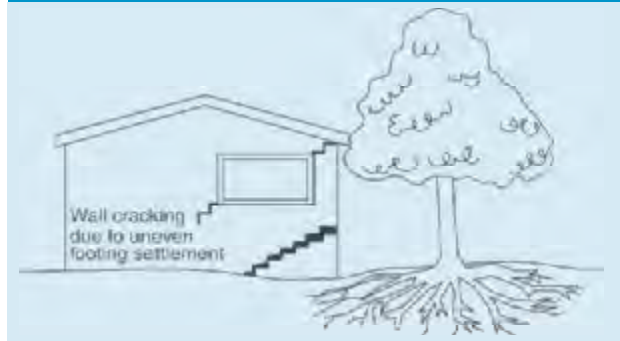
Trees can cause shrinkage and damage

As the moisture absorption process completes its journey to the innermost areas of the building, the internal footings will rise. If the spread of moisture is roughly even, it may be that the symptoms will temporarily disappear, but it is more likely that swelling will be uneven, creating a difference rather than a disappearance in symptoms. In buildings with timber flooring supported by bearers and joists, the isolated piers will rise more easily than the strip footings or piers under walls, creating noticeable doming of flooring.

As the weather pattern changes and the soil begins to dry out, the external footings will be first affected, beginning with the locations where the sun's effect is strongest. This has the effect of lowering the external footings. The doming is accentuated and cracking reduces or disappears where it occurred because of dishing, but other cracks open up. The roof lines may become convex.
