SITE CLASSIFICATION REPORT SUMMARY

BLOCK:	1	SECTION:	109	SUBURB:	Denman Prospect
JOB No:	88231.54			DATE:	December 2023
CLIENT:	Capital Estate Developments Pty Ltd			REV:	0
Classification Procedures: Existing Subsurface Conditions: Refer attached test pit log(s) – Pit(s) 28,29 and Drawing 1. Bulk Earthworks: Controlled fill within the block was placed under Level 1 control as defined in AS 3798:2007. Laboratory Results: Previous laboratory testing results indicated liquid limit ranging from 25-80%, plasticity index ranging from 12-57%, and linear shrinkage ranging from 6-20%.					
Site Classification: Site classification in accordance with AS2870:2011 provides guidance on the patterns and magnitude of moisture related seasonal ground movements that must be considered in design. Based on the current soil profile / state, on limited subsurface information, soil reactivity and allowing for variation in the subsoil profile, the soil profile would be equivalent to Class M* (moderately reactive/filled) conditions. The site classification must be reassessed should the subsurface profile change by either cutting or filling and/or if the presence of service trenches, retaining walls or sub

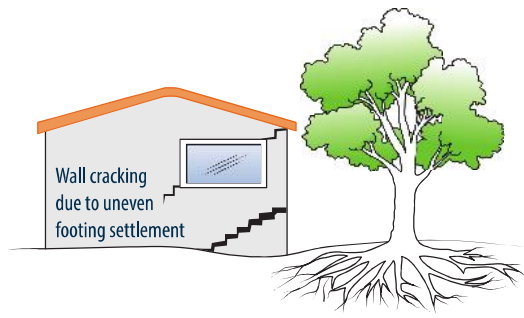
FIGURE 1 Trees can cause shrinkage and damage.

- ▶ Roots in the vicinity of footings will absorb much of the moisture in the foundation soil, causing shrinkage or subsidence.

FIGURE 1 Trees can cause shrinkage and damage.

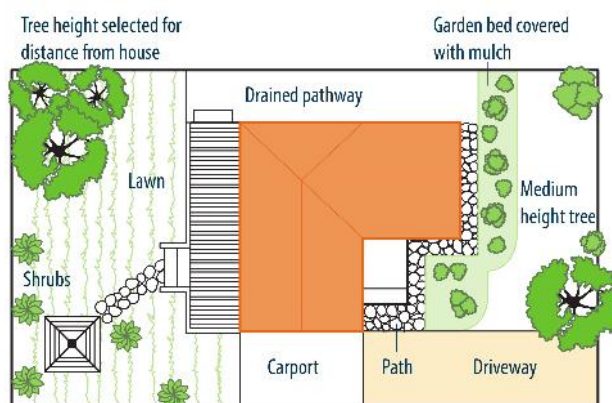
FIGURE 2 Gardens for a reactive site.

FIGURE 2 Gardens for a reactive site.
