Lessons learned from *in situ* corrosion experiments in the HADES URL

From: Li, X. L., Van Geet, M., Bruggeman, C. and De Craen, M. (eds) 2023. *Geological Disposal of Radioactive Waste in Deep Clay Formations: 40 Years of RD&D in the Belgian URL HADES*. Geological Society, London, Special Publications, **536**, 93–130.

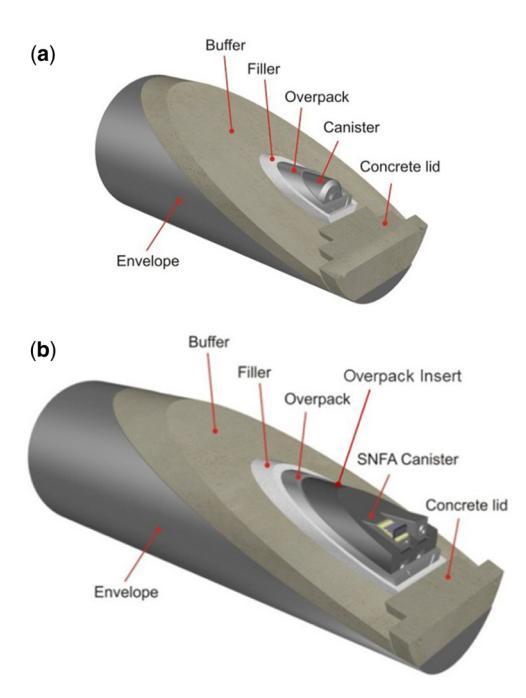
Fig. 1. Drawing of a supercontainer containing (a) two vitrified high-level waste canisters and (b) four spent fuel assemblies (ONDRAF/NIRAS 2019). SNFA, spent nuclear fuel assembly.

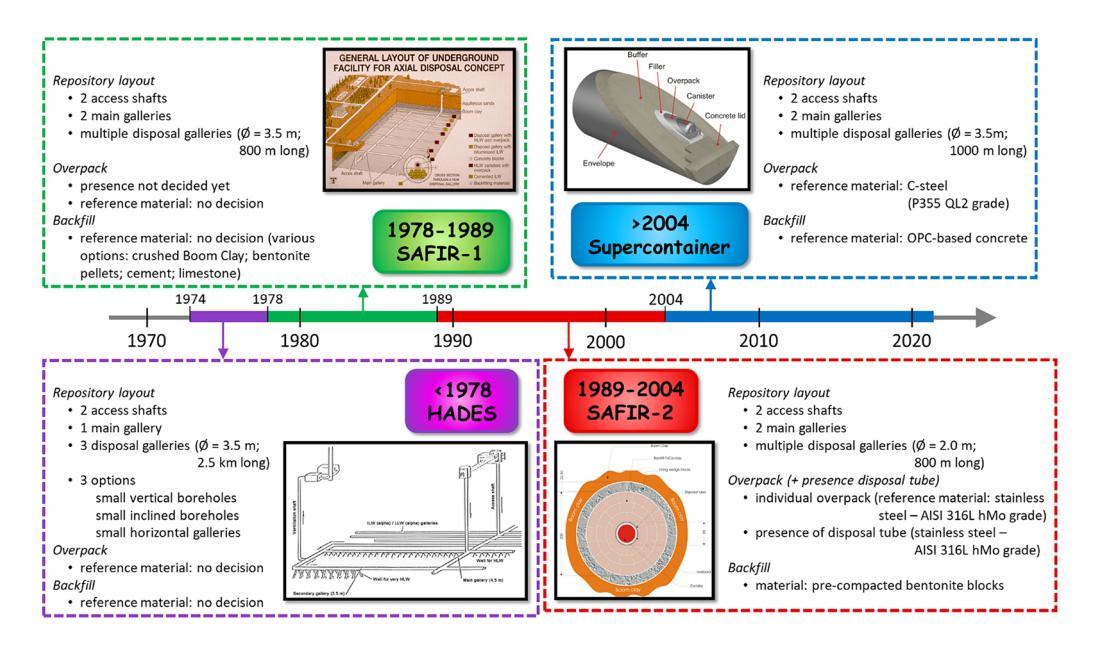
Fig. 2. Schematic representation of the evolution of the disposal concepts and repository designs over time. OPC, ordinary Portland cement.

However, the disposal concept and the repository design have evolved quite a lot over the past 40–50 years (Fig. 2). This has greatly affected the experimental approach adopted for the corrosion studies. The *in situ* corrosion experiments presented in this paper were conceived based on the SAFIR-2 design (Fig. 3). This design was developed in the late 1980s and remained the reference design until

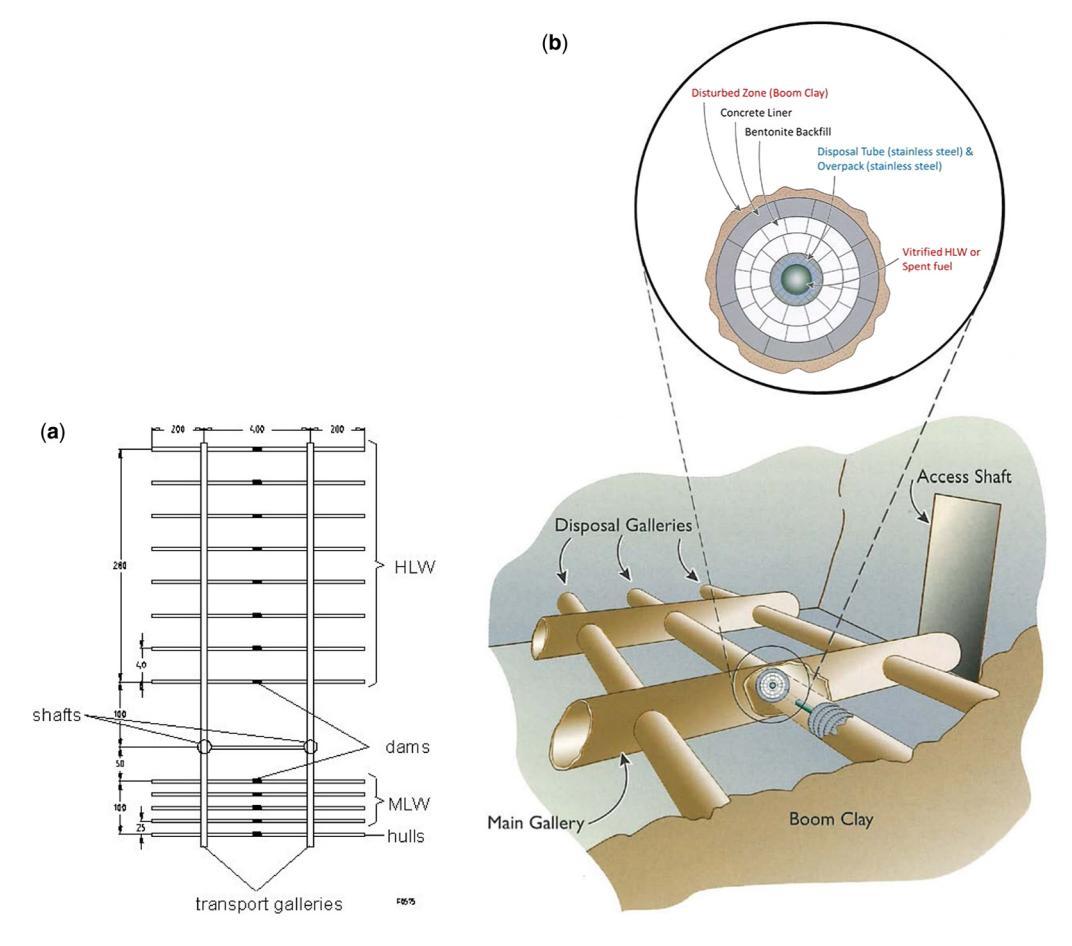
Fig. 3. Schematic view of (**a**) the repository architecture and (**b**) the disposal concept according to the SAFIR-2 reference design (before 2004) (Mallants *et al.* 2001; Neerdael and Volckaert 2001).

about 2004. In this design, the layout of the DGR consisted of a horizontal network of rectilinear disposal galleries ($\emptyset_{int} = 2 \text{ m}$) constructed in the mid-plane of the Boom Clay Formation. The disposal galleries could be as long as 800 m. Two main galleries ($Ø_{int}$ = 3.5 m) connected the disposal galleries to two vertical access shafts ($\emptyset_{int} \approx 6$ m). The access shafts and the disposal galleries would be lined with concrete segments in order to ensure the mechanical stability during the operational phase of the repository. In the centre of the disposal gallery, a stainless steel disposal tube ($\emptyset_{int} = 0.55$ m, wall thickness c. 10 mm) would be installed. Pre-compacted clay-based backfill blocks would fill the gap between the central disposal tube and the gallery lining. The primary waste packages (either vitrified HLW canisters or SF assemblies) would be enclosed in a 30 mm-thick individual stainless steel overpack, which in turn would be pushed into the stainless steel disposal tube using an automated system (pusher robot)

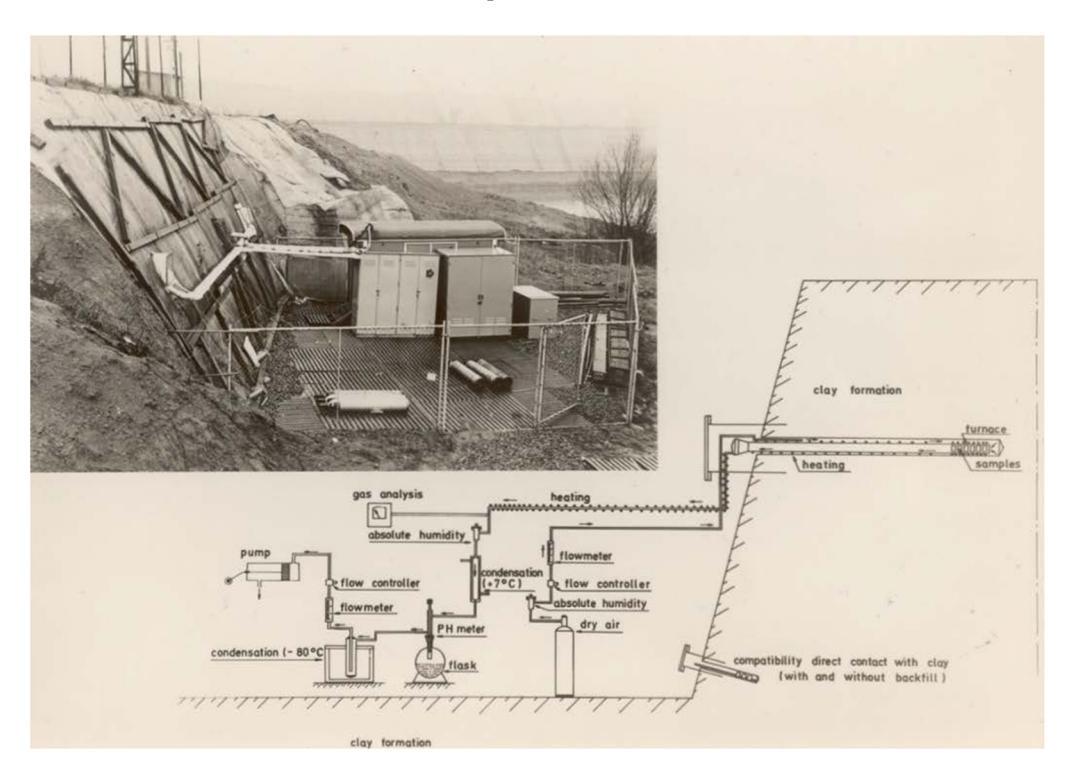
Fig. 4. View of the test site (top left) and the experimental set-up (bottom right) of the 'field' experiments carried out in a surface clay quarry at Terhaegen, Belgium (Shahid 1980).

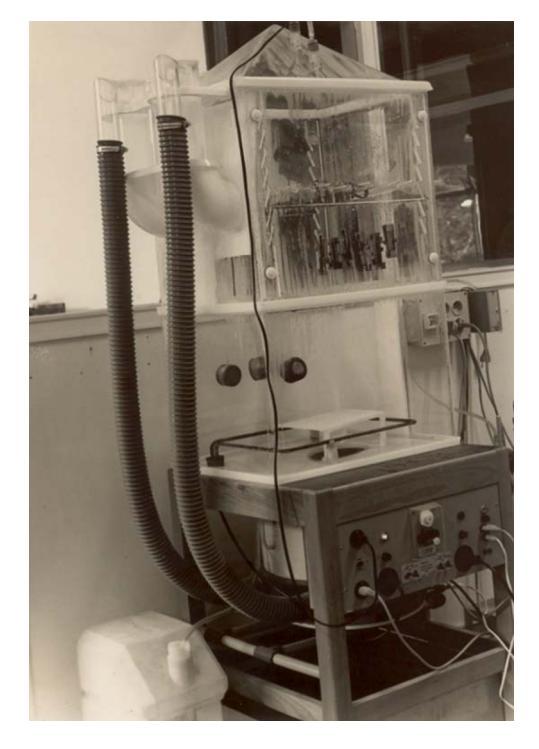
Fig. 5. Experimental set-up used to perform corrosion experiments in a humid clay atmosphere (Shahid 1980).

various specimens is shown in Figure 5. The tests at 150 and 300°C were performed in inert furnaces in which $14.51 h^{-1}$ of air loaded with 3.5 ml h^{-1} of moisture was injected (Casteels *et al.* 1980, 1981; Shahid 1980; Dresselaers *et al.* 1982; Accary 1985; Dresselaers and Tas 1985; Haijtink 1985; Tas *et al.* 1987).

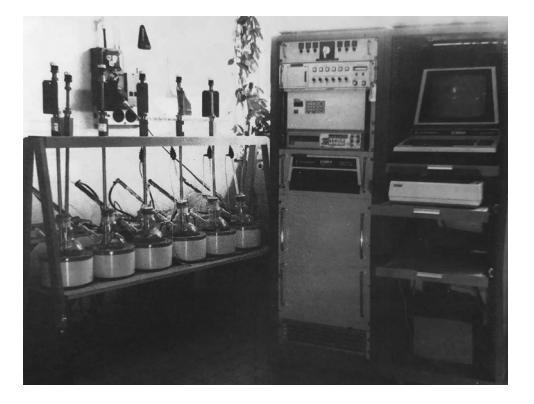
Fig. 6. Experimental set-up used to conduct the corrosion experiments in interstitial clay water and Antwerpian groundwater (Casteels *et al.* 1985; Haijtink 1985).

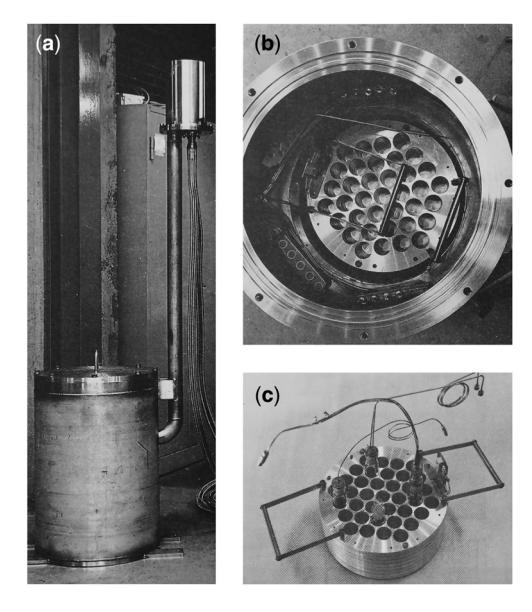
Fig. 7. Experimental set-up used to perform the corrosion tests under γ radiation: (a) outer watertight stainless steel container, (b) inside view of the stainless steel container (with sample basket) and (c) inner aluminium sample basket (with mounting of some Pyrex[®] flasks) (Haijtink 1986).

in which an inner sample basket is inserted. The sample basket is made up of several aluminium plates that are stacked on top of each other. Heating was achieved by means of electrical resistance wires that were fixed between the aluminium plates. Cylindrical holes (37 in total) were drilled in the aluminium plates to house the different test assemblies. The test assemblies consisted of Pyrex[®] flasks that were filled with the corrosive media and in which the metallic samples were placed. Figure 7 illustrates the set-up used to perform the corrosion tests under γ radiation (Haijtink 1985, 1986; Debruyn *et al.* 1987, 1988).

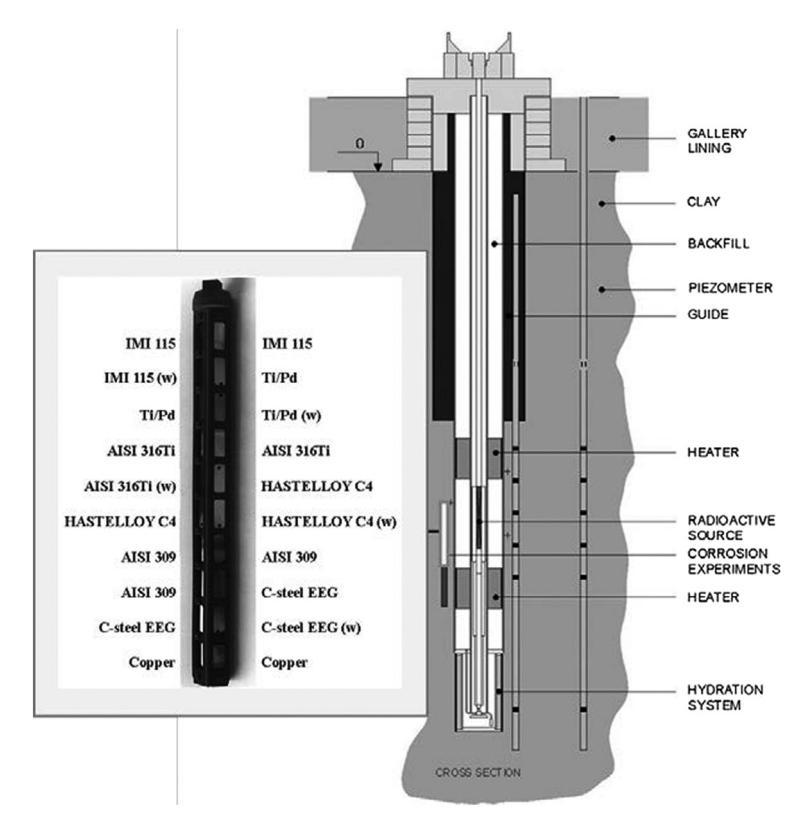
Fig. 8. Design of the CERBERUS in situ experiment (Van Iseghem et al. 2003).

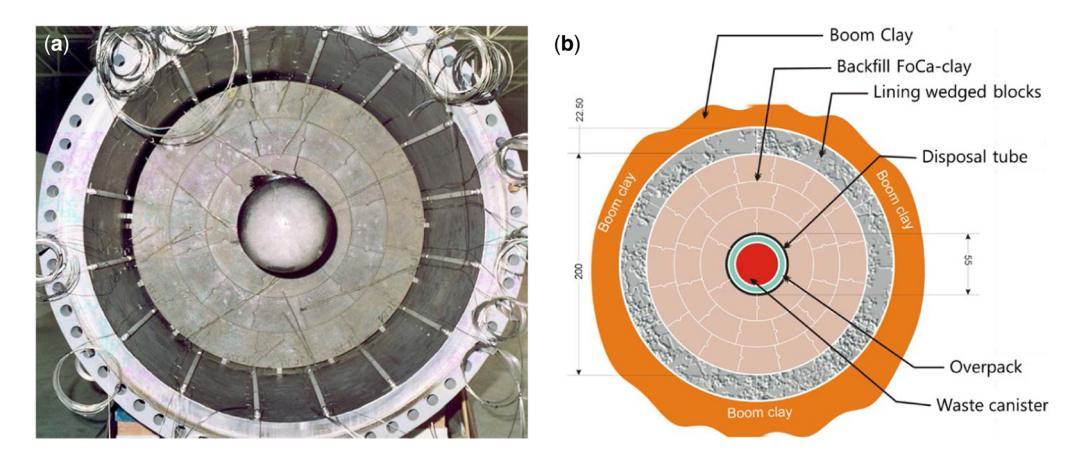
Fig. 9. The on-surface OPHELIE mock-up experiment: (**a**) general view of the cross-section of the mock-up during assembly (showing the backfill blocks, the hydration tubes, the disposal tube and the sensor cabling) and (**b**) schematic view of the cross-section of a HLW disposal gallery (according to the SAFIR-2 reference design) (Kursten and Druyts 2005).

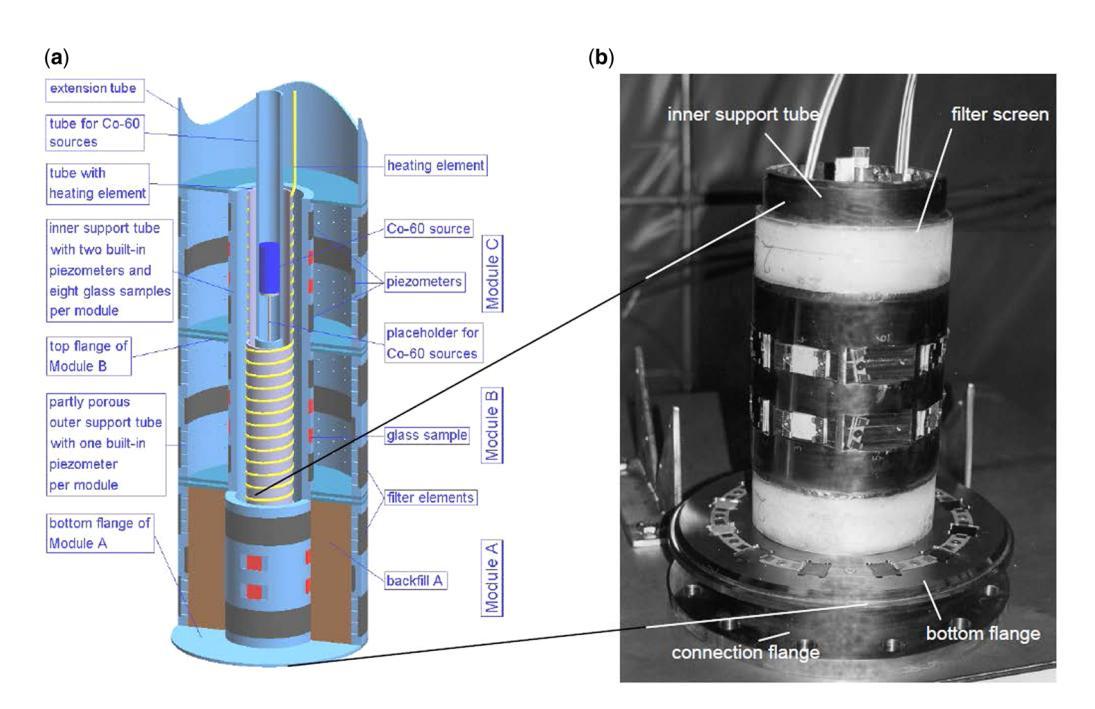
Fig. 10. The CORALUS *in situ* experiment: (a) three-dimensional cutaway of a test tube with 60° C sources and (b) general view of one module showing the inner support tube, bottom flange and connection flange of the module (Valcke *et al.* 2006).

samples in direct contact with a backfill material. Each test tube was divided into three independent modules. Each module consisted of an inner support tube with flanges and an outer support tube with permeable filter elements. The residual space between the inner and outer support tubes was filled with a different type of backfill material (pre-compacted semi-cylindrical blocks):

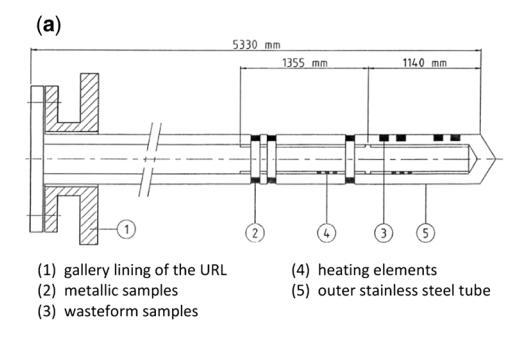
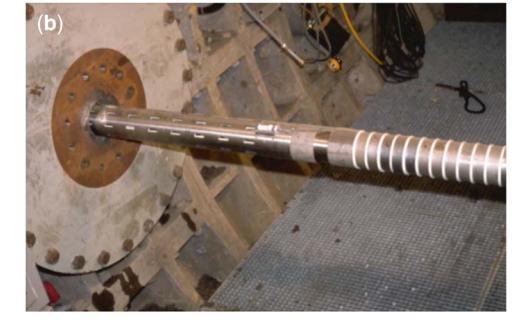
Fig. 11. Images of an *in situ* Type I corrosion test tube (direct contact with clay): (a) schematic drawing of the tube and (b) general view of the tube during installation in the HADES URL (Kursten *et al.* 2004c).

The Type I corrosion test tubes were inserted horizontally into the clay formation. They were connected to the cast-iron linings of the experimental gallery via 76 cm flanges. The tubes were heated by a retractable furnace situated in the tube interior. The furnace consisted of heating wires wound spirally around a stainless steel support tube. The metallic samples were fixed at the outside of the tubes. A schematic drawing of the Type I test tubes together with a photograph taken during installation in the

HADES URL are presented in Figure 11 (Debruyn et al. 1986; Haijtink 1986; Debruyn and Tas 1988; Van Iseghem et al. 1993; Kursten et al. 1997; Kursten and Van Iseghem 1998b, 1999).

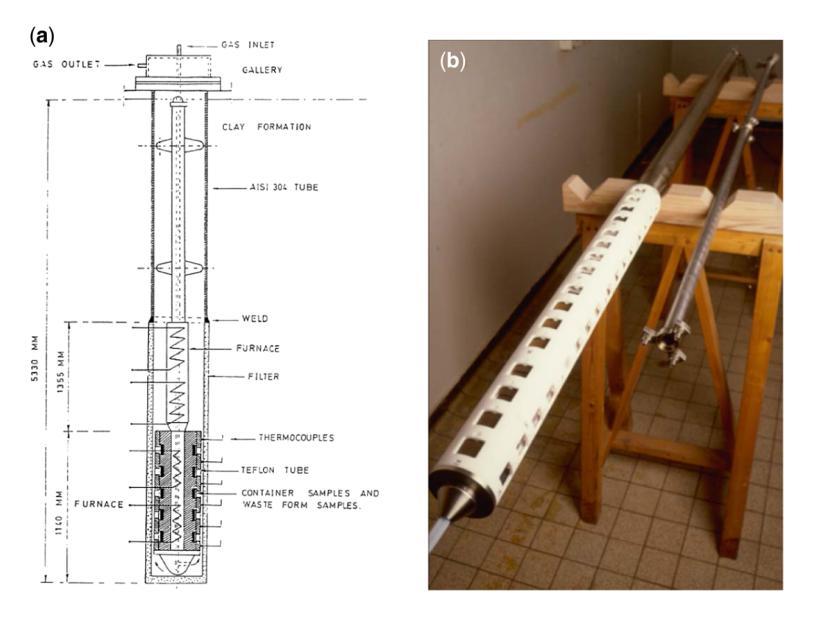
Fig. 12. Images of the second generation *in situ* Type II corrosion test tube (interaction with a humid clay atmosphere: (**a**) schematic drawing of the tube and (**b**) general view of the Teflon[®] holder on which the samples (metallic and wasteform samples) were mounted (Kursten *et al.* 1996).

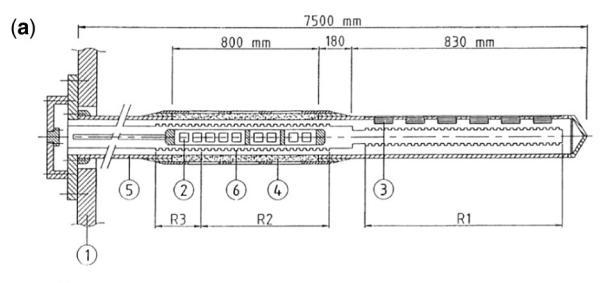
(1) gallery lining of the URL

(5) outer stainless steel tube

(6) heating elements

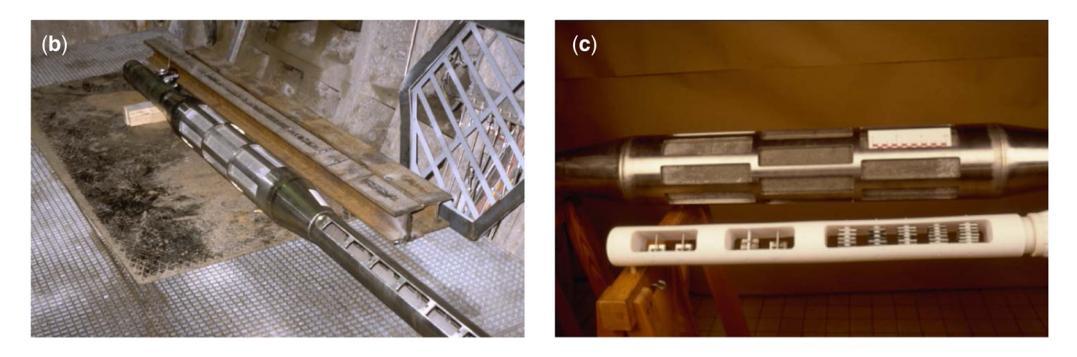
Fig. 13. Images of an *in situ* Type III corrosion test tube (interaction with a concrete-saturated clay atmosphere: (**a**) schematic drawing of the tube, (**b**) general view of the entire tube and (**c**) general view of the Teflon[®] holder on which the samples (metallic and wasteform samples) were mounted (Kursten *et al.* 1996).

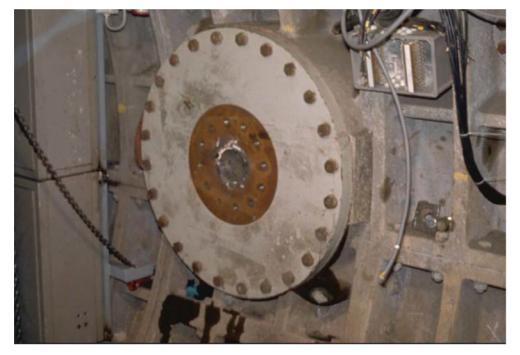
Drilling a borehole and connecting the flange to the gallery lining of the URL.

Fig. 14. Installation procedure of the Type I corrosion experiments in the HADES URL (Kursten and Van Iseghem 1998b).

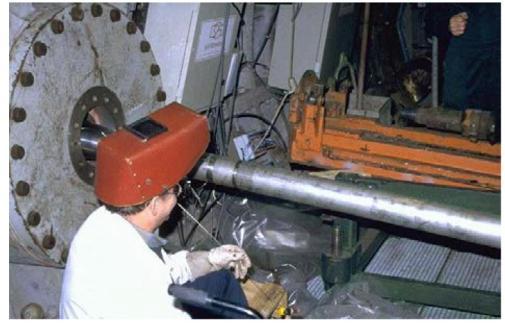
Welding an extension tube to the stainless steel carrier tube for connection to the gallery lining.

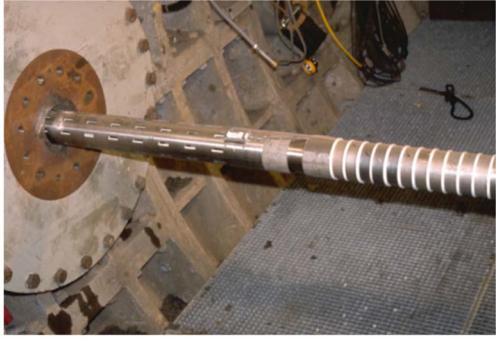
Introducing the stainless steel carrier tube loaded with the overpack and wasteform samples in the borehole.

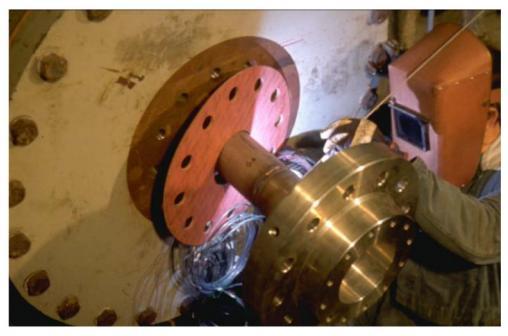
Welding the steel extension tube to a smaller flange for fixation to the gallery lining.

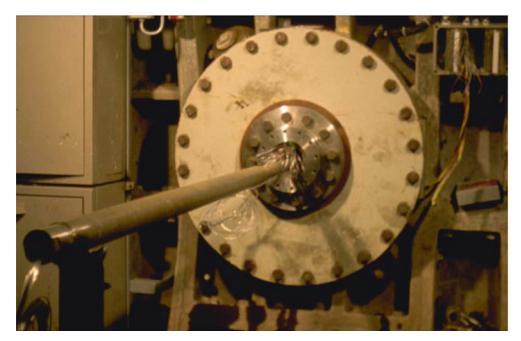
Inserting a retractable furnace in the interior of the stainless steel carrier tube.

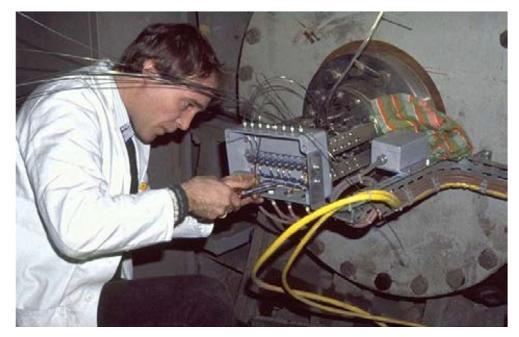
Making the electrical connections (heating elements, measuring devices).

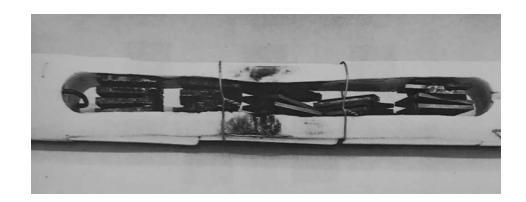
Fig. 16. Teflon[®] sample holder of the originally designed Type II corrosion test tube No. 8 after retrieval after exposure to a humid clay atmosphere for 4 years showing, on the left side of the photograph, the corroded carbon steel samples that are 'partially' coalesced (Kursten *et al.* 1997).

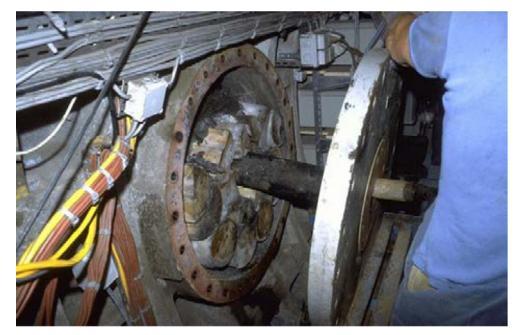
Removing the flange (after disconnecting all electrical wiring from heating elements, measuring devices, etc.).

Fig. 17. Retrieval procedure of the Type I corrosion experiments in the HADES URL (Kursten and Van Iseghem 1998b).

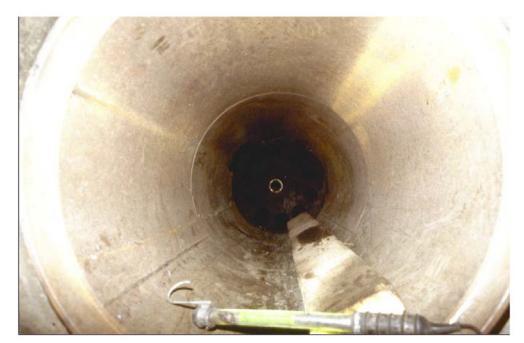
Introducing a steel casing to prevent the clay from collapsing and to provide lining.

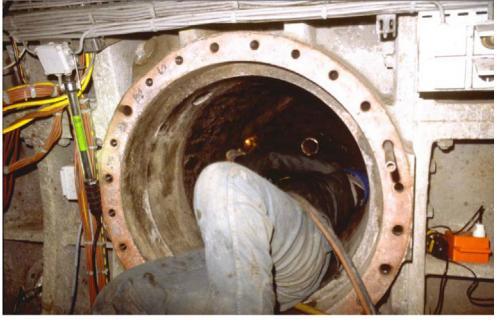
Excavating clay from the access hole up to the steel carrier tube.

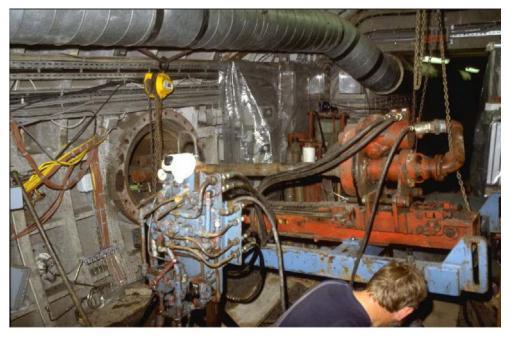
Drilling small holes at the periphery of the carrier tube. A hydraulic jack was used to push a slightly conical jacket through the weakened clay.

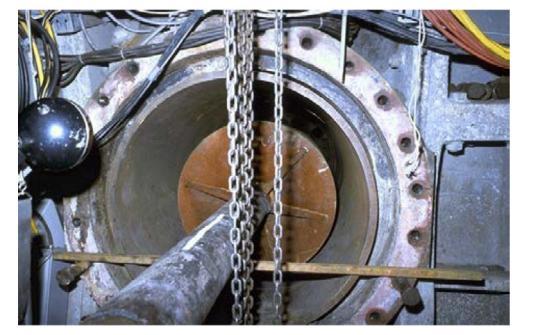
Front view of the conical jacket.

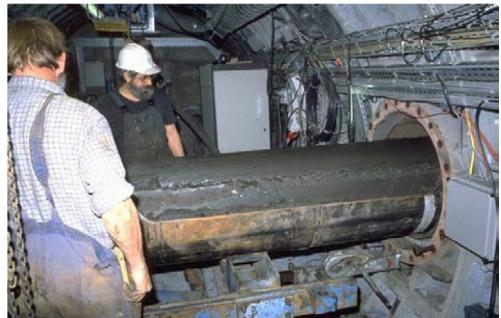
Withdrawing the steel casing containing the specimen section of the test tube embedded in a layer of clay.

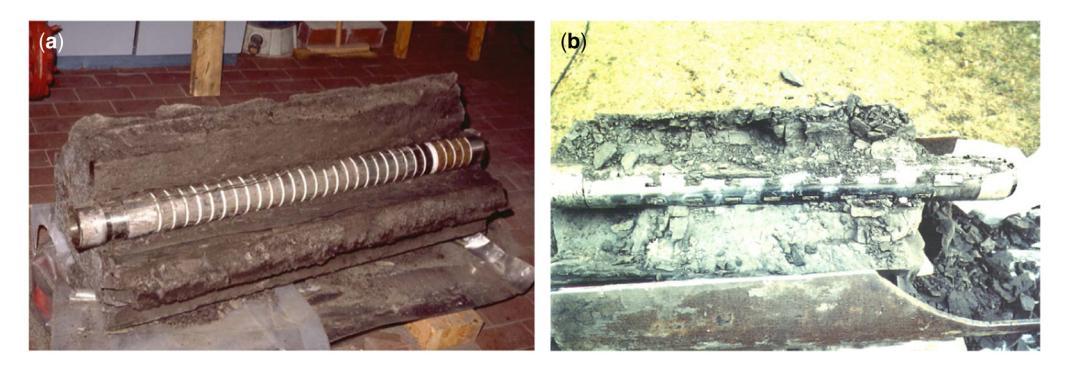
Fig. 18. Type I *in situ* corrosion test tube No. 1 (direct exposure to clay for 5.7 years, 170° C) after mechanically breaking open the clay layer: (**a**) section containing the metallic samples and (**b**) section containing the wasteform samples (Kursten *et al.* 1997).

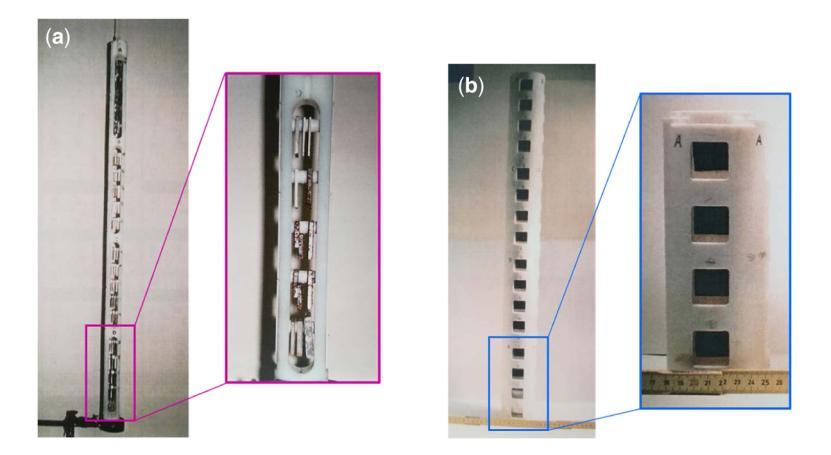
Fig. 19. Teflon[®] sample holder of the Type II *in situ* corrosion test tubes after exposure to a reducing humid clay atmosphere: (a) exposure for 2 years at 90°C, test tube No. 5b; (b) exposure for 2.5 years at 16°C, test tube No. 8b (Van Iseghem *et al.* 1999).

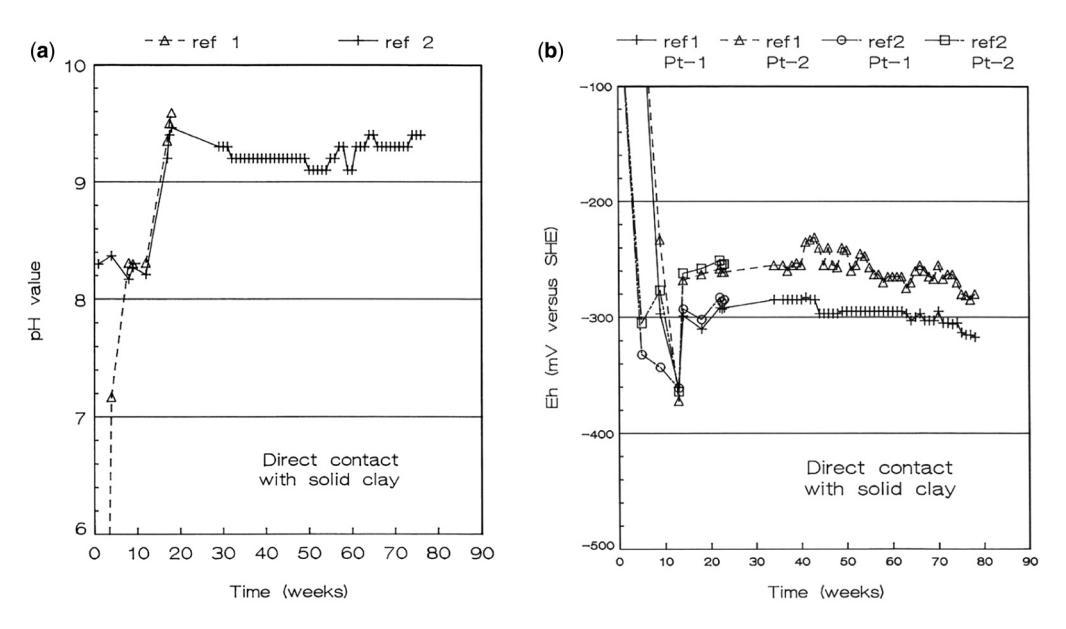
Fig. 20. Evolution of (a) pH and (b) Eh for test tube No. 4 (16°C). Measuring period: October 1986–April 1988 (Debruyn *et al.* 1991).

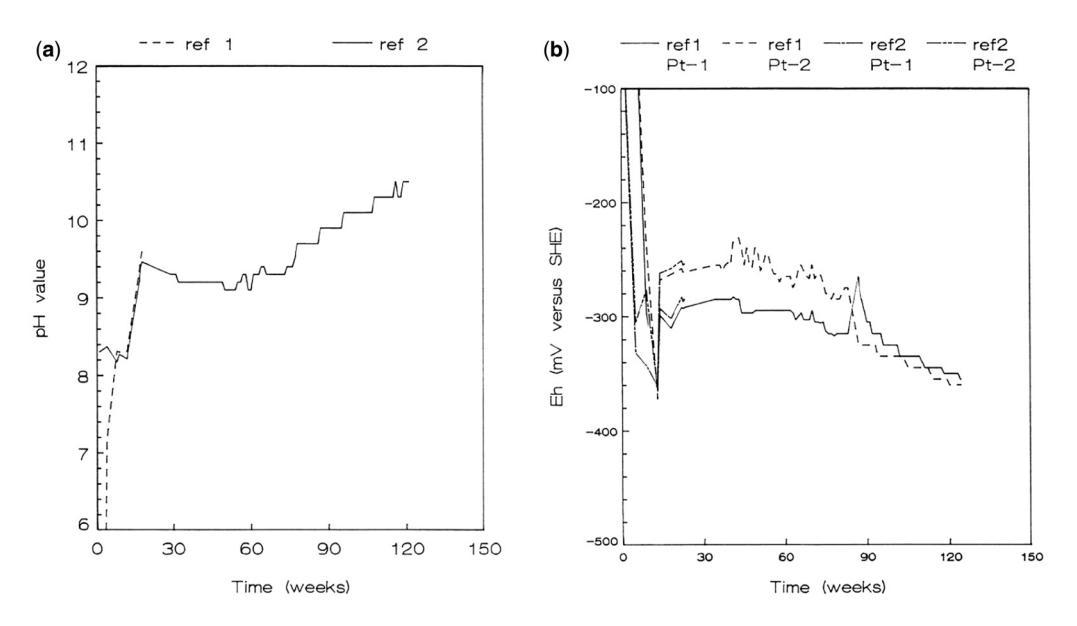
Fig. 21. Evolution of (a) pH and (b) Eh for test tube No. 4 (16°C). Measuring period: October 1986–March 1989 (Debruyn *et al.* 1991).

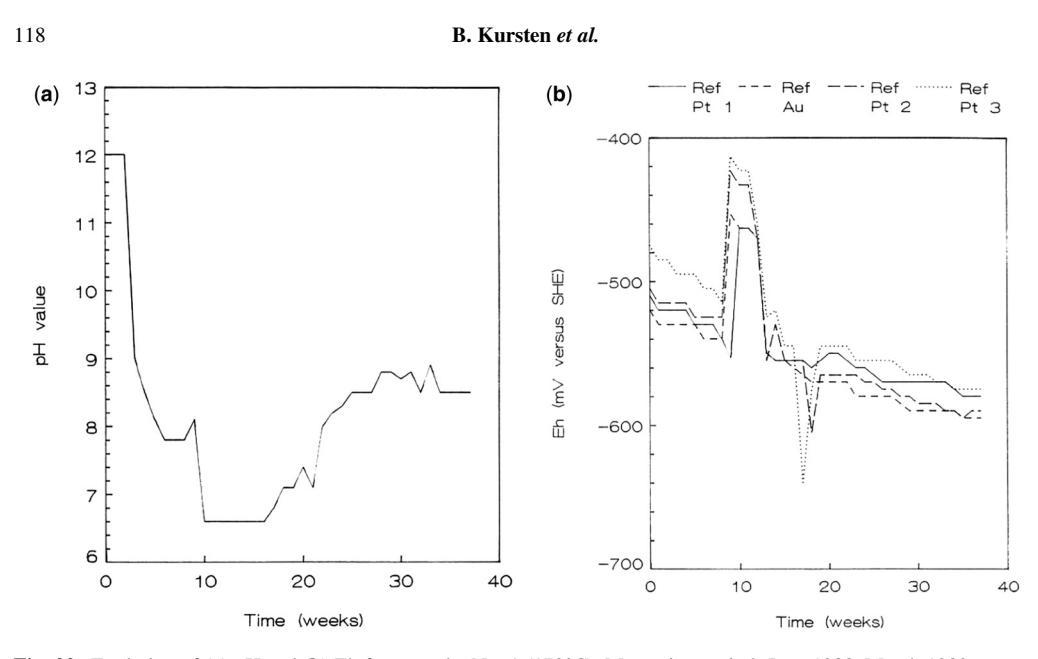
Fig. 22. Evolution of (a) pH and (b) Eh for test tube No. 1 (170°C). Measuring period: June 1988–March 1989 (Debruyn *et al.* 1991).

After relatively long exposure times (\geq 1.5 years), the pH and Eh started to drift from their stable values, and reliable values could no longer be measured. This is illustrated in Figure 21. This failure was believed to be due to a progressive poisoning effect caused by the reducing species present in the clay: the Ag⁺ ions from AgCl were being reduced to form Ag, which resulted in a final destruction of the reference electrode system. At elevated temperatures (90 and 170°C), the disintegration process of the reference electrode seemed to occur even faster. Drifting of the measured values started much earlier in the exposure period and was more accentuated than at 16°C. This is illustrated in Figure 22 (Debruyn *et al.* 1991).

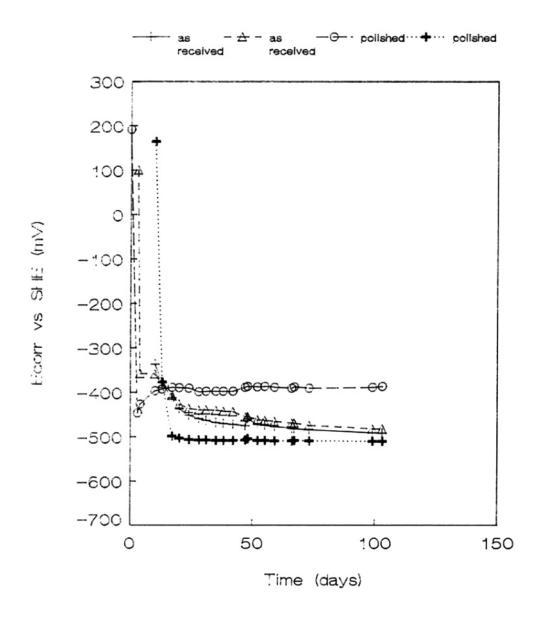
Fig. 23. Evolution of the corrosion potential, E_{CORR} , of as-received and polished carbon steel mounted on test tube No. 4 (16°C) (Debruyn *et al.* 1990*a*, *b*).

the samples were in contact with an oxidized clay environment. After 2 weeks, a steep potential drop proved that the clay became anaerobic and recovered from the drilling disturbances. All samples then evolved towards an equilibrium value of around -500 mV (v. SHE). The evolution of E_{CORR} towards negative stable values was faster for the

polished samples compared to the as-received samples (Debruyn *et al.* 1991).

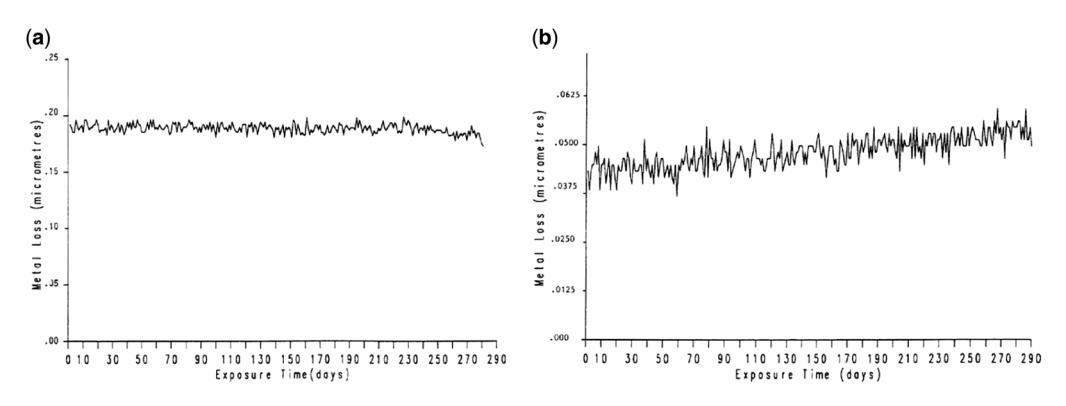
Fig. 24. Metal losses as a function of exposure time, measured with ER probes, for (a) cast iron and (b) Hastelloy C-4 (Debruyn *et al.* 1989*c*).

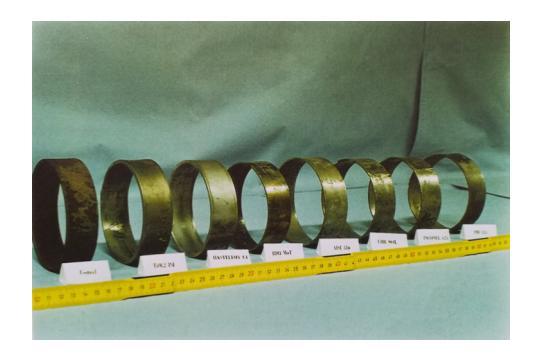
Fig. 25. Line-up of the different types of ring-shaped metallic samples loaded onto test tube No. 3 after direct exposure to Boom Clay for 7.5 years at 90°C (Kursten *et al.* 1997).

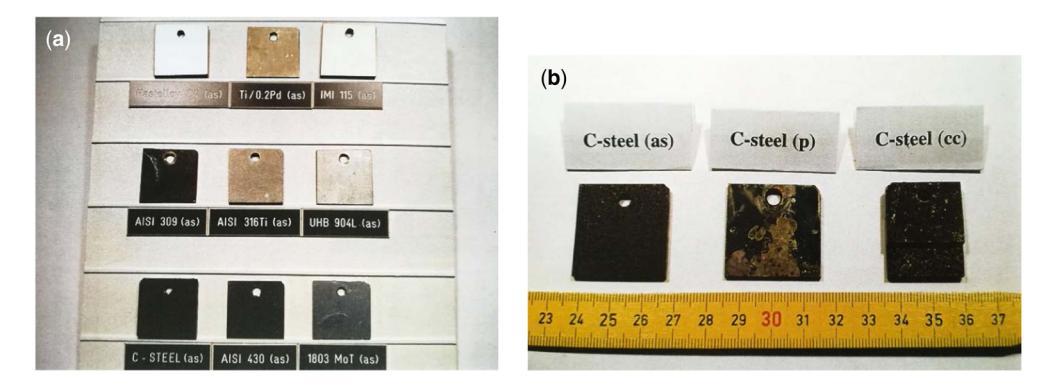
Fig. 26. Line-up of the different types of square metallic samples loaded on test tube No. 8b after exposure to a humid clay atmosphere for 2.5 years at 16°C (Kursten and Van Iseghem 1998*c*).

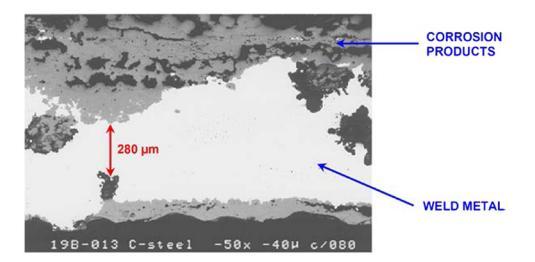
Fig. 27. Optical micrograph of the corrosion attack of a carbon steel weld exposed to clay for 5 years at 80°C and a γ -radiation dose rate of 400 Gy h⁻¹ (Noynaert 2000; Kursten *et al.* 2004*a*, *b*, *c*; Kursten and Druyts 2006).

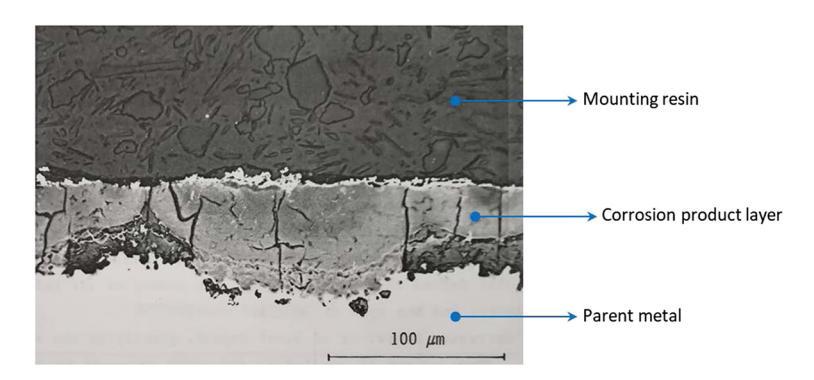
Fig. 28. Unetched polished cross-section of carbon steel after 5 years of exposure to clay at 170°C (Cornélis and Van Iseghem 1993).

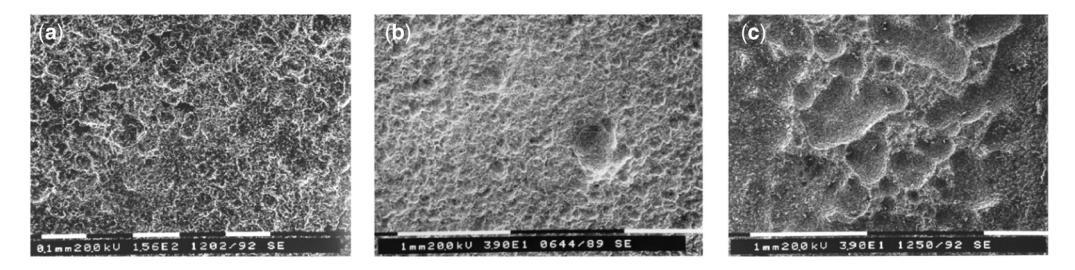
Fig. 29. SEM micrographs of the surface of chemically cleaned carbon steel samples after direct exposure to Boom Clay for (**a**) 5 years at 16° C, (**b**) 2 years at 90°C and (**c**) 5 years at 170°C (Kursten *et al.* 2004*a*, *b*, *c*).

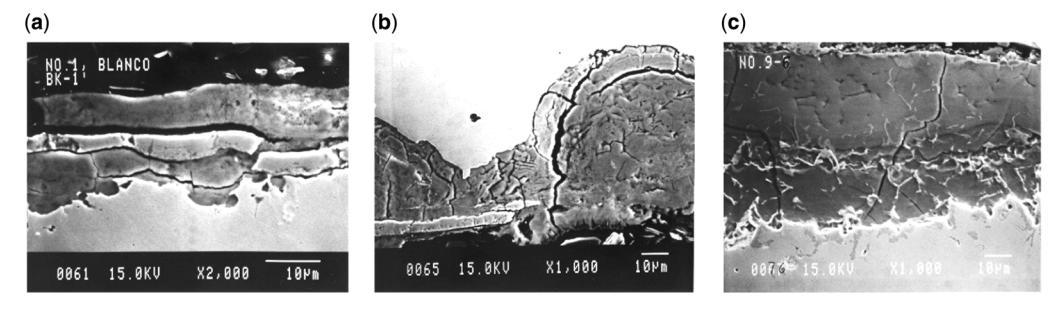
Fig. 30. EMPA micrographs of the cross-section of uncleaned carbon steel samples: (**a**) 'blank' sample (i.e. stored in the laboratory under ambient conditions), (**b**) exposed to clay for 5 years at 16° C and (**c**) exposed to clay for 5 years at 170° C (Kursten *et al.* 2004*a*, *b*, *c*).

To be able to interpret the influence of the solid clay phase on the formation of the corrosion layers, a comparison was made with corrosion layers formed on 'blank' carbon steel samples: that is, samples stored in the laboratory under ambient conditions and for approximately the same length of time. The EMPA micrographs of the cross-section of carbon steel samples exposed to ambient laboratory conditions for 5 years ('blank' sample), and to clay at 16 and 170°C are shown in Figure 30. The corrosion layer formed on the 'blank' carbon steel samples appeared on average to be about 10-20 µm thick. Moreover, the layer was subdivided into three sublayers, of which the middle one had a higher Fe/O ratio compared to the other two. It could have corresponded to a layer that was initially protective - possibly magnetite-containing (Fe₃O₄) - and had cracked, thereby allowing corrosion to proceed further, forming a hematite-type corrosion product (Fe₂O₃). This multilayered structure of the corrosion
