Stability analysis and long-term behaviour of deep tunnels in clay formations

From: Li, X. L., Van Geet, M., Bruggeman, C. and De Craen, M. (eds) 2023. *Geological Disposal of Radioactive Waste in Deep Clay Formations: 40 Years of RD&D in the Belgian URL HADES*.

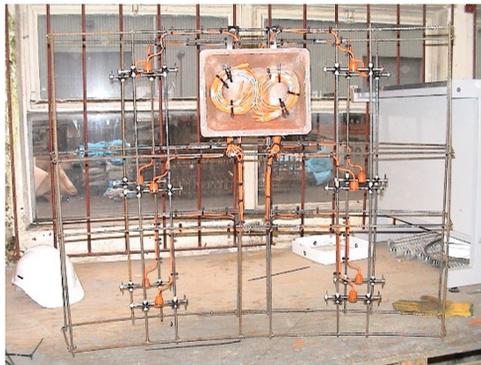
Fig. 6. Framework used to maintain the strain gauges at their position during the concrete pouring, a 12-gauge configuration (Bastiaens *et al.* 2003).

example of one instrumented cage with a 12-gauge configuration can be seen in Figure 6.

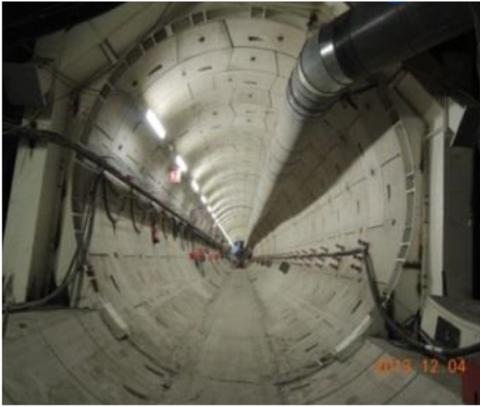
Fig. 8. View of the GRD4 gallery with the segmental concrete lining (Armand *et al.* 2015).
