# Sydney Modern Gallery

Prepared for  
Richard Crookes Constructions

15 October 2019

EA\_RAP For Construction

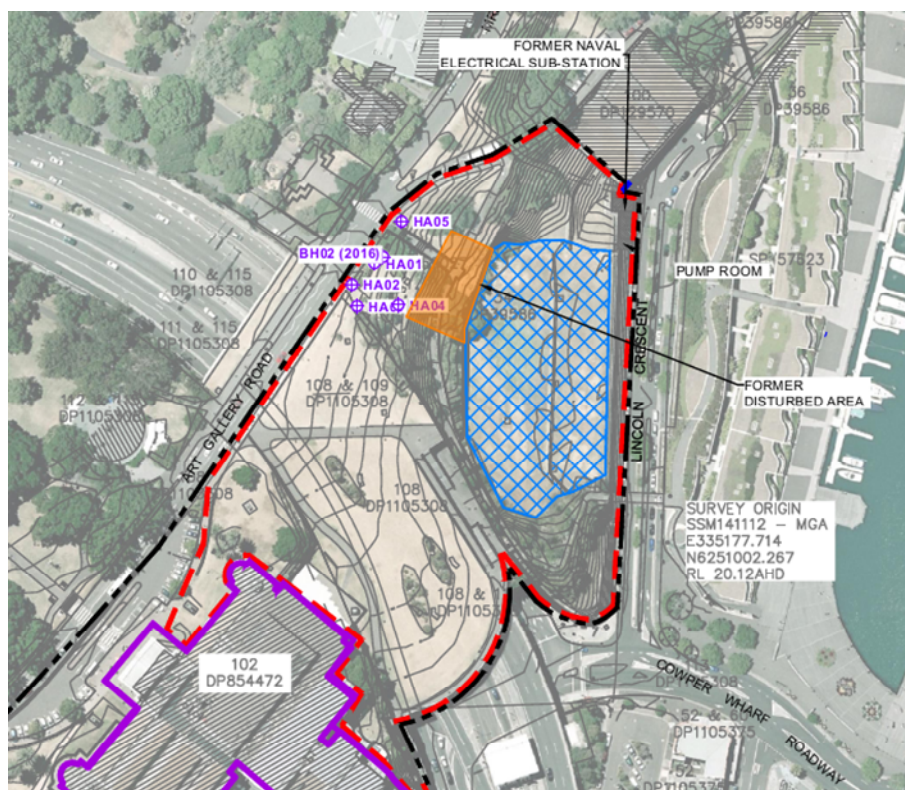
Figure 2 Area of Identified Contamination on the SMG Site

Available information indicates that the extent of the odorous contaminated soils is estimated to be 12m by 25m in area and is estimated to extend to the top of sandstone, which varies between 1.1m and 2.2m bgs. This area is shown on Figure 4, Appendix B and is approximate only<sup>2</sup>. However, it is noted that HA01 and BH02 were bored within this area in 2016 and there was no indication of the strong hydrocarbon odours observed in 2014. It is therefore considered that the odorous soils may therefore be present in discrete pockets.

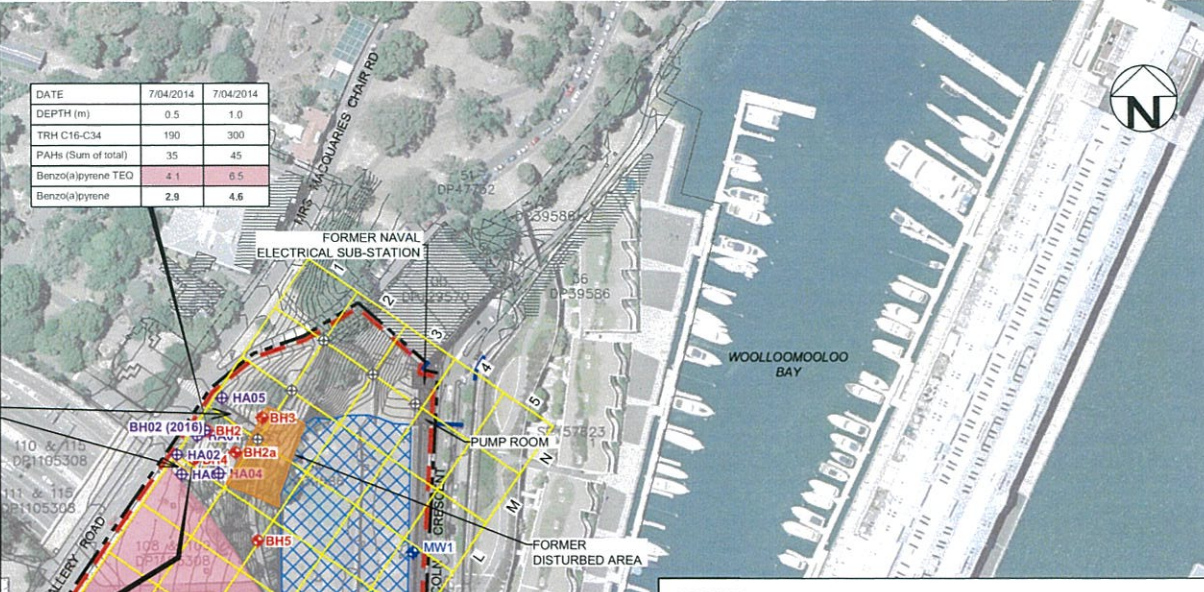
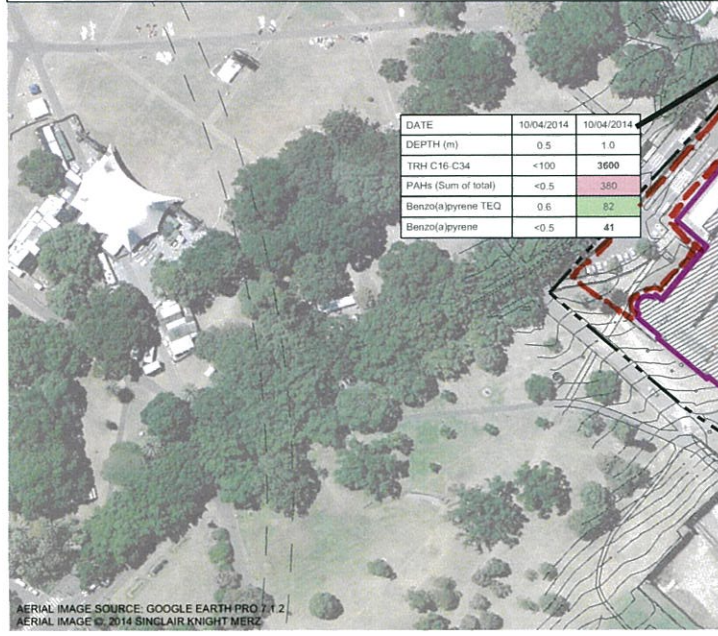
DATE	7/04/2014	7/04/2014
DEPTH (m)	0.5	1.0
TRH C16-C34	190	300
PAHs (Sum of total)	35	45
Benzo(a)pyrene TEQ	4.1	6.5
Benzo(a)pyrene	2.9	4.6

DATE	10/04/2014	10/04/2014
DEPTH (m)	0.5	1.0
TRH C16-C34	<100	3600
PAHs (Sum of total)	<0.5	380
Benzo(a)pyrene TEQ	0.6	82
Benzo(a)pyrene	<0.5	41

NEPM 2013 HILs C	NEPM 2013 HILs D	Management Limits / ESLs (Open Space)
TRH C16-C34			3500 / 300
PAHs (Sum of total)	300	4000	
Benzo(a)pyrene TEQ	3	4	
Benzo(a)pyrene			NA / 1.4

Based on currently available information, one remediation area has been identified and is shown on Figure 4, Appendix B. One additional area of potential contamination has also been identified, and delineation sampling is recommended. However, there is the potential for other (likely localised) areas of contamination to be present on the site. Validation of these areas of the site not previously assessed is outlined in Section 10.3.1.
