## **SAFETY ALERT**

## SA-229 – High Pressure Water Jet Injury

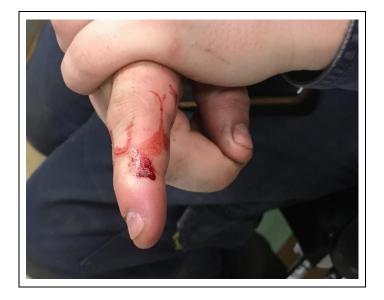
An employee had finished using a high-pressure water jet in a sewer line and was winding the hose onto the hose reel. In the process of winding the hose, the employee went to remove the nozzle when a final stream of high-pressure water was discharged into the employee's finger.

Before winding the hose the employee had turned the water pump off using a remote unit, however had not followed manufacturer's instructions and turned the ball valve off at the mini-reel to discharge any water pressure remaining in the line.

| WHAT CAN BE DONE DIFFERENTLY TO PREVENT A<br>SIMILAR INCIDENT FROM OCCURRING? | | | | | | | |
|--|--|---|--|--|--|--|--|
| POSITIONS | Check the ball valve is 'off' and read the pressure gauge on the reel to make sure it is reading '0.0' before detaching the nozzle. | | | | | | |
| PROTECTIVE | Gloves and safety glasses were worn in this<br>instance, and did provide some protection had<br>the stream of water been directed at the face<br>how\ever a face shield MUST be worn when<br>operating this equipment. | | | | | | |
