SAFETY ALERT

245 – Electrical Risks in Walls

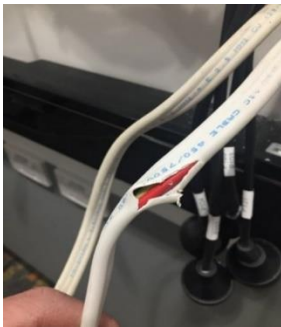
In one incident, two workers received mild electric shocks when they touched a TV mounting bracket, not knowing that the screw holding the bracket had pierced electrical cables inside the wall.

- Wherever possible, power supply should be isolated before drilling into walls.
- When mounting a bracket to a wall, calculate the thickness of the gyprock, ply and the bracket itself and choose a screw that is the closest to this thickness. This will reduce the chance of the excess screw length penetrating cables inside the wall.

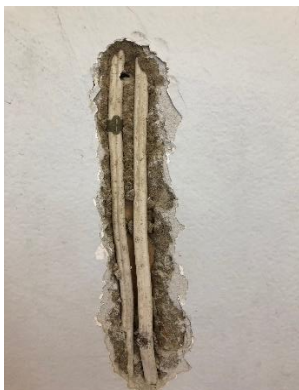
Another incident occurred while a contractor was putting up a paper towel dispenser and his drill nicked an electrical cable inside the wall. No injury occurred.

- Check architectural drawings of the building for electrical wiring. If you don't have access to the drawings, scope out where plug sockets, lights and other electrical equipment is, which will give you an idea of where cabling will be. Cables generally run above and below and then across the fixtures, so approach these areas with caution.

- Check both sides of the wall for any evidence of power such as power outlets, or electrical fittings.
- Evidence that the wall has been re-rendered is also a sign that there could be cables within the wall.

- Use of a battery drill will reduce the risk of injury if the drill does come into contact with power.
