HEALTH AND SAFETY ALERT

DATE: 10/02/2021

Gantry Operations

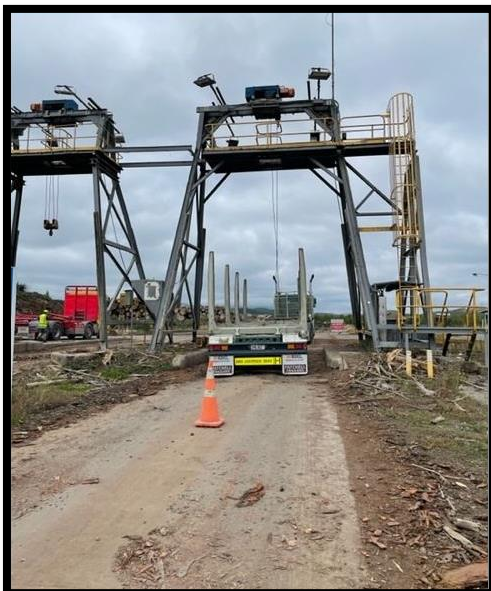
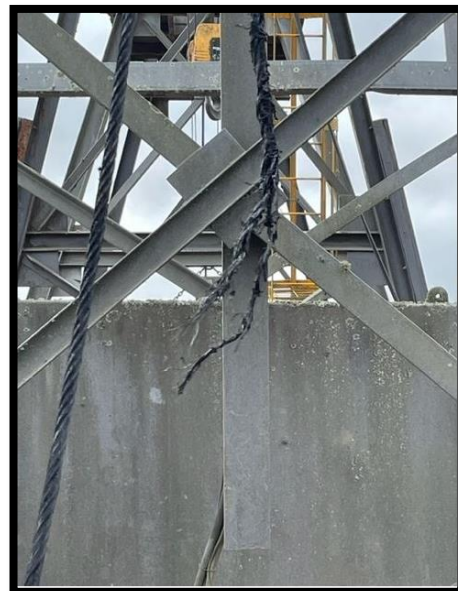
Yesterday an Aztec driver was involved in a serious incident at a gantry where the gantry cable has failed, causing the trailer to drop to the ground. At the time, the trailer has been raised to loading height, in preparation for the truck to be backed under the trailer. Fortunately, the driver was in the correct position, away from the raised load when the incident occurred. The driver had been inducted into the safe use of a gantry and had been following the safe operating procedures.

- When putting a trailer up, drivers shall ensure that they do not jeopardise personal safety.
- Drivers will not position themselves under the chassis of the trailer
- When rotating the dolly, ensure trailer is lifted only to a minimum height in which to complete the procedure safely
- Please be observant of the deterioration of lifting cables or any exposed wires and report it immediately
- In case of emergency make sure you are familiar with the location of the hoist isolation box

Do not - under any circumstance- place yourself under a raised load
