# SAFETY ALERT

## Swing Yarder Tip-Over During Repositioning

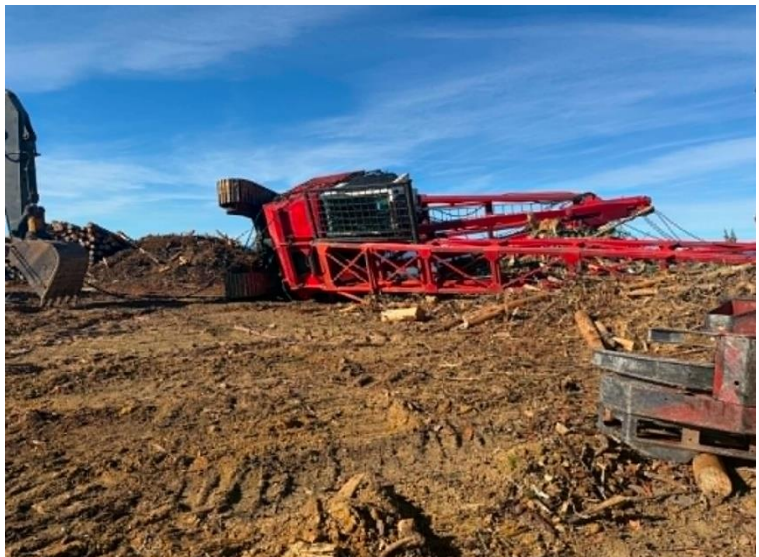
A Madill 123 swing yarder tipped over while being shifted with the tower up. During the process the tail was being slightly raised/lowered to help the Felling machine lift the tail over obstructions on the ridge. With over 1000 m of tail rope out, this created load high on the tower. The machine passed its balance point and tipped onto a slash pile. At the time the Guy anchor (which was walking in conjunction with Yarder along the skid/road) was not directly behind the Yarder as there was limited room due to a slash pile.

- Shifting yarder with tower raised.
- Tail rope tension/loading applied high on tower.
- Different machine stability.
- Slash limiting machine and support excavator positioning.
- No formal procedure for shifting yarder with tower up.
- Multiple machines and operators working in a dynamic task.

Do **not** shift a swing yarder with the tower up unless a move plan and risk assessment has been completed.

- Complete a **Move Plan / Take 5** before any yarder repositioning.
- Confirm rope tensions, tail rope length, terrain, and machine balance risk.
- Position support excavator directly in line with expected pull where possible.
- Avoid movement of tail rope unless the stability risk has been fully assessed.
- Develop and follow a formal SWP for shifting swing yarders with the tower raised.
- Refresher training for operators on centre of gravity and rope loading effects.
